Rear Cap Bracket and Fuel Filter Housing

Bulletin Type:	Recall	Publication Date:	May 2025
Bulletin #(s):	25V-241	Make(s):	Entegra Coach
Job Code(s):	9903625	Model(s):	Aspire (44D, 44R, 44C) Anthem (44D, 44V) Cornerstone (45B, 45D, 45V)
Flat Rate(s):	9903625 .50 HR Rear Cap Bracket Repair		Model Year(s):

Incident:	Rear cap bracket making contact with fuel filter housing.
Affected Units:	2025 - 2026 Entegra Coach Aspire, Anthem, Cornerstone
Parts Kit:25V-241	Parts Kit #: 25V-241
	Part Kit Contents: 1 EA – PLATE,RR CAP SPRT 04.00X06.00 10GA BPC 3 EA –SCREW,HEX WSHR .25X1.00 TEK3 ZC 3 EA – WASHER,FL .25 ZC USS
Misc. Tools & Supplies:	Screw Gun with ¼” Hex Head Driver Bit
Parts Return Information:	N/A

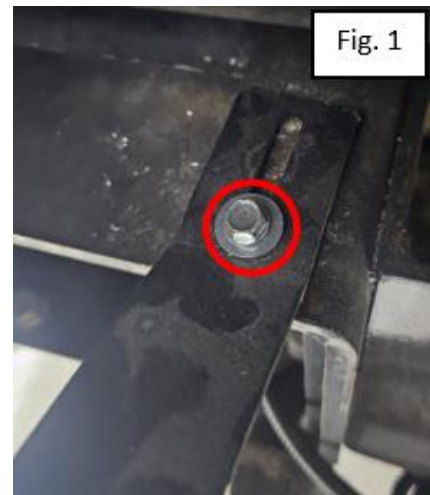
- Using a screw gun and ¼” hex head driver bit, remove the fastener holding the bracket to the chassis frame. (Figure 1)

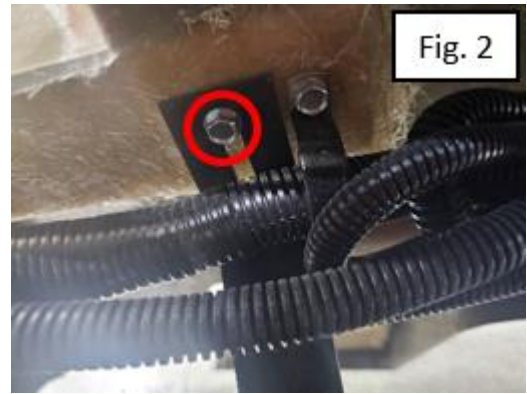
2. Loosen the second fastener between the bracket and the rear cap. (Figure 2)
 - a. **Note: You will only want to loosen this fastener and not fully remove it.**
3. With the bracket loosened, move it over and out of the way.
4. Use two fasteners and two washers to secure the new plate to the chassis frame where the bracket was originally secured. (Figure 3)

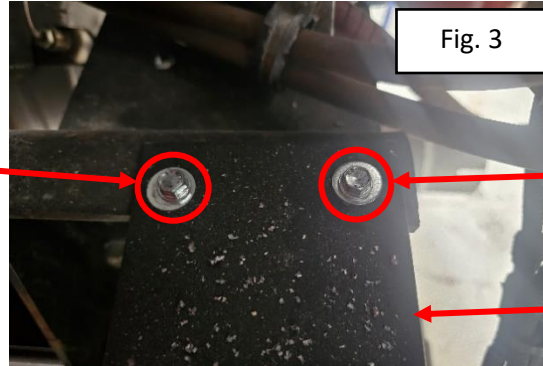
– Screw
– Washer

– Plate

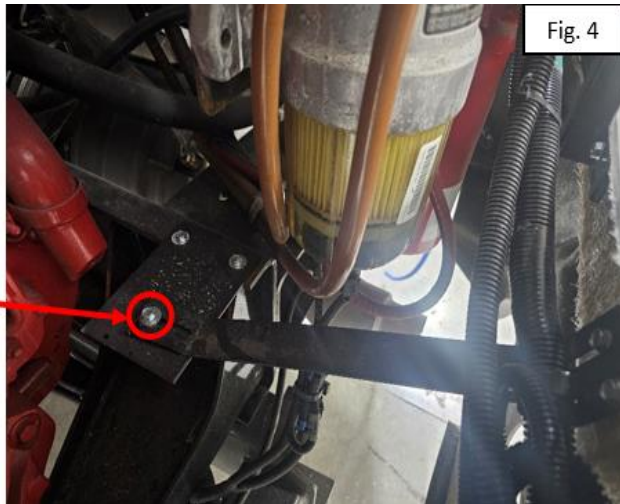
5. Swing the bracket back down and into position over the plate. Then use one fastener and one washer to secure the bracket to the plate. (Figure 4)
6. Re-fasten the screw that was loosened between the bracket and the rear cap. (Figure 5)

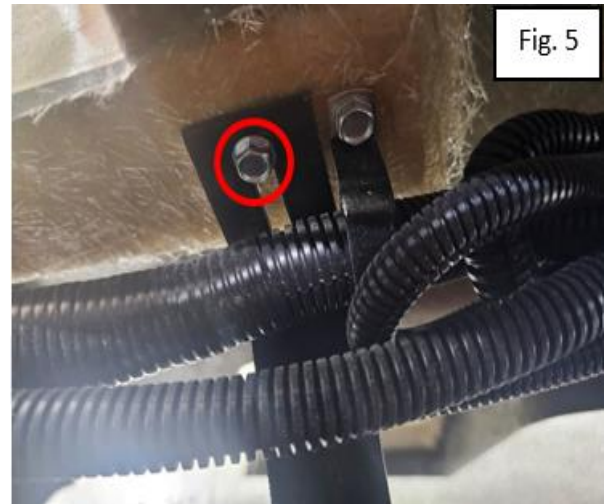
– Screw
– Washer
