SAFETY RECALL BULLETIN

NHTSA RECALL 25V258

AUTOCAR, LLC ACTT-2502

Autocar, LLC has decided that a safety defect exists with the alternator cable routing on certain 2023-2024 model year ACTT (Xspotter) vehicles.

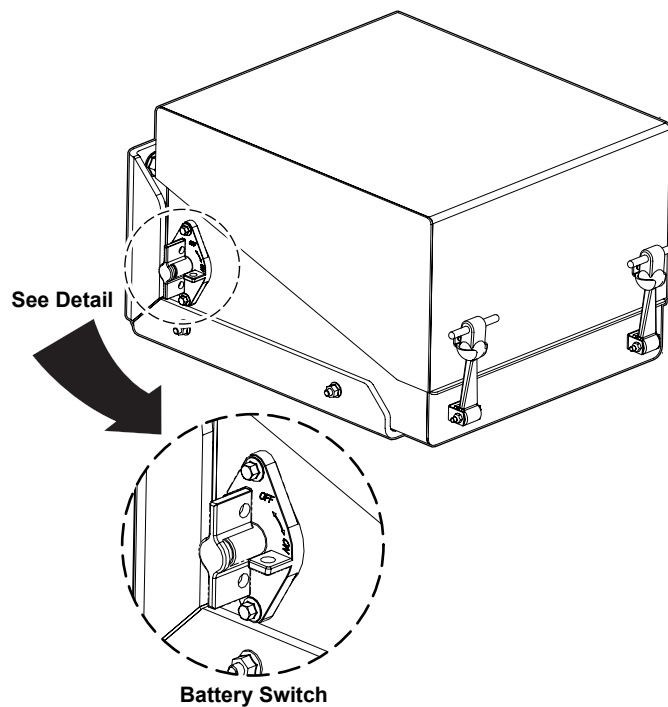
Figure 1

1. Follow all lockout/tagout procedures and verify the battery disconnect switch is in the “OFF” position. If the unit is not equipped with a battery disconnect switch, disconnect the battery cables beginning with the negative cables, followed by the positive cables.
2. Verify that the battery disconnect switch is in the “OFF” position (*see Figure 1*).

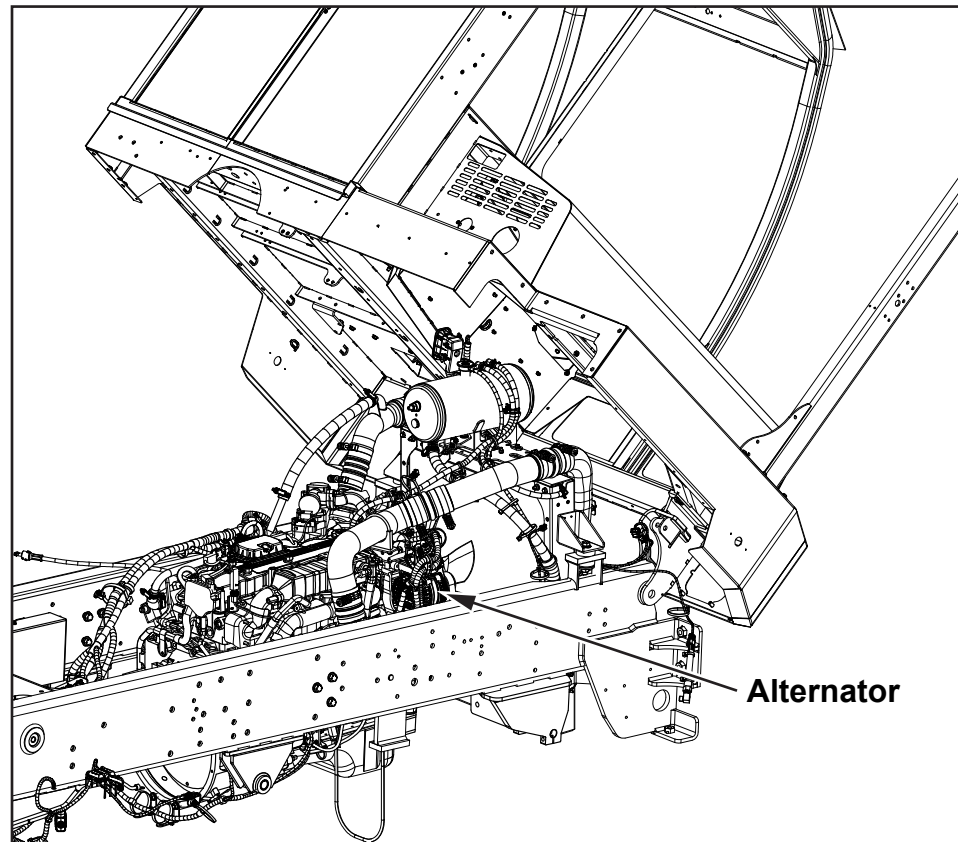
Figure 2

4. Locate the alternator and cables at the right side of the engine (see *Figure 2*).

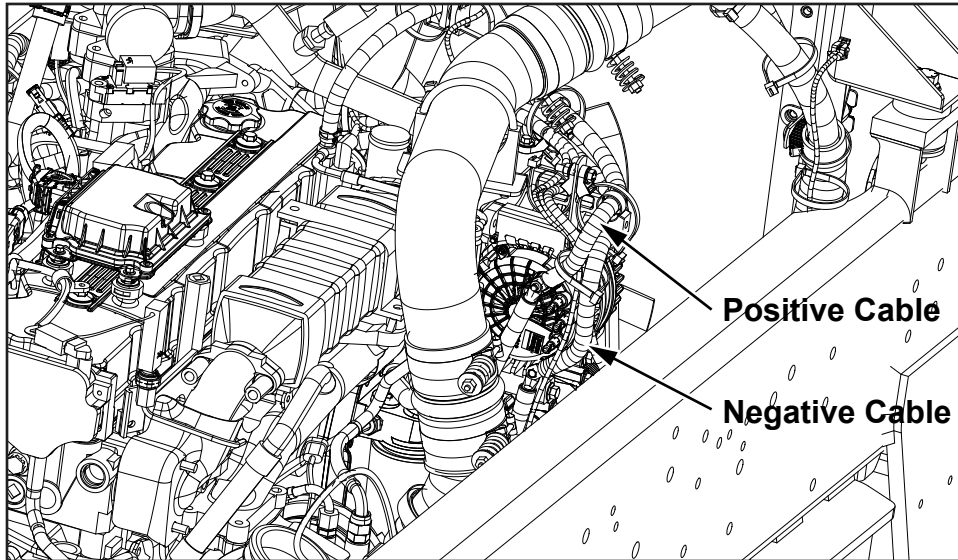
Figure 3

5. Inspect the routing and clipping of the positive and negative cables. Verify there is no rubbing or chaffing of the cables (see *Figure 3*).

6. If the routing is correct, proceed to Step 7. If the routing is incorrect, route and secure all harnesses following proper techniques and verify no rubbing or chafing can occur.
7. Reconnect all battery terminals beginning with the positive connections then the negative connections.
8. Turn the battery disconnect switch to the “ON” position.
9. Installation is complete.
