RECALL 25V278 REMEDY INSTRUCTIONS

FOREST RIVER	Make(s): FOREST RIVER BUS Model(s): SEE BELOW Model Year(s): SEE BELOW	Repair Code: RC-003-00-22-004339 Allotted Time: .50 Inspection Code: N/A Allotted Time: N/A
	Concern: The entry door ground wire may be hooked to a battery positive.	Photo(s) Required: NO Prior Authorization Required: NO Part(s) Kit Number: 1-480698-0 Part(s) Return: NO, FIELD DESTROY

2023-2025 Champion Challenger, Champion Defender
2024-2025 Glaval Entourage
2023-2024 Glaval Universal Transit Buses.

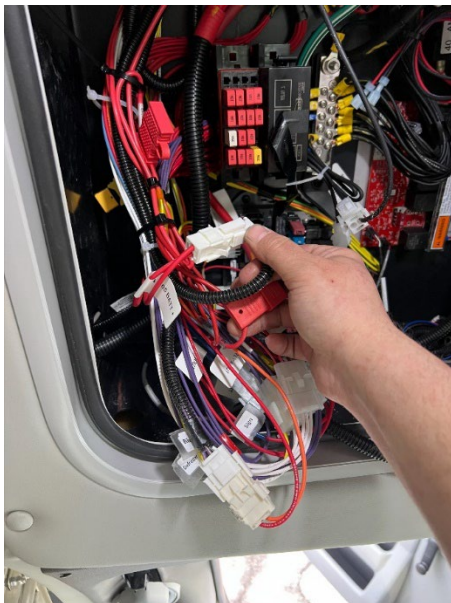
LOCATION OF HARNESS:

STEP 2: LOCATE THE HARNESS "F04 F05 BATT. +" AND UNPLUG THE HARNESS (FIG. BELOW);

STEP 3: INSTALL THE PLASTIC CAP INTO THE "F04 F05 BATT. +" HARNESS FOR PROPER TERMINATION;

- SECURE WITH SEVERAL WRAPS OF ELECTRICAL TAPE;

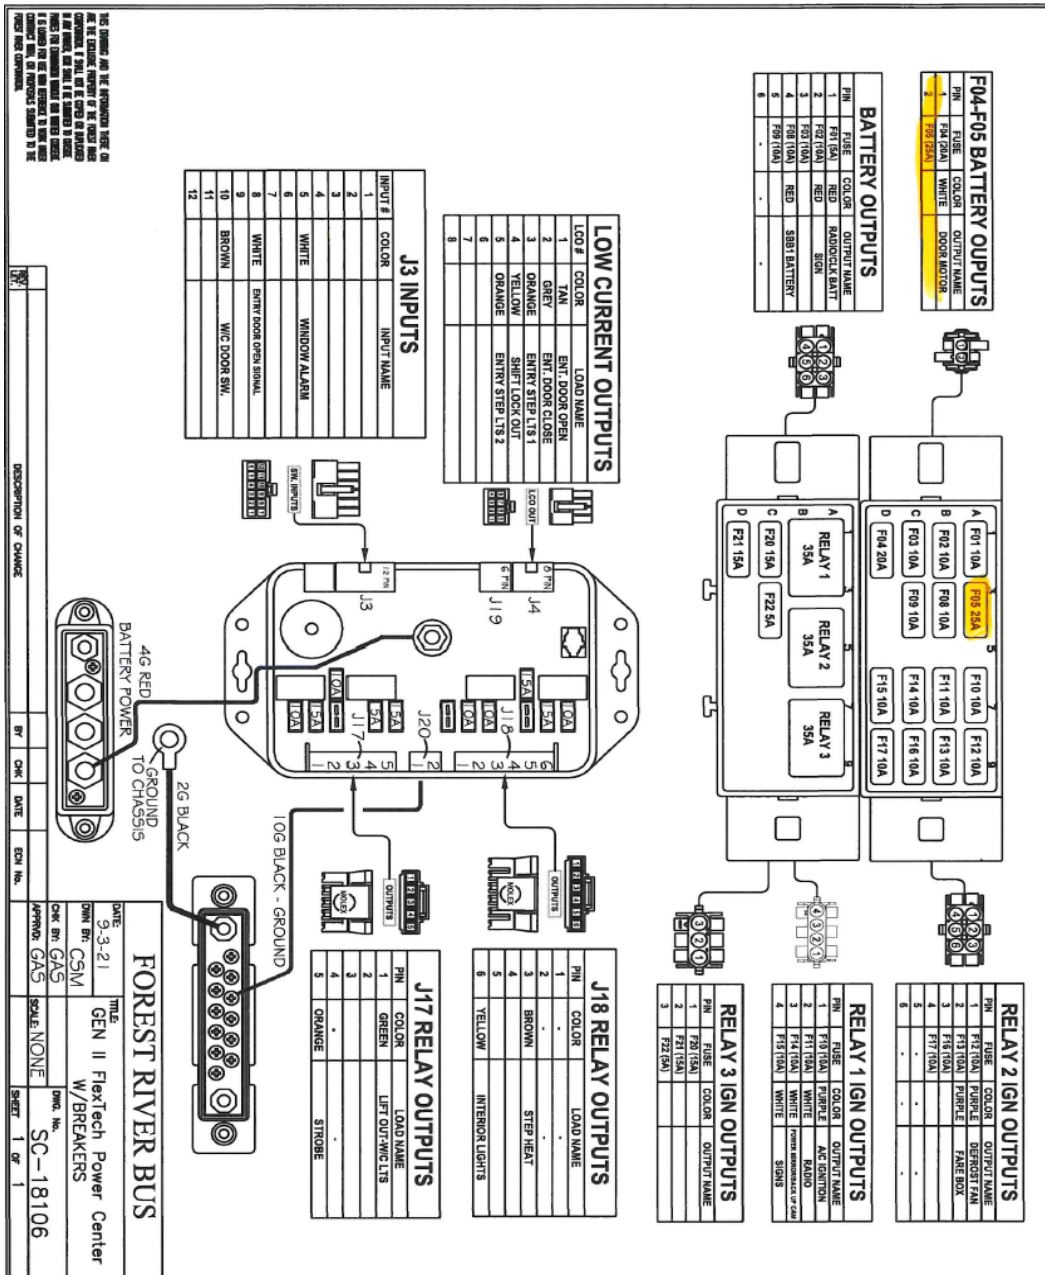
STEP 4: REMOVE THE 25 AMP FUSE LOCATED "F05 25A" LOCATION (SEE ATTACHED DIAGRAM);
