WORK INSTRUCTIONS

MODEL G & Z MORryde PATIO STEP MOUNTING BOLTS RECALL

RECALL:	900008 Model G & Z MORryde Patio Step Mounting Bolts Recall		
PRODUCT:	Model G and Z	REVISION:	REV-B
DATE:	May 8, 2025	LABOR RATE:	0.3 hours

This document refers to Model G and Z Fifth Wheels with MORryde detachable patio steps installed. It applies to all Model G floor plans, between VINs 0919 and 2238. It also applies to Model Z 3400 floor plan between VINs 3269 and 7218.

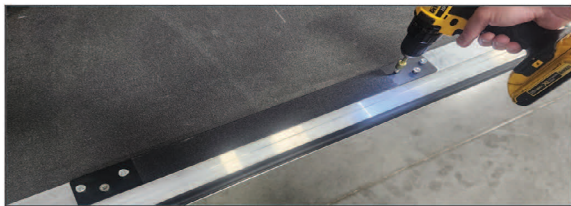
STEP 1

Remove the four mounting screws that secure the STP56-015 mounting bracket. Once removed, discard the original mounting bracket.

Note: It is OK to use a drill for the removal of each of the screws.

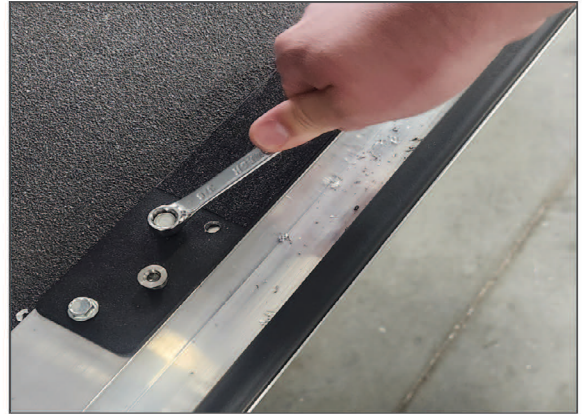
STEP 2

Use the replacement kit (STP54-080) to attach the new mounting bracket. To install the new bracket, start by installing four mounting screws into the four original holes.

Note: The above mentioned holes will line up with the holes from the bracket that was removed.

Note: To avoid over-torquing these screws, it is necessary that final tightening be by hand with a 3/8" wrench.

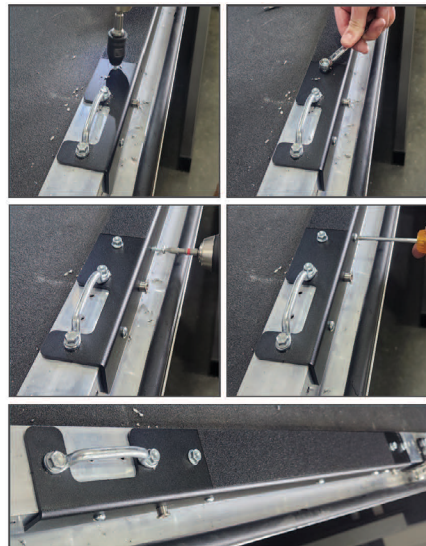
STEP 3

Use a drill and 3/8" driver to install the two new screws on top of the mounting brackets. Then use the drill and #2 square screwdriver to install the two new flathead screws on the front of the bracket.

Note: To avoid over-torquing these screws, it is necessary that final tightening be by hand with a 3/8" wrench and a #2 drive screwdriver.
