MODEL G & Z MORryde PATIO STEP MOUNTING BOLTS RECALL

RECALL:	900008 Model G & Z MORryde Patio Step Mounting Bolts Recall		
PRODUCT:	Model G and Z	REVISION:	REV-A
DATE:	May 2, 2025	LABOR RATE:	0.3 hours

This document refers to Model G and Z Fifth Wheels with MORryde detachable patio steps installed. It applies to all Model G floor plans, between VINs 0919 and 2238. It also applies to Model Z 3400 floor plan between VINs 3269 and 7218.

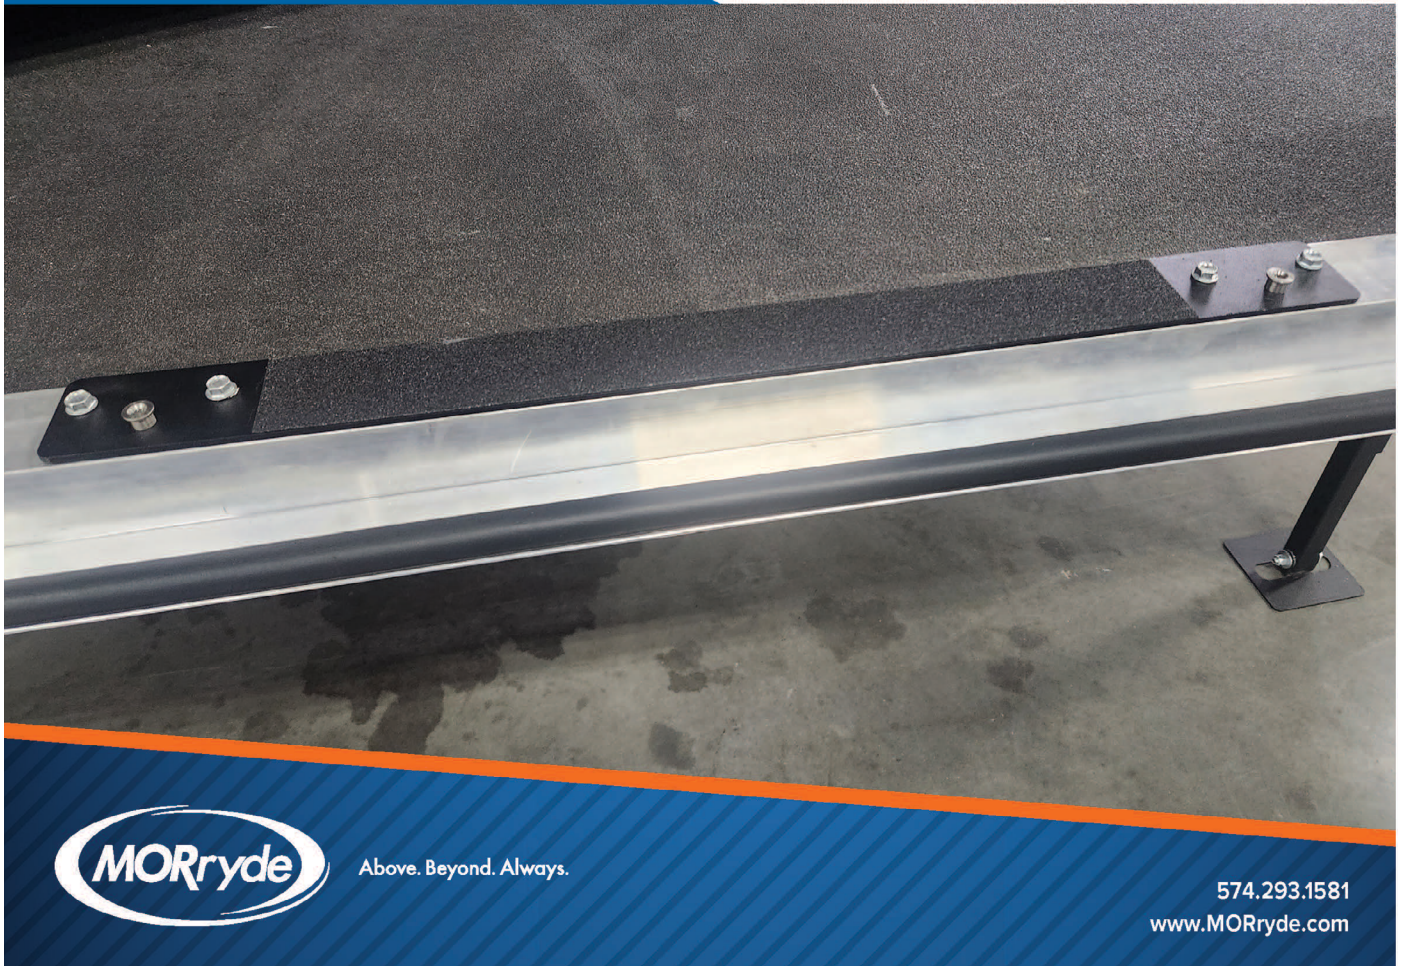
REPLACEMENT INSTRUCTIONS FOR STP56-015

CLIP-ON BRACKET

REPLACEMENT KIT | STP54-080

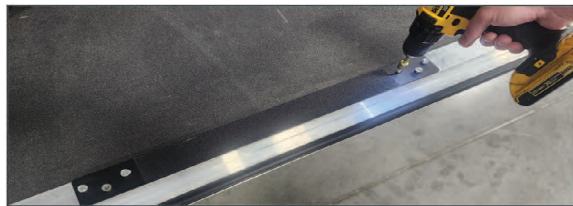
STEP 1

Remove the four mounting screws that secure the STP56-015 mounting bracket. Once removed, discard the original mounting bracket.

Note: It is OK to use a drill for the removal of each of the screws.

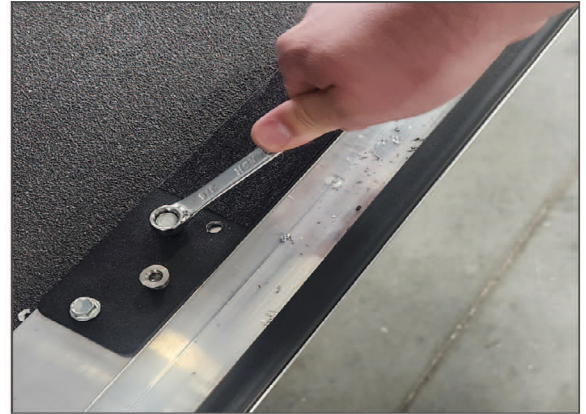
STEP 2

Use the replacement kit (STP54-080) to attach the new mounting bracket. To install the new bracket, start by installing four mounting screws into the four original holes.

Note: The above mentioned holes will line up with the holes from the bracket that was removed.

Note: To avoid over-torquing these screws, it is necessary that final tightening be by hand with a 3/8" wrench.

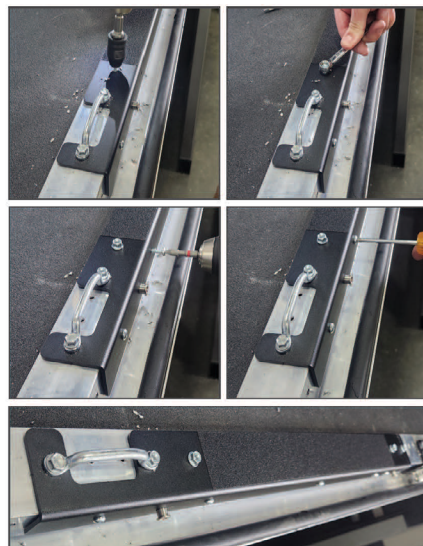
STEP 3

Use a drill and 3/8" driver to install the two new screws on top of the mounting brackets. Then use the drill and #2 square screwdriver to install the two new flathead screws on the front of the bracket.

Note: To avoid over-torquing these screws, it is necessary that final tightening be by hand with a 3/8" wrench and a #2 drive screwdriver.
