# RECALL 25V287 / 2025-235 REMEDY INSTRUCTIONS

<b>FOREST RIVER</b>	Make(s): CAMPSITE RESERVE Model(s): MANY, SEE BELOW Model Year(s): 2025	Repair Code: RC-003-09-00-004715 Allotted Time: .30 HRS. Inspection Code: RC-003-05-00-004714 Allotted Time: .10 HRS.
	Concern: The solar controller may be wired to constant hot of a 30AMP mini-breaker, whereas it should be on the breaker side.	Photo(s) Required: NO Prior Authorization Required: YES Part(s) Kit Number: N/A Part(s) Return: N/A

CERTAIN 2025 – CAMPSITE RESERVE - CRT19KB, CRT26BW, CRT26CJL & CRT26TH

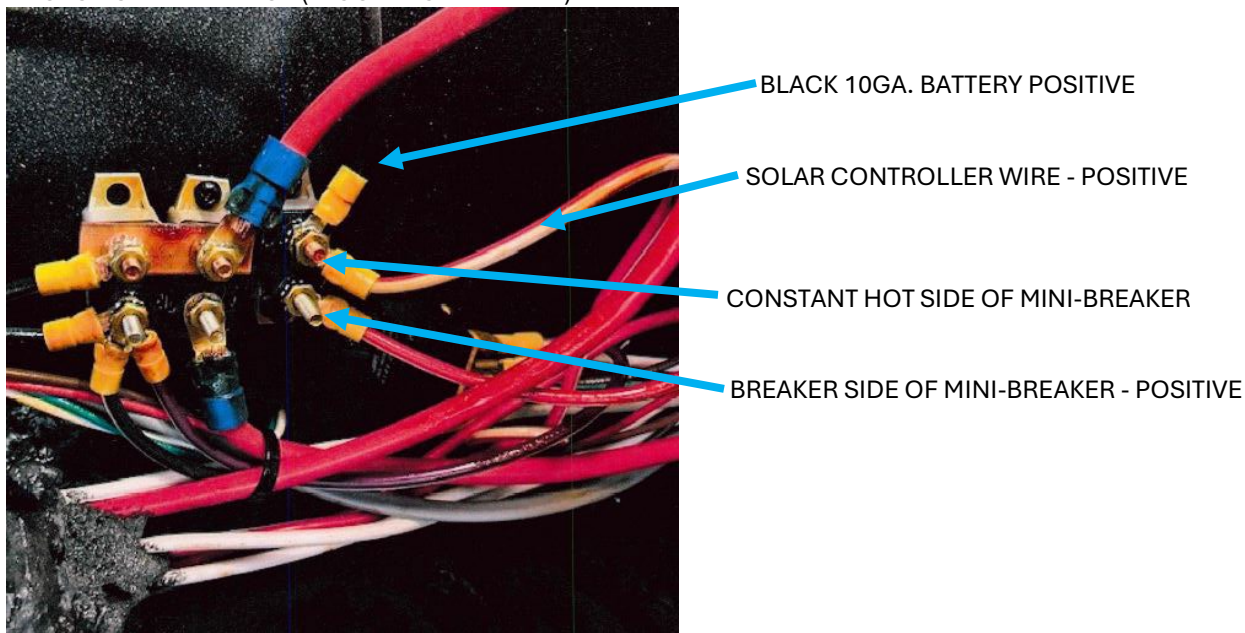
- IF THE SOLAR CONTROLLER WIRE IS HOOKED TO THE SIDE AS THE RED/WHITE WIRE/BREAKER SIDE OF THE MINI-BREAKER, CLAIM INSPECTION ONLY;
- IF THE SOLAR CONTROLLER WIRE IS HOOKED TO THE SAME SIDE AS THE BLACK BATTERY POSITIVE, PROCEED TO REMEDY;

PHOTO FOR REFERENCE (INCORRECTLY WIRED):

STEP 1: LOCATE THE RED/WHITE POSITIVE WIRE FROM THE SOLAR CONTROLLER;

STEP 2: USING A 3/8" SOCKET, REMOVE THE NUT ON THE MINI-BREAKER (BOTH POSTS);

STEP 3: REMOVE THE SOLAR CONTROLLER WIRE FROM THE POST WITH THE BLACK WIRE;

STEP 4: INSTALL THE SOLAR CONTROLLER WIRE ONTO THE POST WITH THE OTHER RED/WHITE WIRE;

STEP 5: REINSTALL THE TWO – 3/8" NUTS AND TIGHTEN DOWN, ENSURING THERE IS NO PLAY IN THE WIRES;
