VOLUNTARY RECALL CAMPAIGN

Classification: EM25-011C	Reference: NTB25-054C	Date: February 26, 2026
------------------------------	--------------------------	----------------------------

VOLUNTARY SAFETY RECALL CAMPAIGN 2024 ROGUE; KR15DDT ENGINE INSPECTION

CAMPAIGN ID #: R25A9
APPLIED VEHICLES: 2024 Rogue (T33)

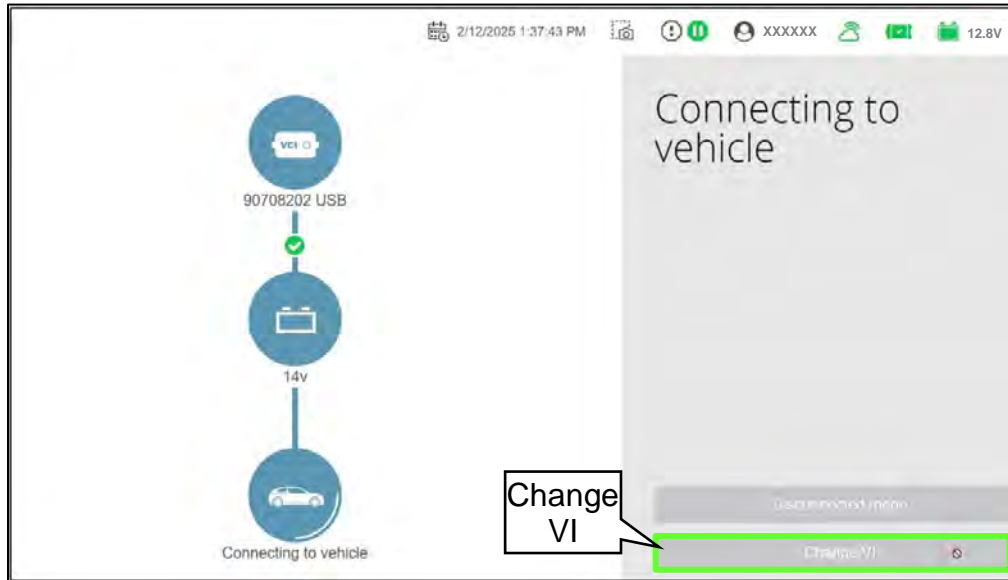
Figure 5

5. Allow the VI3 to connect to the vehicle (Figure 5).

HINT: VI3 may not automatically connect the first-time logging in. If the VI does not automatically connect, select **Change VI** on the RH side of the screen.

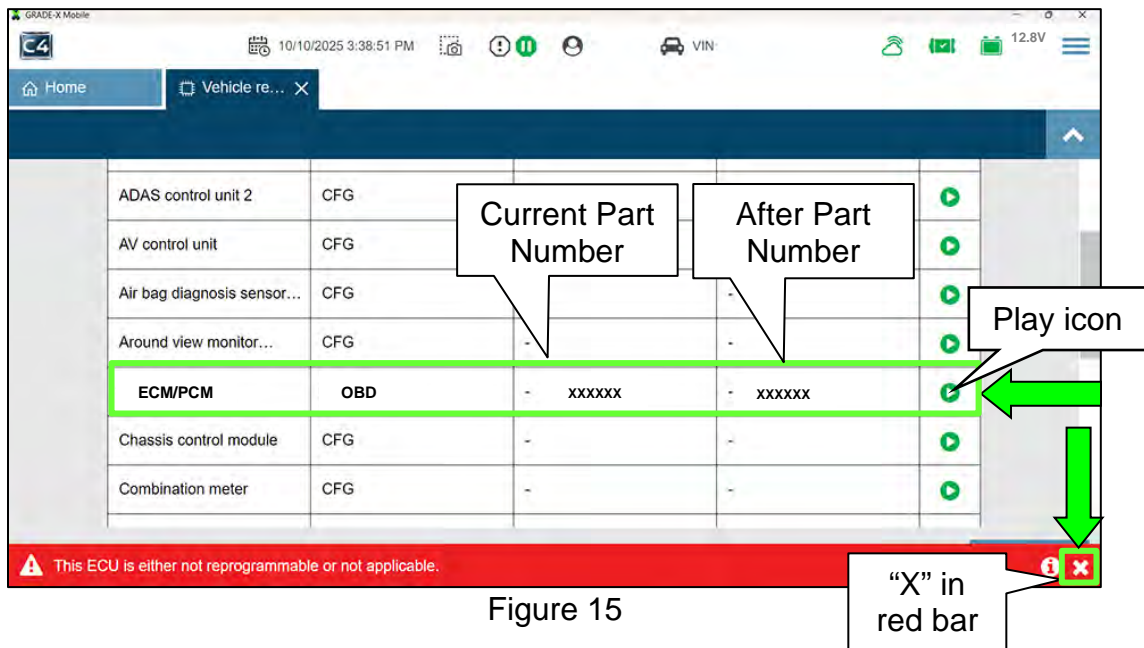
17. Scroll down to locate **ECM/PCM**.

- a. Verify ECM/PCM Current and After part numbers are Present, as shown in Figure 15.
 - o If the ECM/PCM part numbers are present, write them on the repair order and continue to step b.
 - o If the ECM/PCM part numbers are NOT present, continue to **IMPORTANT** below.
- b. Select the “X” at the bottom RH corner, as shown in Figure 15.
- c. Select the “Play” icon for **ECM/PCM**, as shown in Figure 15.

19. Confirm if the **VIN**, **Current part number**, and **Part number after programming** are correct as shown in Figure 15 on page 11, and then select **Next**.

30. Confirm “Previous” and “Current” part numbers match the part numbers shown in Figure 15 on page 11, and then select **Complete**.
