VOLUNTARY RECALL CAMPAIGN

VOLUNTARY SAFETY RECALL CAMPAIGN 2024 ROGUE; KR15DDT ENGINE INSPECTION

CAMPAIGN ID #: R25A9
APPLIED VEHICLES: 2024 Rogue (T33)

Nissan is conducting this voluntary safety recall campaign on certain specific model year 2024 Rogue vehicles equipped with the KR15DDT engine to install new engine software, inspect the engine, and if applicable, replace the engine. This service will be performed at no charge to the customer for parts or labor.

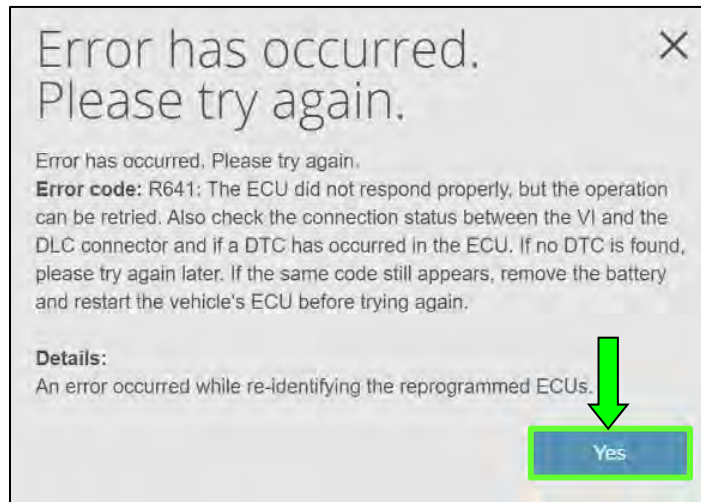
Figure 26

28. If the Error code R641 appears (Figure 26), Select **Yes** and continue to step 29.
 - If the Error code R641 does NOT appear, skip to step 31 on page 18.
