## INSTRUCTION TO SERVICE

| ITS61387 | | DATE:07/14/2025 |
| SUBJECT: | Rework emergency exit window decals – D45CRT EN/SP 57P W/O LAV | |
| ISSUE: | Emergency exits labelling are noncompliant to the requirements of FMVSS Standard No. 277, <i>Bus rollover structural integrity</i> . | |

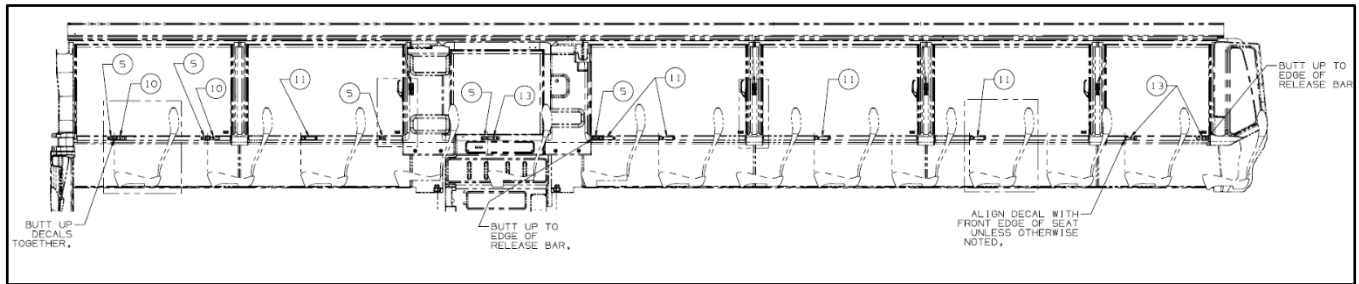
Figure 1: RH Curbside Interior of the Coach

3. On the interior of the coach, locate the new horizontal emergency nameplates.
4. It is important to follow nameplates positioning as shown on Figure 1 and 2 for coach to be safety compliant.

**Note: If the decals exist in the below locations, confirm whether the PNs match. If decals don't match, remove by drilling the rivet and install new decals as per below.**

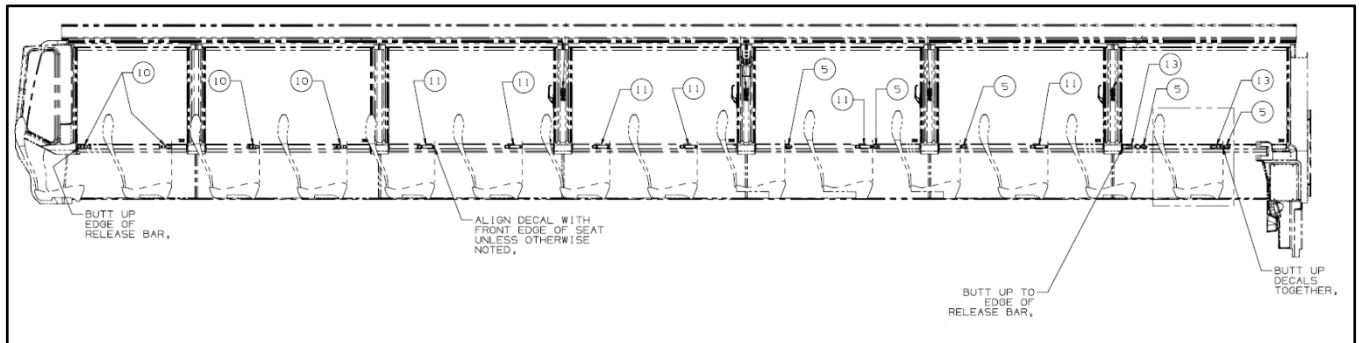
Figure 2: LH Streetside Interior of the Coach

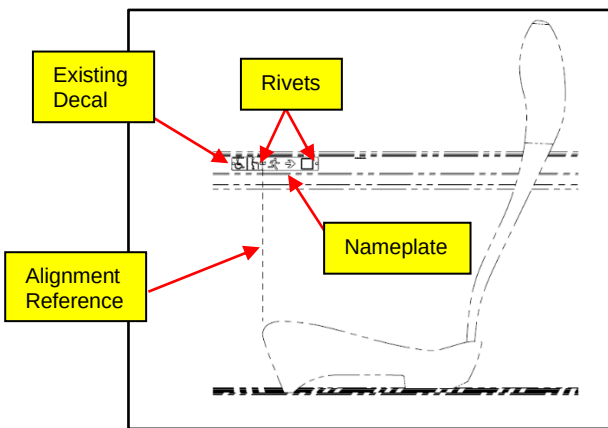
Figure 3: Nameplate and Existing Decal

5. As shown on Figure 3, butt up nameplate together with existing decal (NF PN: 03-15-7278 ref).
6. Position nameplates, items 10 to 13, as close as possible to the front edge of the seat cushion (See Figure 4).  
If there is not enough room to line up with front edge of seat, butt up to edge of release bar as (See Figure 5 and 6).
7. As required, match-drill a 0.12" dia x 0.37" deep hole using the nameplate being mounted as a template.  
Repair/patch up existing unused holes as necessary.
8. Use rivets (NF PN: 19-13-24) to mount new nameplates at the specified locations.

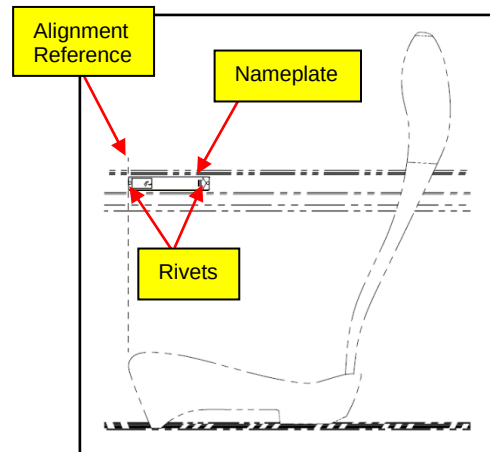
Figure 4: Nameplate Aligned with Seat

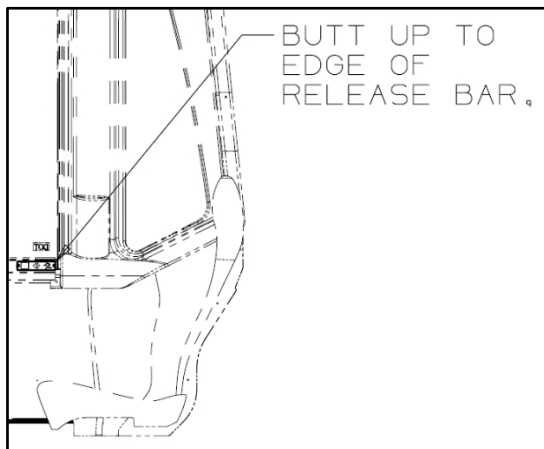
Figure 5: Last Row Seat Configuration

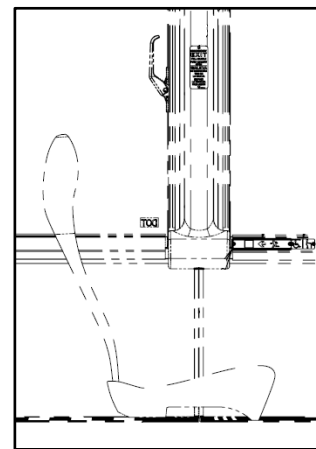
Figure 6: 2<sup>nd</sup> Row Seat configuration Streetside
