# Safety Recall

## N252514930 Fire Risk During Fuel Fill

**Release Date:** November 2025

**Revision:** 02

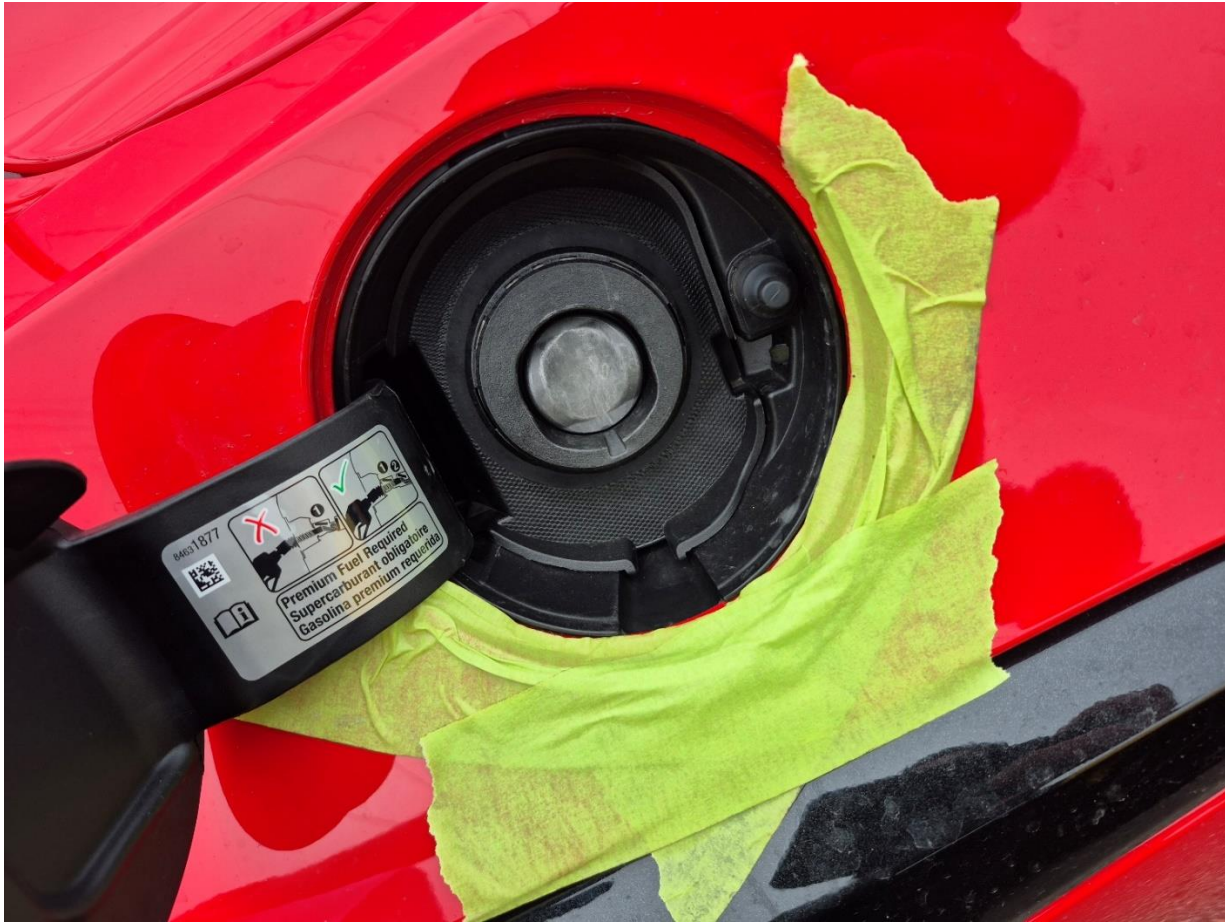
7012032

1. Open the fuel fill door.

2. Install painters tape around the fuel fill door opening as shown.

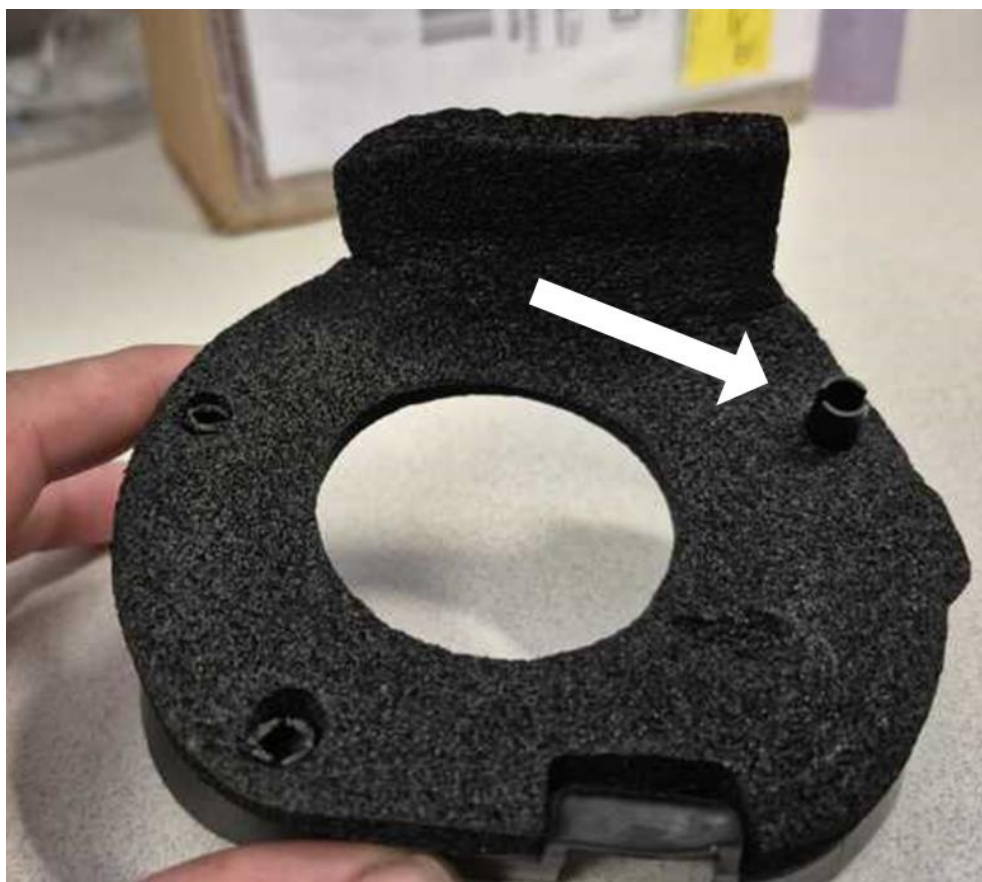
7012575

- If movement is still observed remove the bezel and inspect the rear of it. There should be only one mounting tab as shown. If that mounting tab is broken, install a new bezel starting at step 5.
- If that mounting tab is NOT broken and you are still observing movement, you are not fully seating the bezel. Reinstall it starting at step 5 and be sure to fully seat it.
- If movement is not observed, you may remove the protective tape and paper, no further action is required.
