# INSTRUCTION TO SERVICE

| ITS61626 | | March 19, 2026 |
| SUBJECT: | Replace XALT ESS batteries with ABS ESS batteries on XE35 5 str | |
| ISSUE: | Freudenberg Gen 3 batteries (XMOD125E, XMOD123E, XMP123E) recall. | |

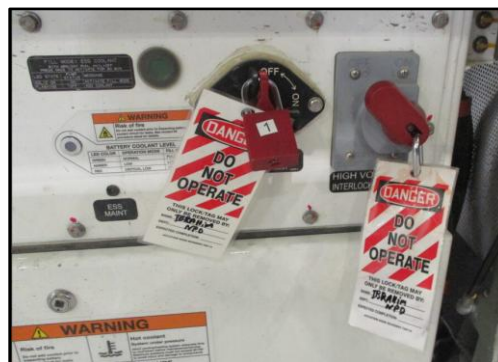
**Figure 1: Main Battery & HV Disconnect Switches**

4. Drain the air from the rest of the air system.
5. Turn the main battery disconnect switch to the “OFF” position.
6. Turn the HV interlock switch to the “OFF Position.

7. Tag and lockout the switch.

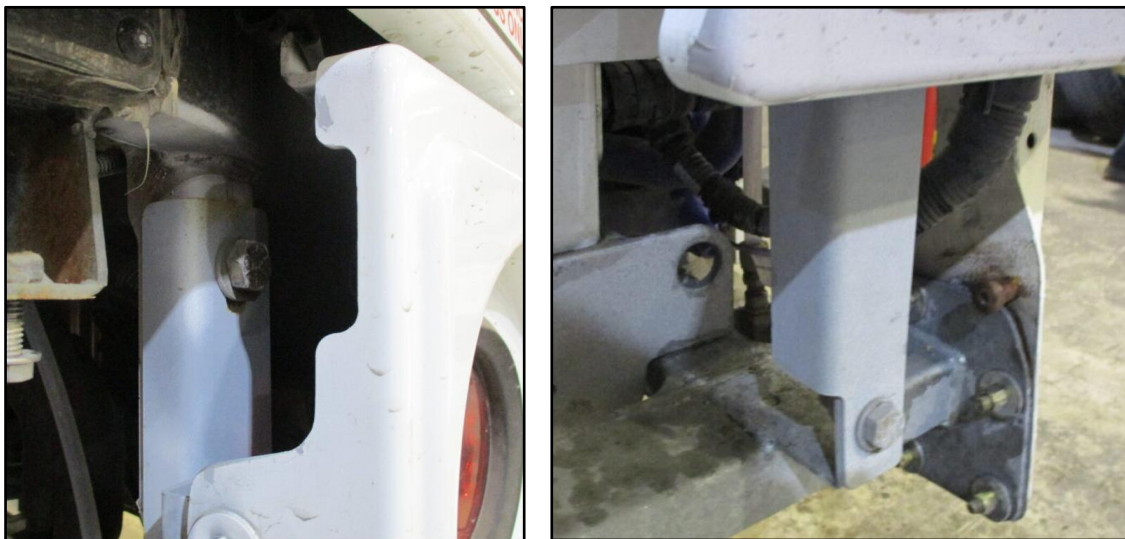
**Figure 6a & 6b: Pillar Structure Attachment Points**

19. Unbolt the rear bumper. Note the number and location of any alignment shim that may be present to aid in re-installation later. Remove the bumper and set it aside.
20. Disconnect the wiring connectors for the taillights and any hose clamps or tie straps connected to the corner pillar structure behind the rear lights next to the rear door opening. Remove the nut and bolt at the top and bottom of the pillar structure and carefully free the structure and taillight surrounds from the vehicle. Set them aside in a safe location.

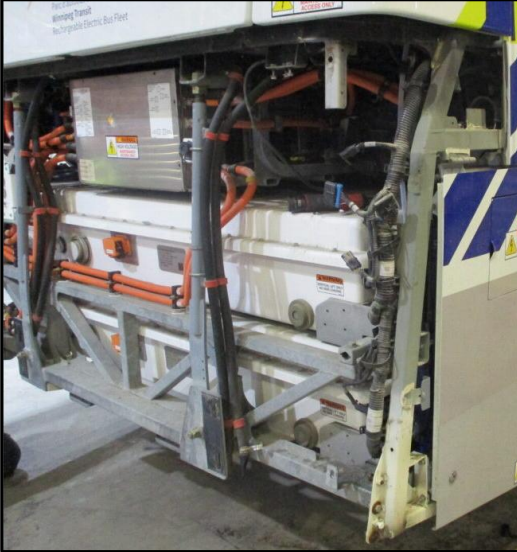
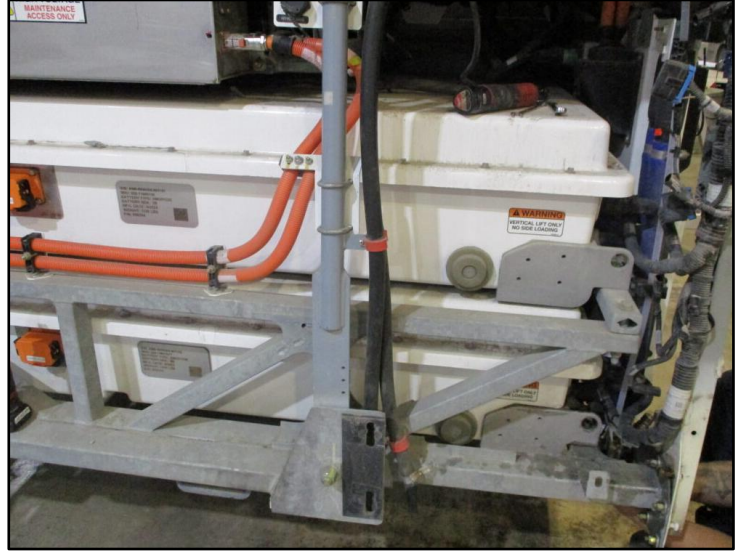
**Figure 7a & 7b: Rear Struts, HVAC Drains & HV Cable Mounts**

21. Disconnect the HVAC drain lines that are attached to the rear vertical struts at three points. Set the hardware aside for reuse and tuck the HVAC drains away above the HV box.
22. Disconnect the bracket for the HV cables attached to the curb side vertical strut.

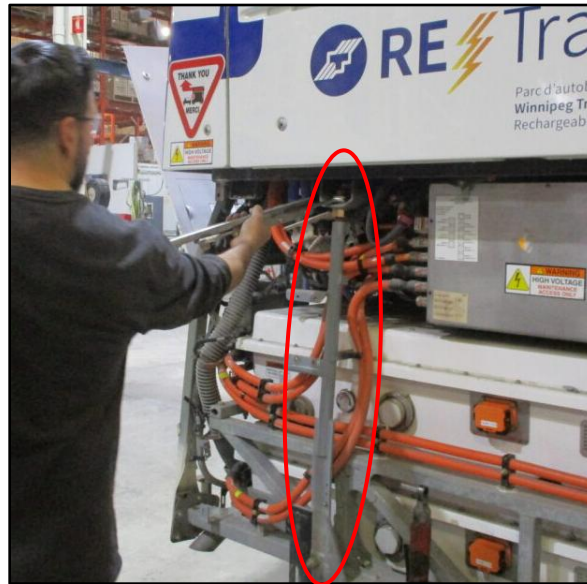
**Figure 9: Loosening Strut Hardware**

24. Remove the upper and lower nuts on the two vertical struts at the rear of the bus using a socket and large breaker bar.

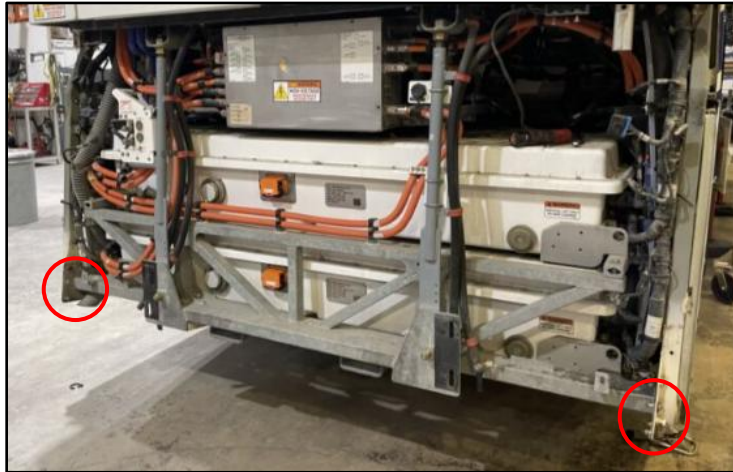
**Figure 13: ESS Cradle Cross Member Hardware Removal**

31. Remove the bolts of the ESS cradle cross member at each rear lower corner of the bus chassis, remove the four bolts at each side and set the hardware aside.

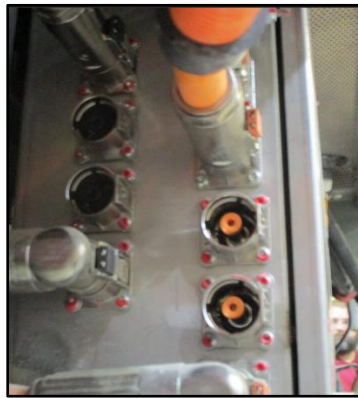
**Figure 14: HV Cables Disconnected on Streetside of HV Box**

32. Disconnect the four HV cables that run from the ESS units to the streetside of the High Voltage box.

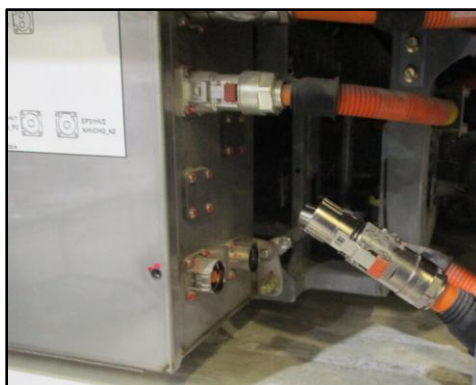
**Figure 15: HV Cables Disconnected on Curbside of HV Box**

33. If applicable, disconnect the two HV cables that run from the ESS units to the curbside of the High Voltage box. Cover the connectors with bags to prevent corrosion.

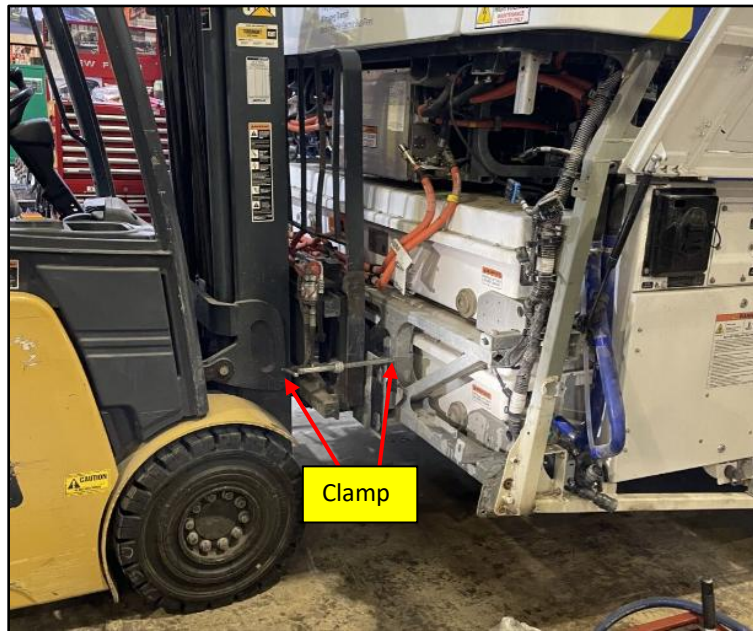
**Figure 18: ESS Cradle Secured to Forklift**

36. Position an appropriately sized fork-lift truck behind the bus and carefully insert the forks into the fork brackets on the underside of the ESS cradle. Secure the cradle to the forklift with two large clamps.

**Note:** There is some compressive force exerted on the sides of the ESS cradle by the bus frame. The clamps will prevent the forks pulling out from under the cradle during the removal procedure.

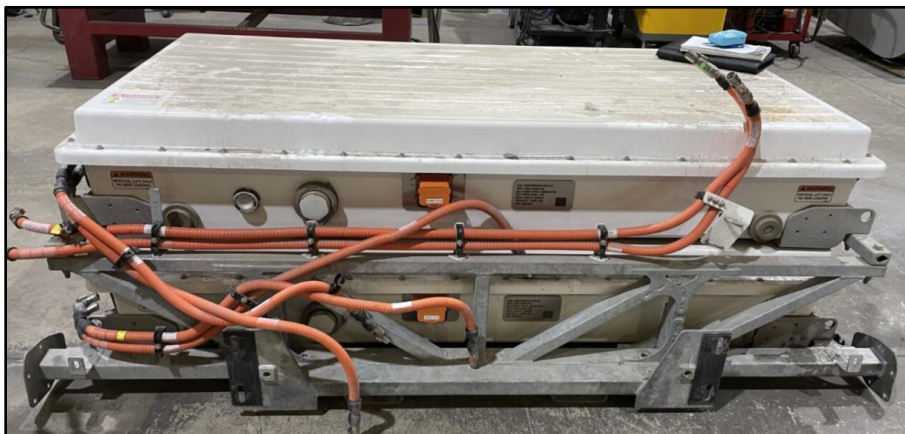
**Figure 19: ESS Cradle on the Floor**

37. Place the ESS rear rack assembly on the floor or area for ESS enclosure removal.

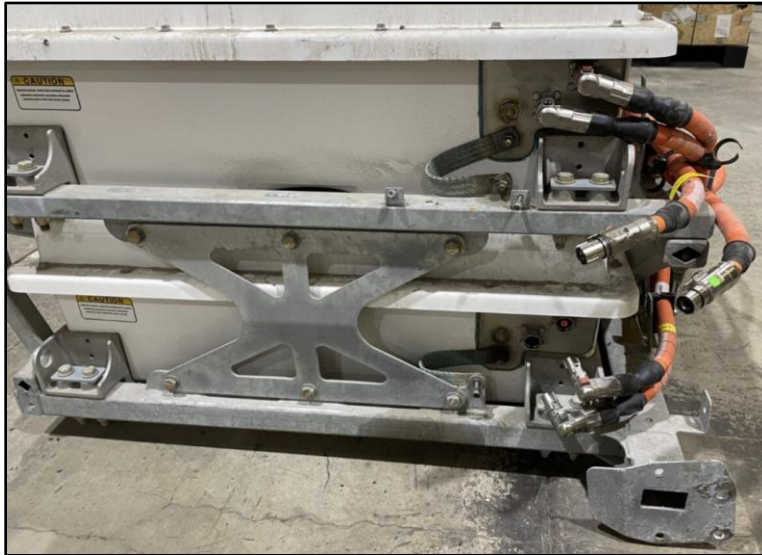
**Figure 20: ESS Rack Assembly Side View**

38. Disconnect electrical connections and ground straps. Cover all electrical connectors.
39. Remove the eight bolts that secure each ESS unit to the ESS rack and set the hardware aside.

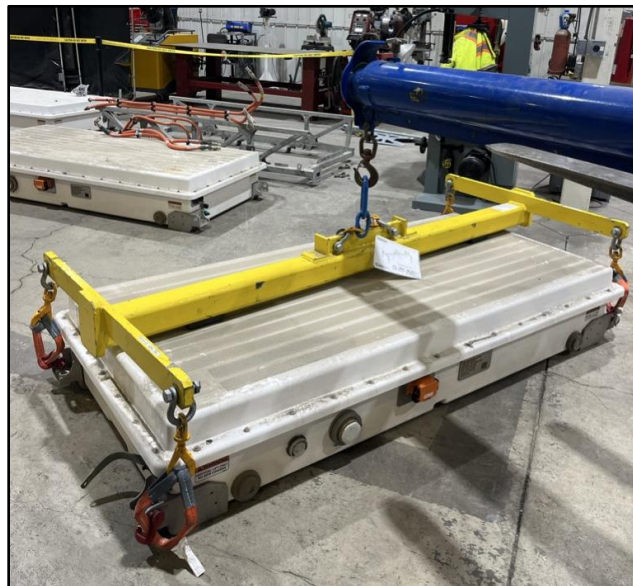
**Figure 21: Lifting ESS**

40. Position the boom over the rear top ESS unit to be lifted.
41. Attach the boom to the lift points at each corner of ESS unit.
42. Carefully lift the ESS from the rack and place it on the floor.

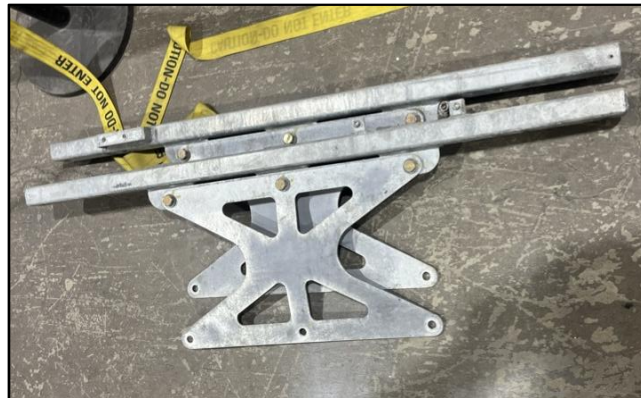
**Figure 23: Rear Upper Rack Assemblies**

44. Set the upper rear upper rack assemblies and mounting hardware aside for reinstallation later.

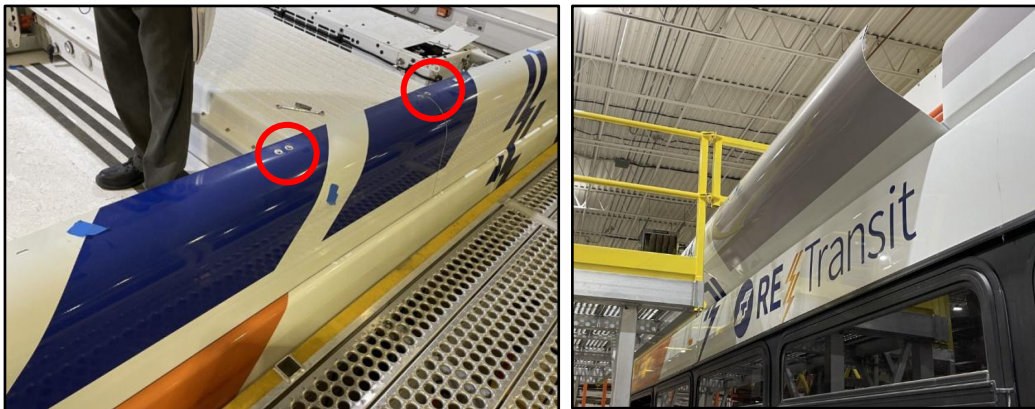
**Figure 25: Sidescreen Access Panels**

48. Access the roof of the bus. Remove and set aside the bolts that secure the roof side panels to the side panel mounting towers and pivot the panels to the open service position. Once the panels are open reposition the scaffolding if necessary.

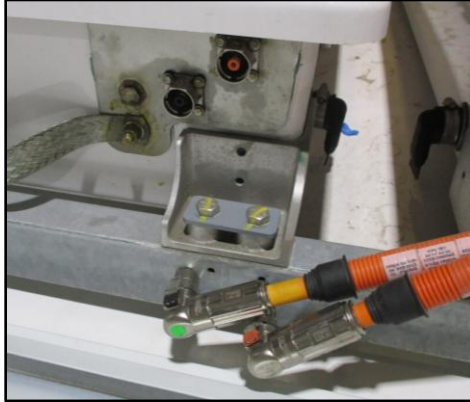
**Figure 27: HV Cables Disconnected on Streetside of Rooftop ESS Enclosure**

60. Access the roof of the bus using appropriate scaffolding and fall protection safety equipment.
61. Disconnect the two High Voltage cables on the streetside of each ESS unit on the roof.

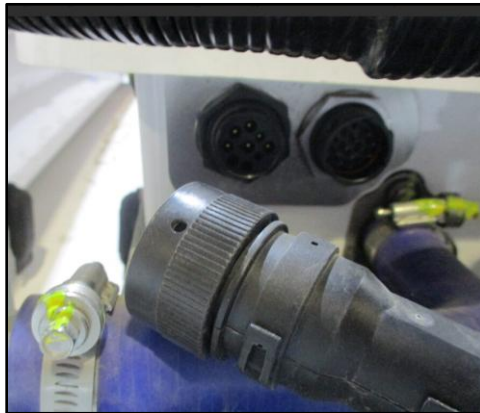
**Figure 28: LV Cables Disconnected on Curbside of Rooftop ESS Enclosure**

62. Disconnect the Low Voltage cables on the curbside of each ESS unit on the roof.

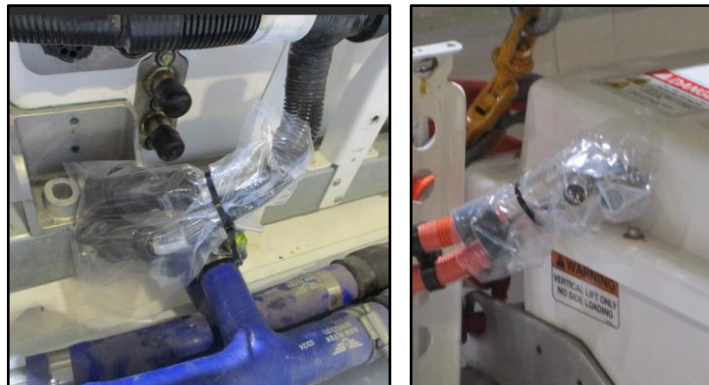
**Figure 29a & 29b: Bagged Electrical Connectors**

63. Place plastic bags over all the electrical connectors to ensure that they remain clean and dry.

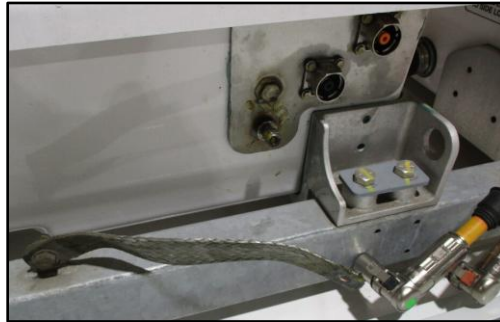
**Figure 30: Ground Cable Disconnected on Streetside of Rooftop ESS Enclosure**

64. Disconnect the ground strap on the streetside of each ESS unit near the HV connectors.

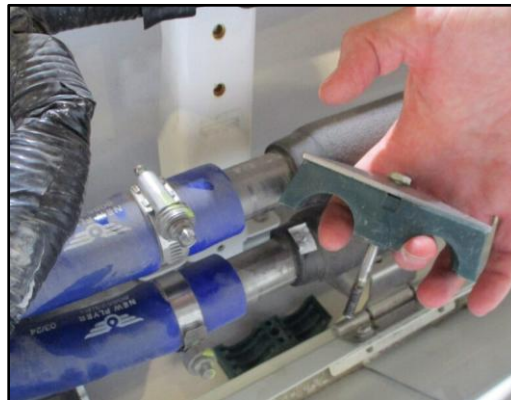
**Figure 31: Twin Clamps Disconnected on Curbside of Rooftop ESS Enclosure**

65. Disconnect the twin clamps near the coolant hose connections on the curbside of each rooftop ESS unit.

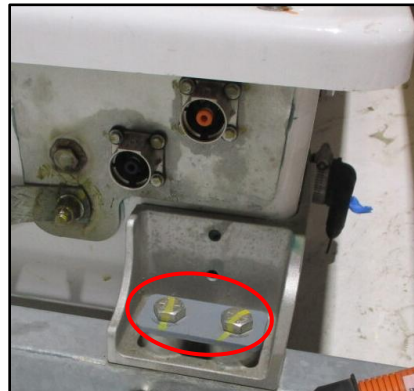
**Figure 34: Mounting Hardware**

70. Remove the eight bolts that secure each ESS unit to the ESS rack. Discard the existing bolts and ESS support plates as new hardware will be provided.

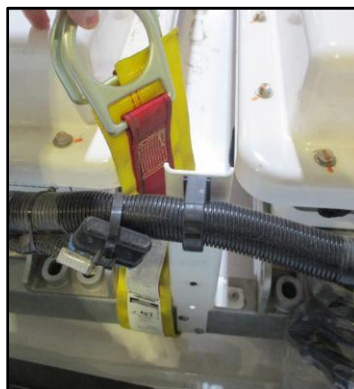
**Figure 35: Safety Hook Attached to ESS Rooftop Rail**

71. Prior to removing the scaffolding on the scaffold on one side of the bus install safety strap hooks on the ESS rack to allow for the connection of a fall protection safety harness.

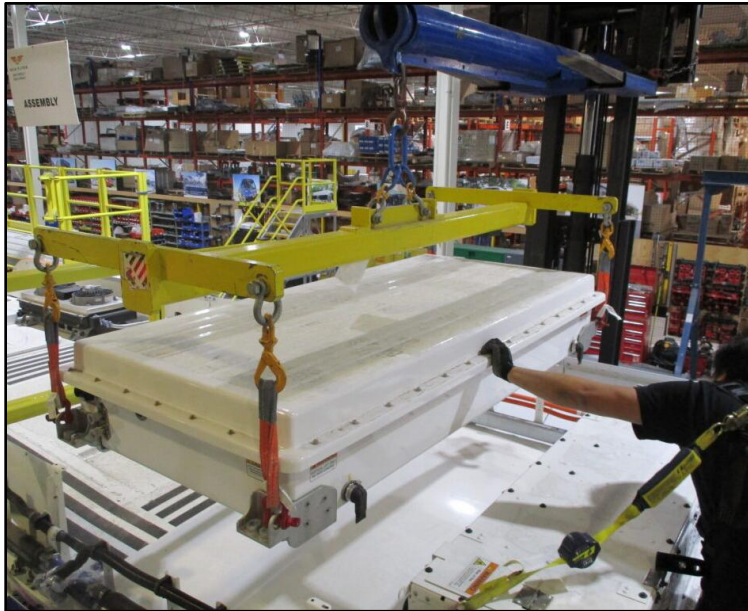
**Figure 36: Lifting the ESS from Rooftop**

72. Position an appropriately rated forklift truck and lifting boom next to the bus.

- Position the boom over the ESS unit to be lifted.
- Attach the boom to the lift points at each corner of ESS unit.
- Carefully lift the ESS from the roof of the bus and place it on the floor.

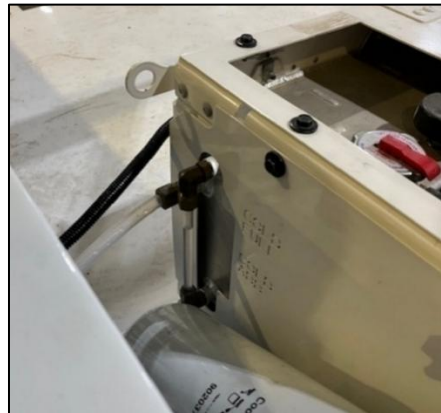
**Figure 42: BTMS Sight Glass**

84. Inspect sight glass and ensure fluid shows clear.

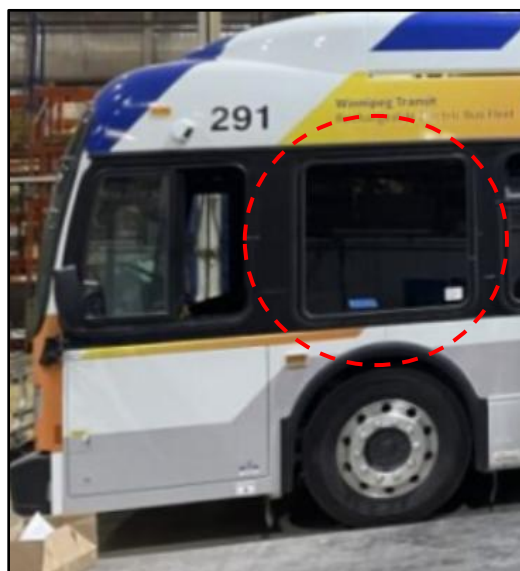
**Figure 48: SDS Window**

97. Gain access to SDS panel by opening the SDS window.

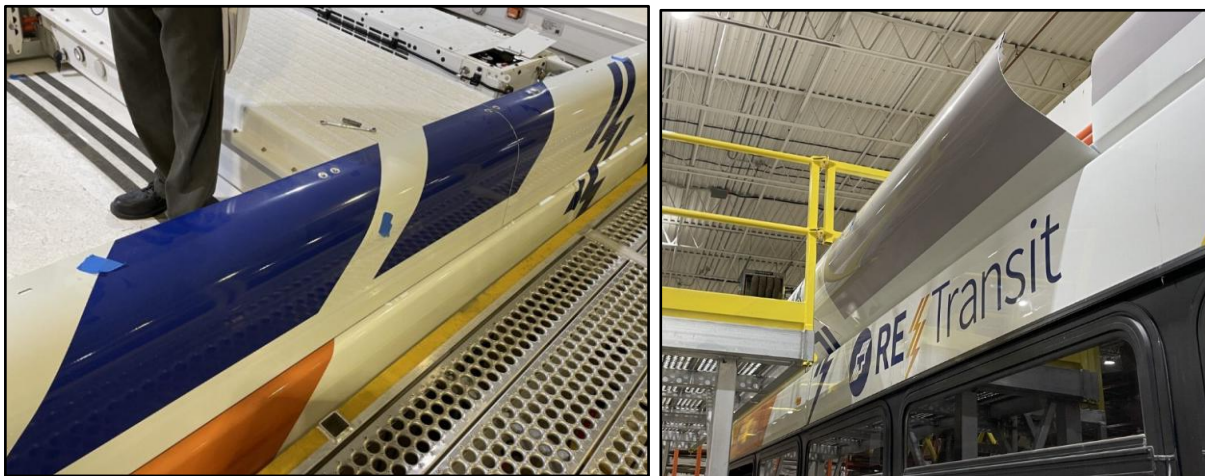
**Figure 69a & 69b: Sidescreen Access Panels**

141. Flip close the curbside side screen panels and re-install the existing hardware applying one or two drops of Loctite to their threads and torque to 50 in-lbs. Reapply torque marks.

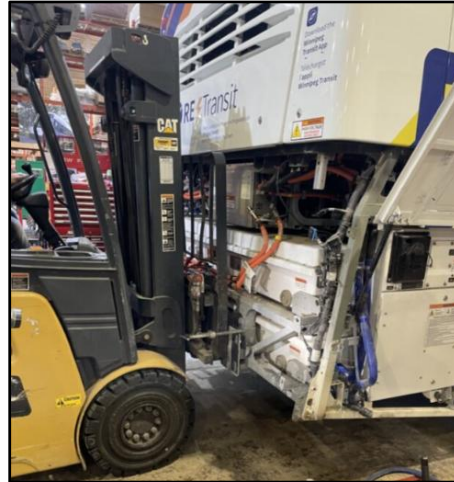
**Figure 77: Rear Rack Assembly with ABS Packs Installation**

162. Lift the bus to a reasonable height for rear rack assembly reinstallation.
163. Using a forklift, carefully install the ESS battery rack assembly back inside the vehicle and align the mounting holes to the vehicle structure.

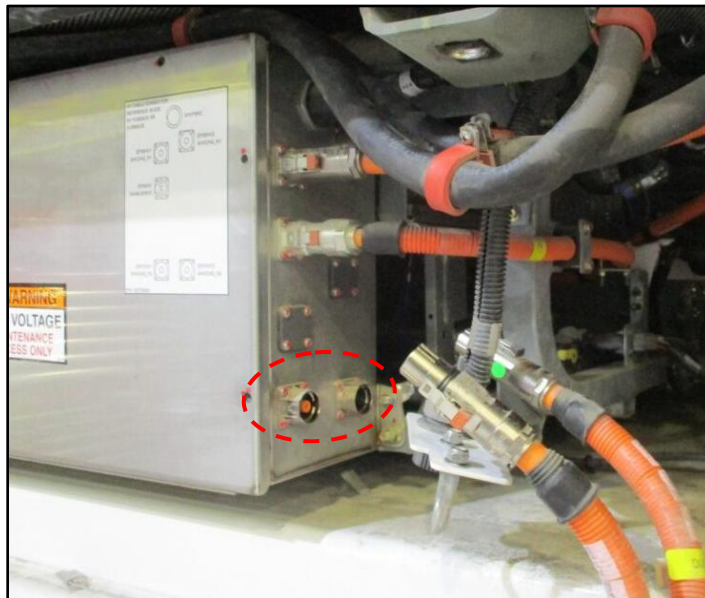
**Figure 89: HV Box Curbside Connections**

182. If applicable, reconnect the two HV cables that run from the ESS units to the curbside of the High Voltage box. Follow the HV box connectors decal for connections.

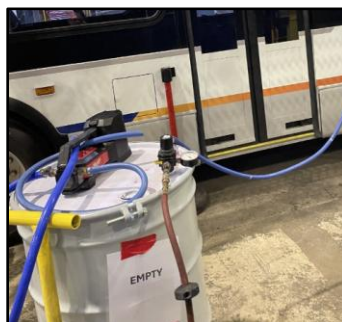
2. Ensure the pressure relief cap on the coolant fill neck is tight and the pressure relief lever on the cap is closed. The BTMS cover must be removed and the 4 psi pressure relief cap replaced with the high pressure test rad cap (NF PN: 590112).
3. Ensure all drain cocks are closed and all drain plugs are installed.
4. Ensure all shutoff valves are open.
5. Remove the cap on the pressure fill port and set aside.
6. Remove the cap on the overflow tank (if applicable).
7. Connect the leak down tester (NF PN: 594400 or 660817) to the system pressure test/fill port and close the 1/4 turn shutoff valve on the test tool.
8. Secure test apparatus and hose to prevent personal injury or damage to coach while conducting the pressure test.

9. Attach a shop air line to the quick coupler on the pressure tester.
