# INSTRUCTION TO SERVICE

| ITS61688 | | April 25, 2026 |
| SUBJECT: | Replace XALT ESS batteries with ABS ESS batteries on XE40 6 str | |
| ISSUE: | Freudenberg Gen 3 batteries (XMOD125E, XMOD123E, XMP123E) recall. | |

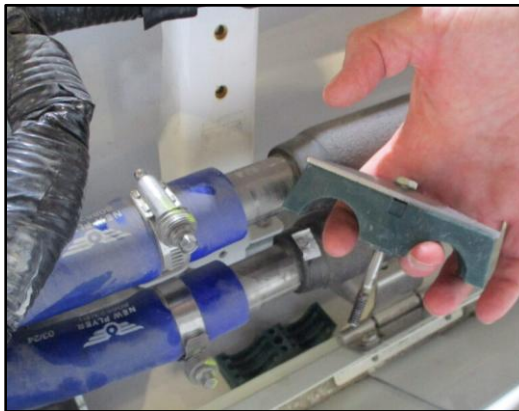
**Figure 31: Twin Clamps Disconnected on Curbside of Rooftop ESS Enclosure**

66. Disconnect the twin clamps near the coolant hose connections on the curbside of each rooftop ESS unit.
