# INSTRUCTION TO SERVICE

| ITS61649 | | April 7, 2026 |
| SUBJECT: | Replace XALT ESS batteries with ABS ESS batteries on XE40 6 to 5 str | |
| ISSUE: | Freudenberg Gen 3 batteries (XMOD125E, XMOD123E, XMP123E) recall. | |

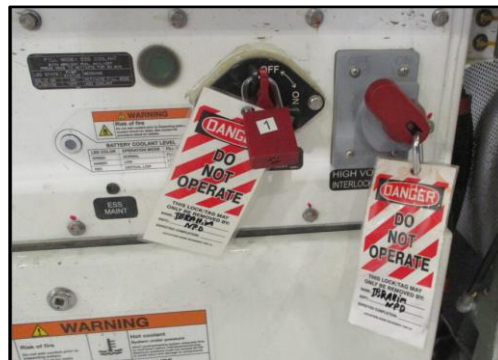
**Figure 1: Main Battery & HV Disconnect Switches**

4. Drain the air from the rest of the air system.
5. Turn the main battery disconnect switch to the “OFF” position.
6. Turn the HV interlock switch to the “OFF Position.

7. Tag and lockout the switch.

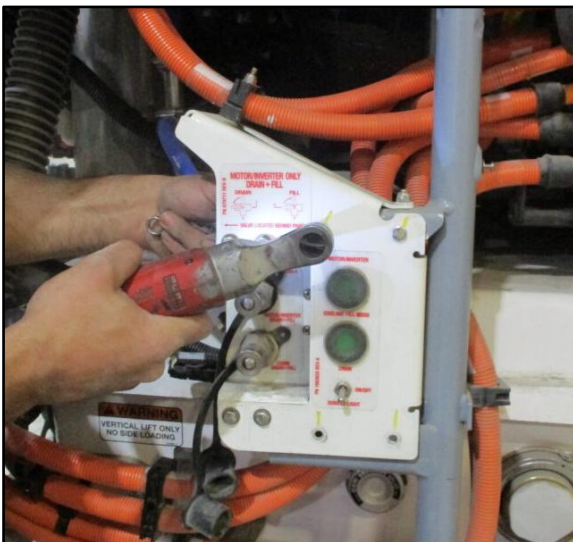
**Figure 8a & 8b: Motor/Inverter Coolant Fill Panel**

23. Remove the five bolts that secure motor / inverter coolant fill panel. Remove the two twin clamps that secure the HV cables above and behind the fill panel and set them aside. Disconnect the electrical connectors to the fill panel lights and flip the panel upwards out of the way. It is not necessary to disconnect the motor / inverter fill lines.

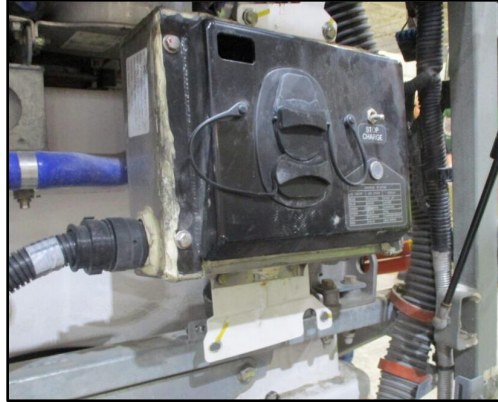
**Figure 11: Charger Box Mounting Hardware & Cable Connection**

27. Locate the charger box on the streetside rear of the bus. Disconnect the HV cables and remove the bolts that attach the charger box to the ESS cradle. Let the Charger box hang.

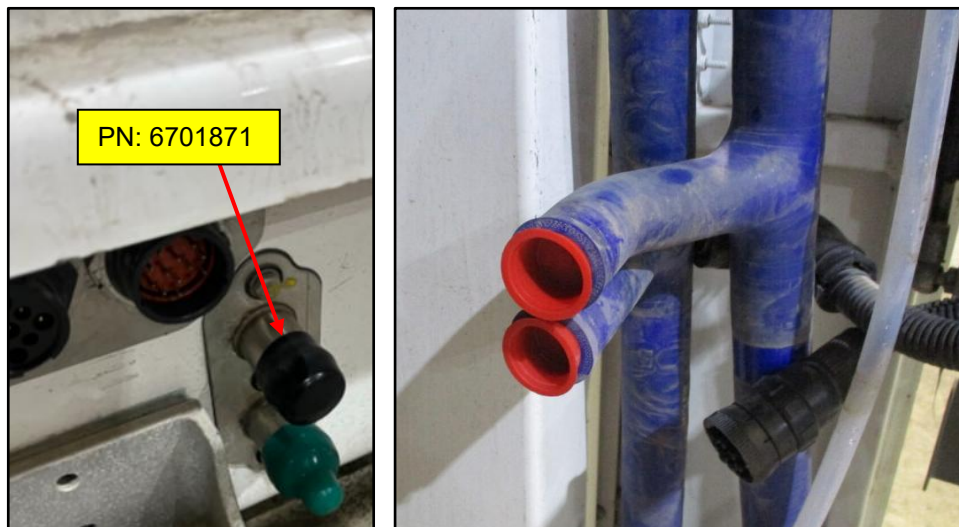
**Figure 12: Plugged Coolant Hoses**

29. Install coolant port caps (NF PN: 6701871) on ESS to prevent leaks.  
30. Install plugs or cover all the ESS hose connections to prevent dirt and debris entering the cooling system.

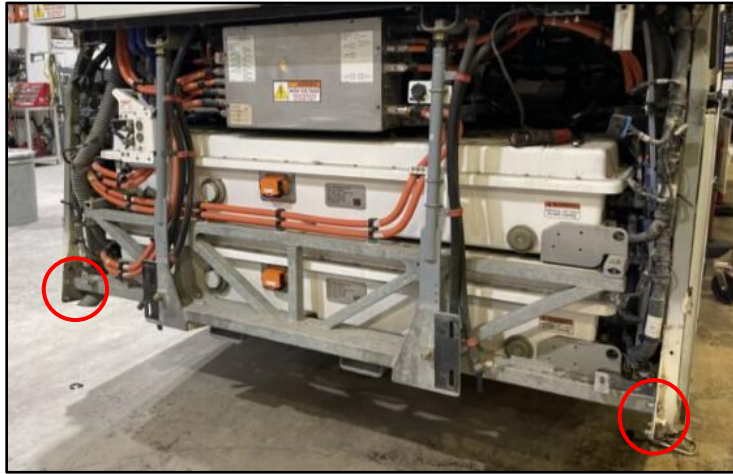
**Figure 13: ESS Cradle Cross Member Hardware Removal**

31. Remove the bolts of the ESS cradle cross member at each rear lower corner of the bus chassis, remove the four bolts at each side and set the hardware aside.

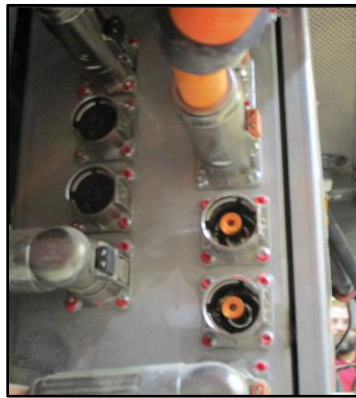
**Figure 14: HV Cables Disconnected on Streetside of HV Box**

32. Disconnect the four HV cables that run from the ESS units to the streetside of the High Voltage box.

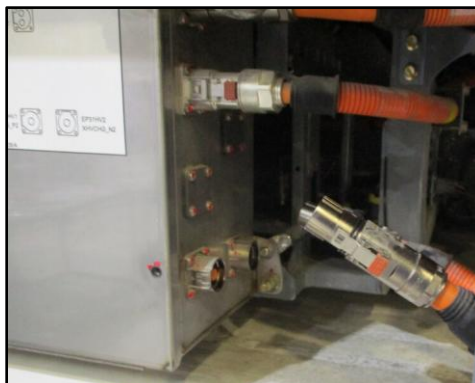
**Figure 15: HV Cables Disconnected on Curbside of HV Box**

33. If applicable, disconnect the two HV cables that run from the ESS units to the curbside of the High Voltage box. Cover the connectors with bags to prevent corrosion.

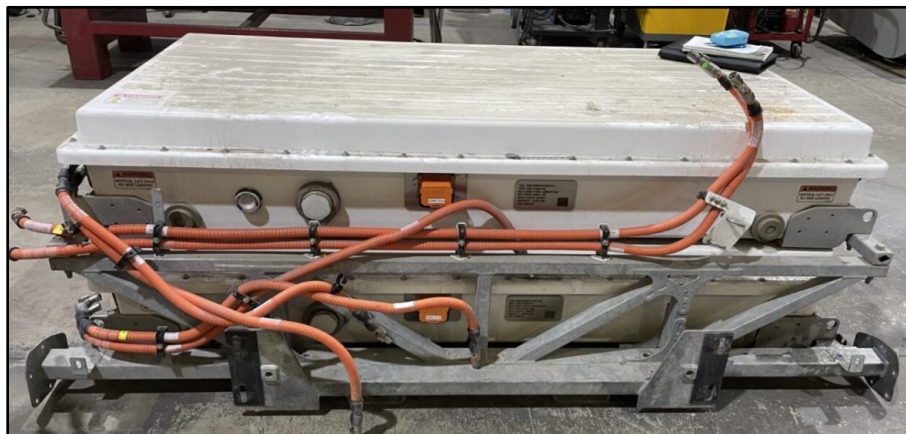
**Figure 19: ESS Cradle on the Floor**

37. Lift the ESS slightly and slowly remove it from the rear of the vehicle taking care to ensure that none of the components snag on each other and looking out for anything that may not have been disconnected.
38. Place the ESS rear rack assembly on the floor or area for ESS enclosure removal.

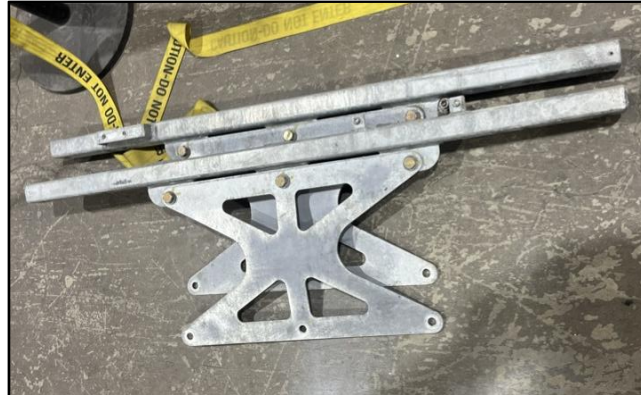
**Figure 23: Rear Upper Rack Assemblies**

45. Set the upper rear upper rack assemblies and mounting hardware aside for reinstallation later.

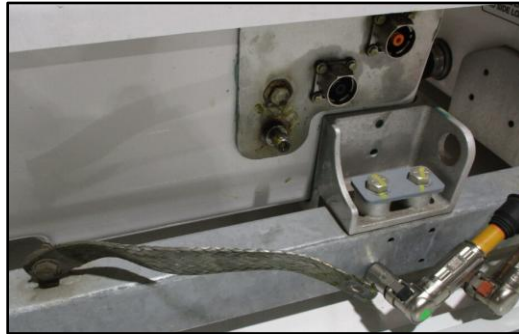
**Figure 30: Ground Cable Disconnected on Streetside of Rooftop ESS Enclosure**

65. Disconnect the ground strap on the streetside of each ESS unit near the HV connectors.

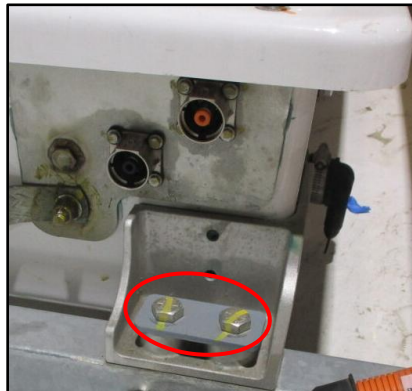
**Figure 34: Mounting Hardware**

71. Remove the eight bolts that secure each ESS unit to the ESS rack. Discard the existing bolts and ESS support plates as new hardware will be provided.

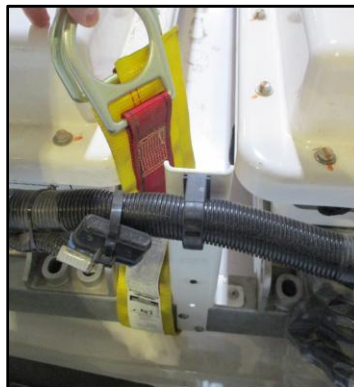
**Figure 35: Safety Hook Attached to ESS Rooftop Rail**

72. Prior to removing the scaffolding on the scaffold on one side of the bus install safety strap hooks on the ESS rack to allow for the connection of a fall protection safety harness.

**Note: Once the scaffold is removed on one side, a fall protection harness must be worn when working on the roof of the bus.**

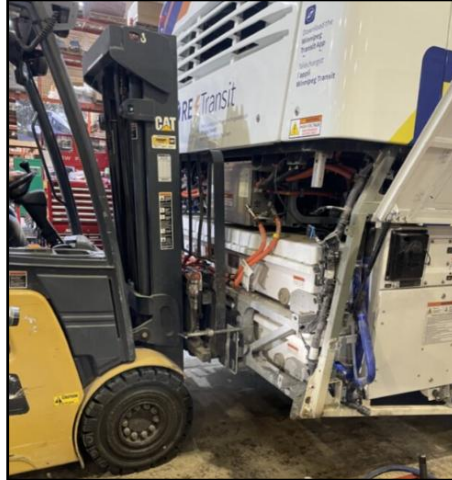
**Figure 75: Rear Rack Assembly with ABS Packs Installation**

158. Lift the bus to a reasonable height for rear rack assembly reinstallation.
159. Using a forklift, carefully install the ESS battery rack assembly back inside the vehicle and align the mounting holes to the vehicle structure.

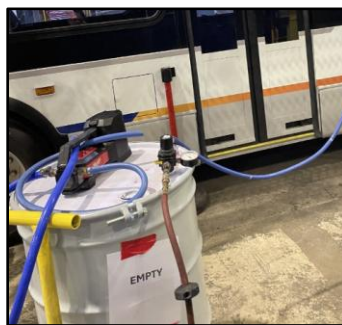
9. Attach a shop air line to the quick coupler on the pressure tester.
