Remedy available for
 2022-2024 (WS) Jeep Wagoneer / Grand
 Wagoneer

The quarter window glass trim on about 123,390 of the above vehicles may not have been properly secured during assembly and can detach from the vehicle. A quarter window trim which detaches may create a road hazard to other vehicles and can cause a crash without prior warning.

SAFETY RECALL
NORTH AMERICA
Quarter Window Trim

Reference: 88C / NHTSA 25V-642

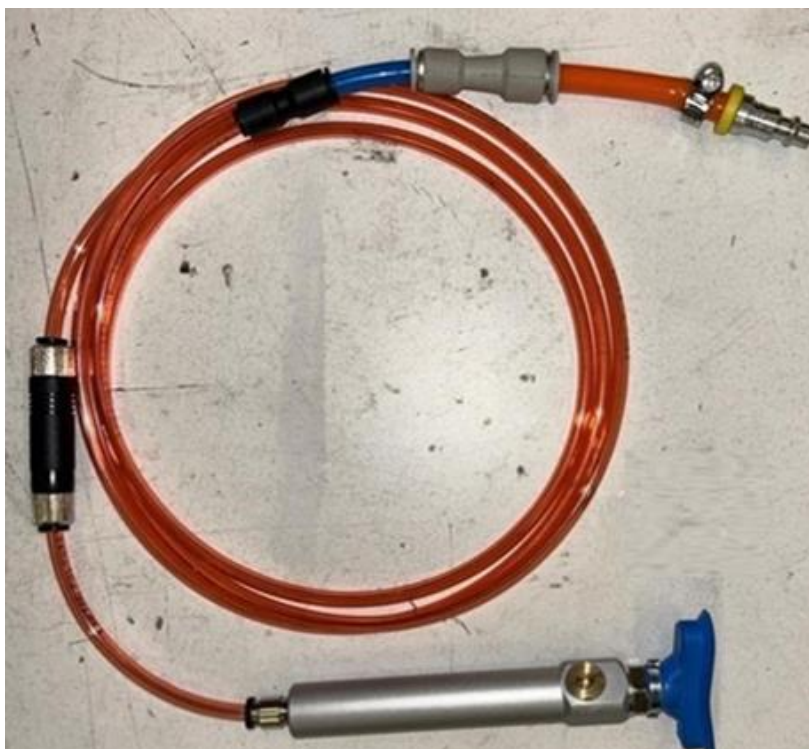
Figure 1 – Trim Testing Tool

1. Clean the quarter glass trim.
2. Connect the suction cup tool to shop compressed air (Figure 1).

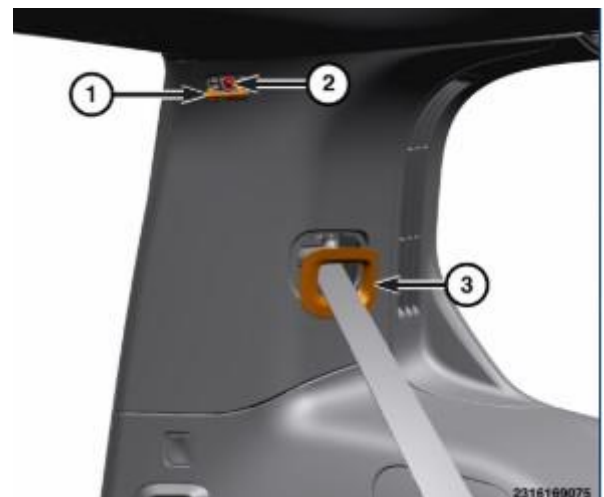
Figure 5 – Rearward D-Pillar Trim Fasteners

2. Remove the fastener cover (1) and the fastener (2) from the rearward D-pillar trim panel (Figure 5).

1 - Fastener Cover

2 - Fastener

3 - Seat Belt Closeout

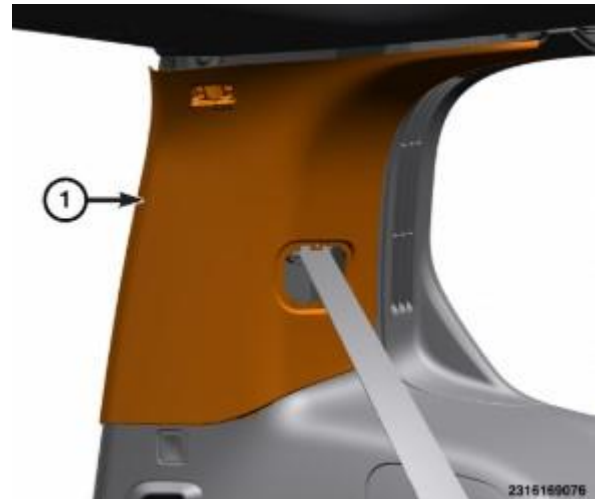
Figure 6 – Rearward D-Pillar Trim

3. Using a trim stick or equivalent, release the retaining clips to separate the rearward D-pillar trim (1) from the forward D-pillar trim panel (Figure 6).

1 - Rearward D-Pillar Trim Panel

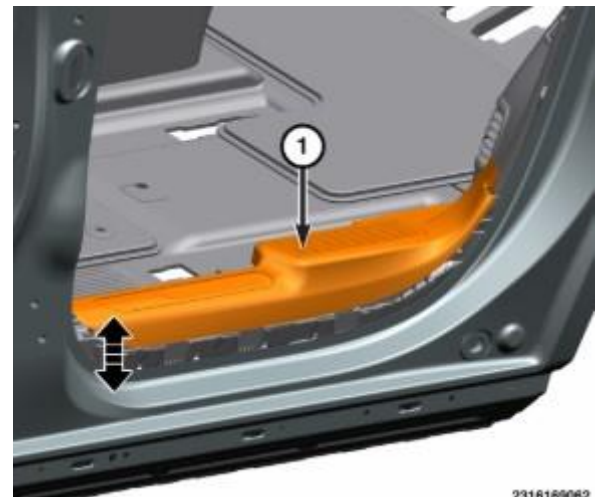
Figure 7 – Rear Door Sill Scuff Plate

4. Using a trim stick or equivalent, disengage the retaining clips that secure the rear door sill scuff plate (1) to the rear door sill and remove from vehicle (Figure 7).

1 - Rear Door Sill Scuff Panel

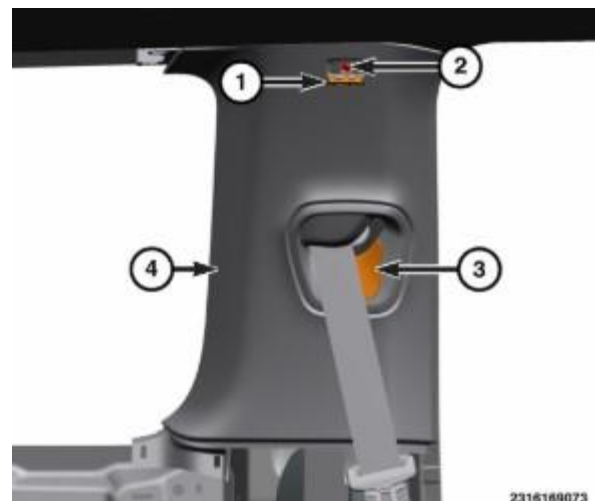
Figure 9 – Upper C-Pillar Trim

- 7. Remove the fastener cover (1) and remove the fastener (2) from the upper C-pillar trim panel (4) (Figure 9).
- 8. Position the C-pillar trim aside.

- 1 - Fastener Cover
- 2 - Fastener
- 3 - Seat Belt Closeout
- 4 - Upper C-Pillar Trim Panel

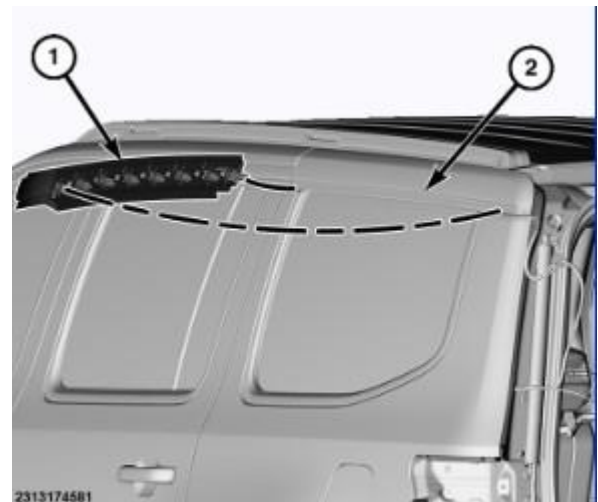
Figure 11 – Quarter Panel Applique

10. Using a trim stick or equivalent, release the applique (1) from the upper quarter panel (2) (Figure 11).

- 1 - Quarter Panel Applique
2 - Upper Quarter Panel

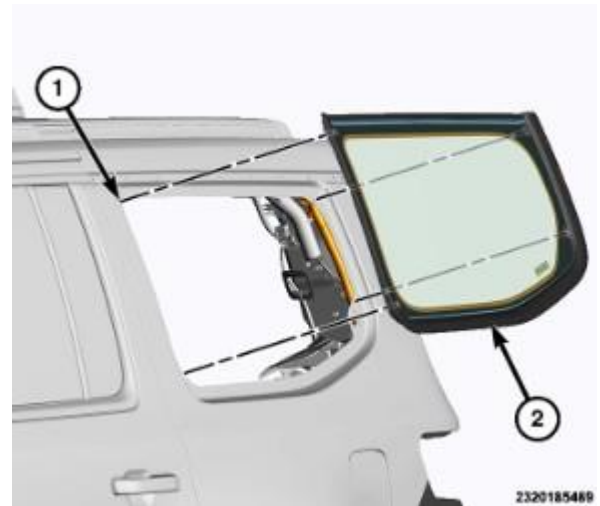
Figure 12 – Quarter Glass

12. Carefully push the quarter window glass from the window opening.

- 1 - Window Opening
2 - Quarter Glass

11. Using a glass extraction tool or equivalent, cut and separate the urethane adhesive and the alignment pins that secure the quarter glass to the window fence.

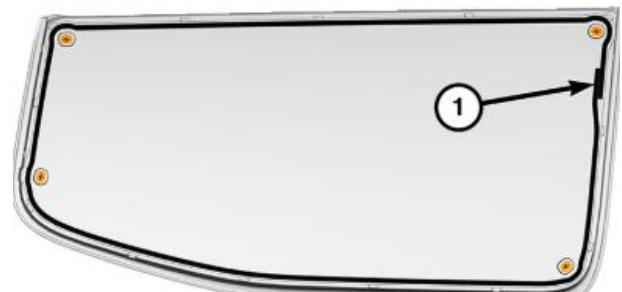
Figure 13 – Urethane Bead

NOTE: The quarter glass fence should be cleaned of most of its old urethane adhesive. A small amount of old urethane, approximately 1 mm (0.04 in.) in height should remain on the fence. Do not completely remove all old urethane from the fence, the paint finish and bonding strength will be adversely affected.

2. Using a razor knife, level the original bead of urethane on the fence to a thickness of approximately 1 mm (0.04 in.) (Figure 13).

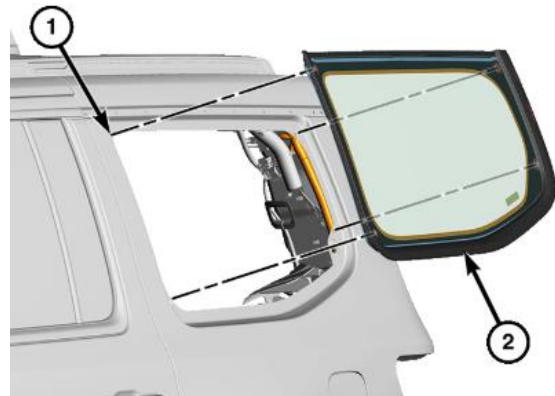
Figure 14 – Window Installation

12. Apply approximately a 7 mm (0.3 in.) wide and 13 mm (0.5 in.) tall bead of adhesive with a triangular nozzle approximately 6 mm (0.230 in.) from the edge of the glass seal starting at the bottom center of the quarter glass.
13. Run the end of the adhesive bead on the quarter glass parallel to the start of the bead and smooth the ends flush.
14. Place the quarter glass in the window opening and insert mounting studs through the alignment holes in the window fence.
15. Reinstall the trim panels using steps 1- 10 of the **B. Glass Removal** procedure above.
