RECALL 25V708 / 2025-568 REMEDY INSTRUCTIONS

FOREST RIVER	Make(s): SALEM & WIDLWOOD Model(s): SBT301FAM & WBT301FAM Model Year(s): 2026	Repair Code: RC-096-09-00-004763 Allotted Time: .25 HRS. Inspection Code: RC-096-05-00-004762 Allotted Time: .10 HRS.
	Concern: The exterior griddle may be stowed while still connected to LP Gas.	Photo(s) Required: NO Prior Authorization Required: YES Part(s) Kit Number: F100799572 Part(s) Return: NO, FIELD DESTROY

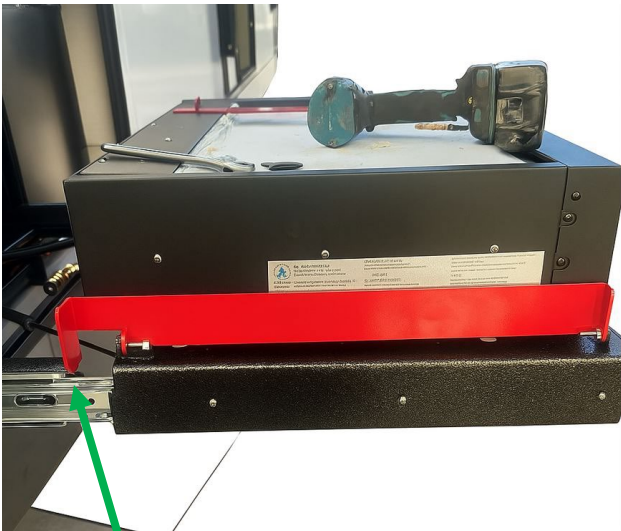
FIGURE 1:

CORRECT LOCKING BRACKET
NOTICE THE END - HAS LOCK

- IF THE RED LOCKING MECHANISM LOOKS LIKE FIGURE 1, CLAIM THE INSPECTION CODE;
- IF THE RED LOCKING MECHANISM LOOKS LIKE FIGURE 2, MOVE ON TO THE REMEDY;

STEP 2: INSTALL THE REPLACEMENT RED LOCKING MECHANISM AS SHOWN IN FIGURE 1;

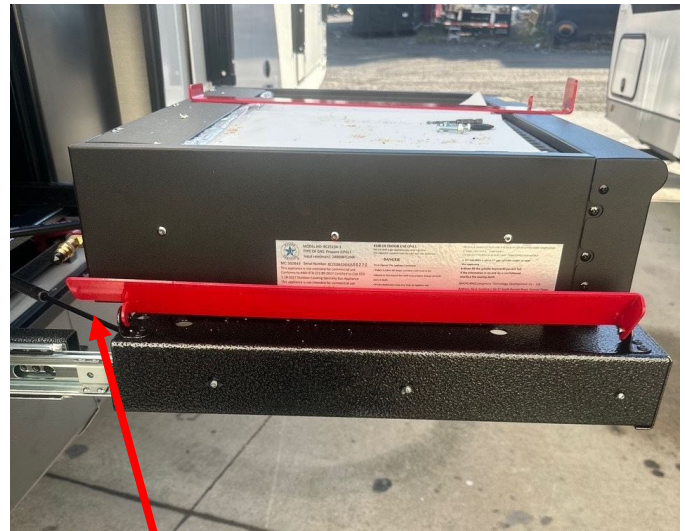
FIGURE 2:

INCORRECT LOCKING BRACKET
NOTICE THE END - NO LOCK

STEP 1: DRILL OUT THE RIVET(S) OUT WITH A 3/16" DRILL BIT;

- DISCARD THE RED MECHANISM;

- USE THE INCLUDED BOLT(S) AND NUT(S);

STEP 3: ENSURE THE LOCKING MECHANISM PERFORMS AS INTENDED, NOT ALLOWING THE GRILL/GRIDDLE BE STOWED;
