Thor Motor Coach Recall Repair Instructions

Recall #	25V-709 2025-570		
Description/Title:	Generator Exhaust		
Affected Product Line(s):	Certain MY 2025-2026 Chateau, Coleman, Echelon, Eddie Bauer, Four Winds, Freedom Elite, Geneva, Pasadena, Quantum		
Service Campaign # :	RC000335		
Repair Code:	Inspect with Repair: TMCRC10121V	Document Date:	12/15/2025
Time Allowed:	Inspect with Repair: 0.4	Document Revision:	A

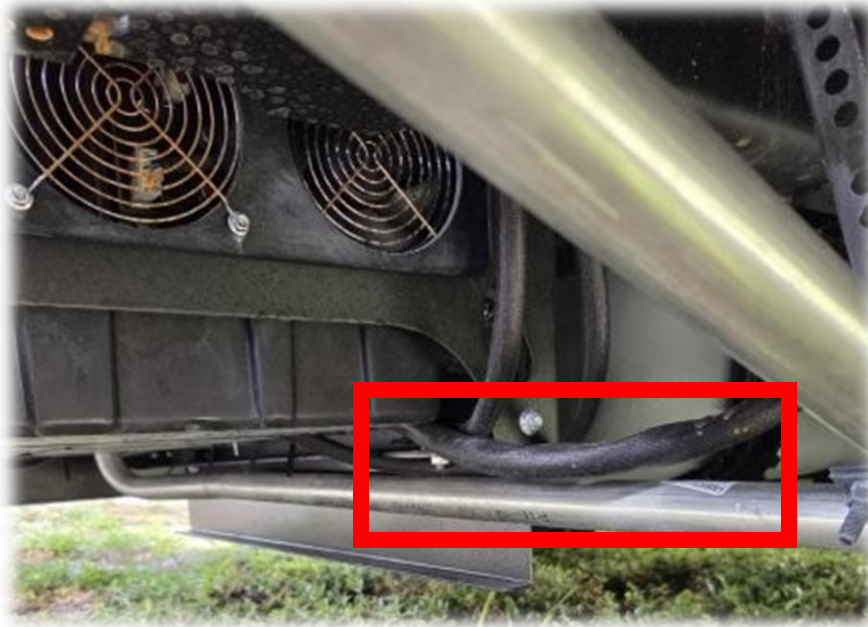
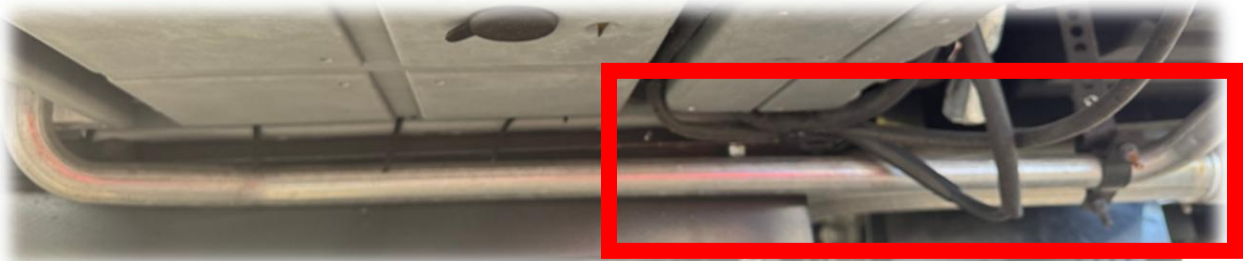
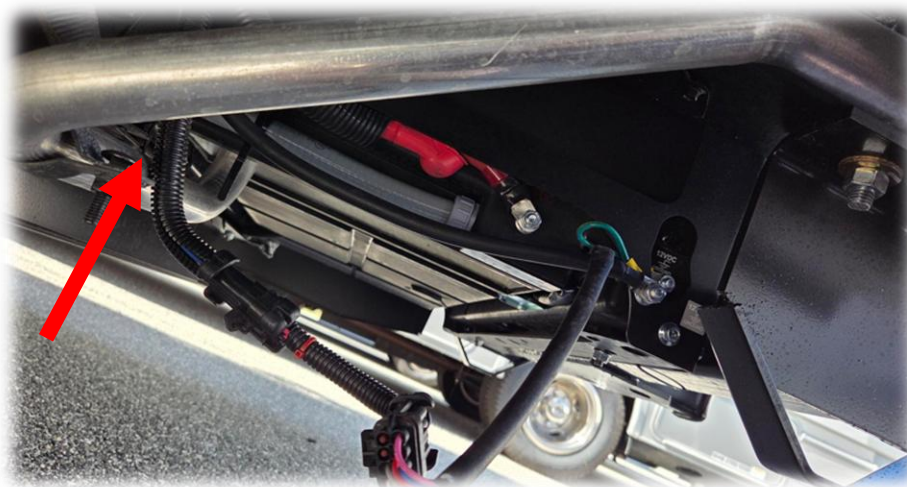
Examples:

It has been discovered that p-clamps may be missing allowing the fuel hose and/or wire harnesses to rest on the generator exhaust.

1. Inspect generator exhaust for any fuel hose or wire harnesses making contact.

2. If any fuel hose or wire harness is damaged, replace it prior to proceeding. ***This is not part of the recall and will need to be submitted to TMC as a separate repair claim***

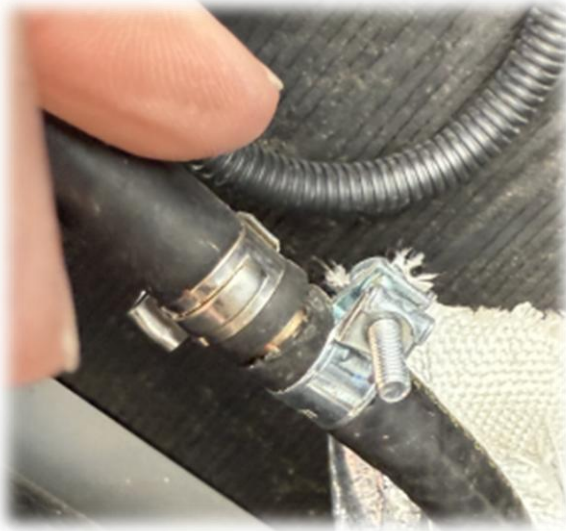
3. Find the union for the generator fuel line.

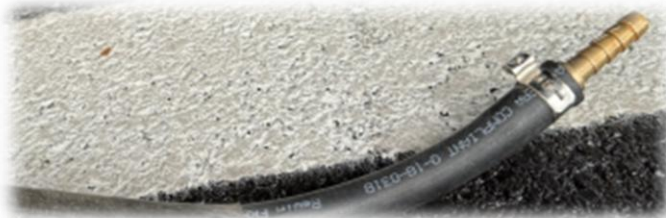
4. Clamp the fuel hose on the fuel tank side of the union to prevent fuel spillage. Separate the fuel hose at the union.

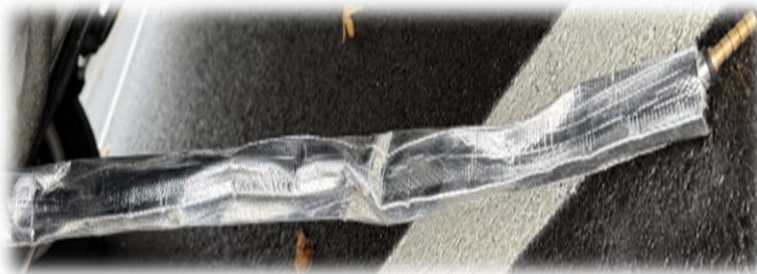
5. Install the heat sleeve onto the fuel hose leading towards the generator, then resecure the fuel hose to the union.

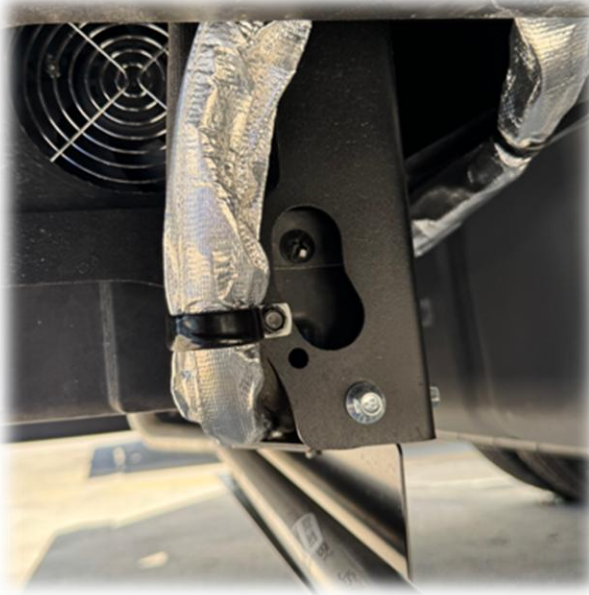
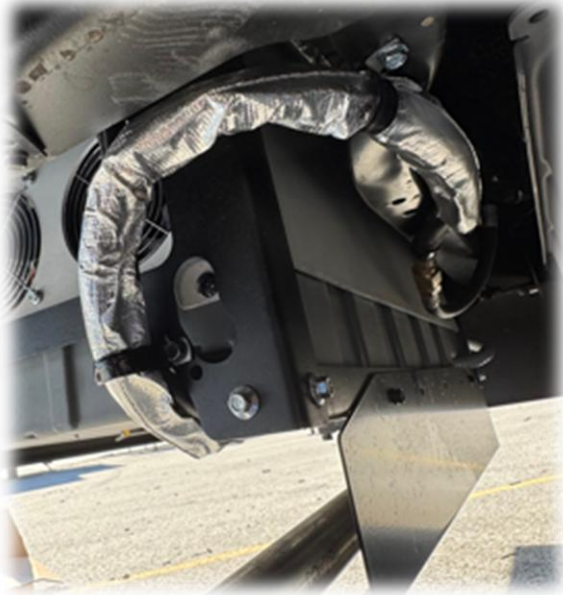
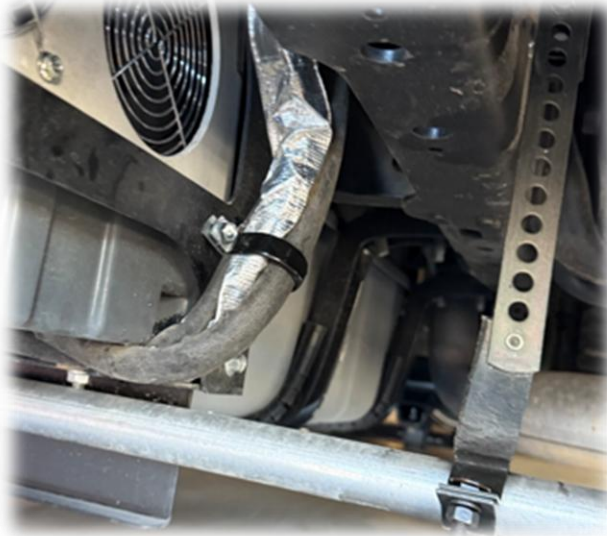
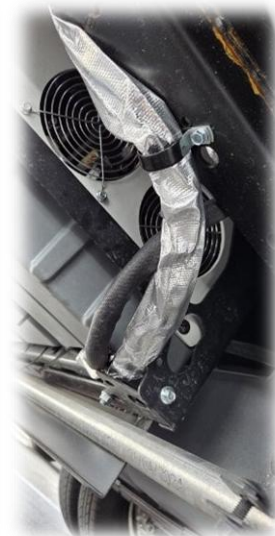
6. Use the supplied p-clamps to hold the fuel hose and any necessary wire harness away from the generator exhaust. Examples:
