GROUP	MODEL
<b>Noncompliance Safety Recall Campaign</b>	<b>2026MY Sorento (MQ4a)</b> <b>2025MY Telluride (ON)</b>
NUMBER	DATE
<b>SC355</b>	<b>October 2025</b>

## NONCOMPLIANCE SAFETY RECALL CAMPAIGN

### SPARE WHEEL AND TIRE ASSEMBLY REPLACEMENT (SC355)

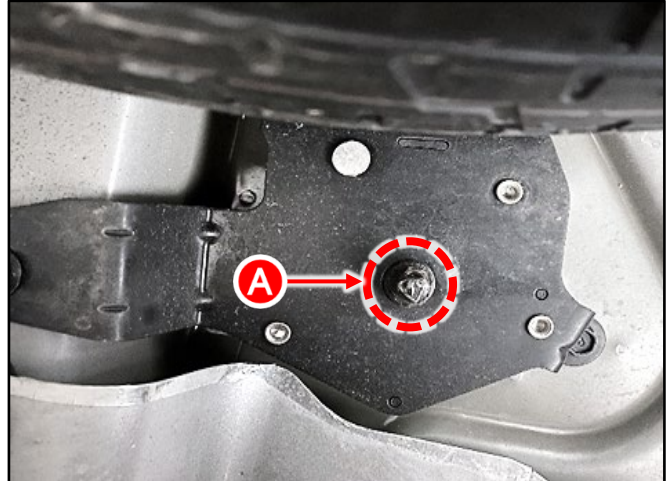
1. Using a ratchet and 3/8" socket, loosen the spare wheel and tire assembly retaining bracket bolt (A) to remove the incorrect spare tire and wheel assembly.

Use a hand tool to remove the bolt (A). Do not use an impact gun.

2. Install the correct spare tire for the applicable model.

Tightening torque for bolt:  
21.7 - 25.3 lb.ft (28.5 - 34.32 N.m)
