**HYUNDAI**  
**Technical Service Bulletin**

NUMBER  
**26-01-023H-1**

MODEL(S)  
**SONATA  
(DN8, DN8A)**

**SUBJECT:** FUEL TANK EXPANSION - CHECK VALVE REPLACEMENT, FUEL TANK INSPECTION, & ECM UPDATE (RECALL 286)

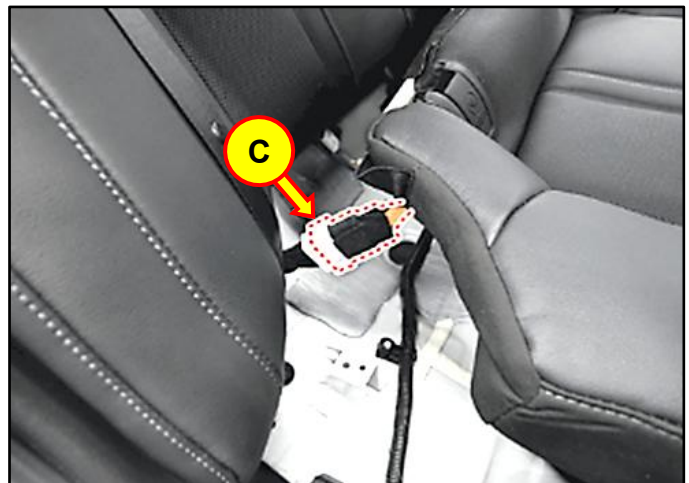
3. Disconnect the rear seat heater unit connector if equipped (C).

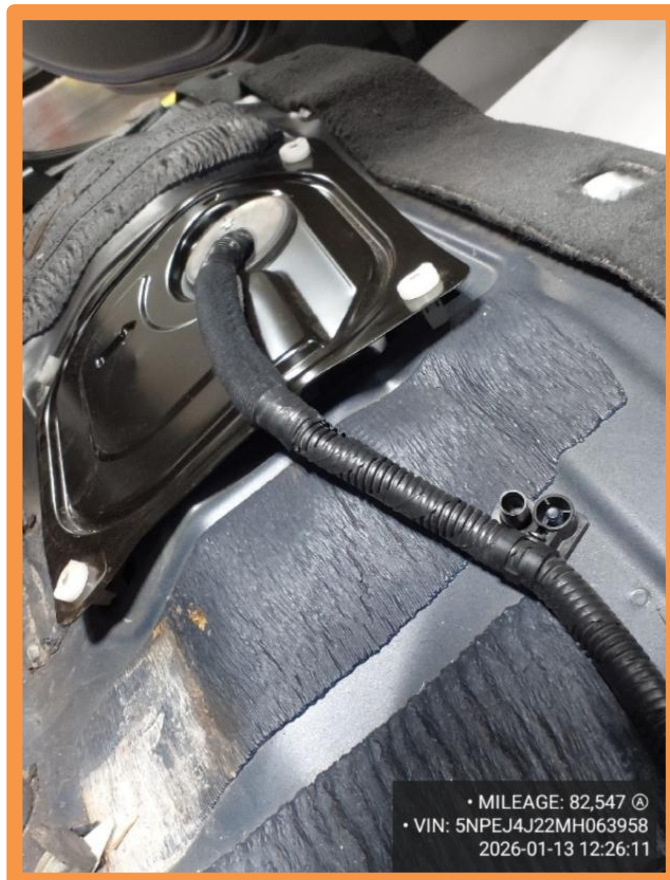
Using the STUI camera function, take a photo of the fuel pump service cover area.

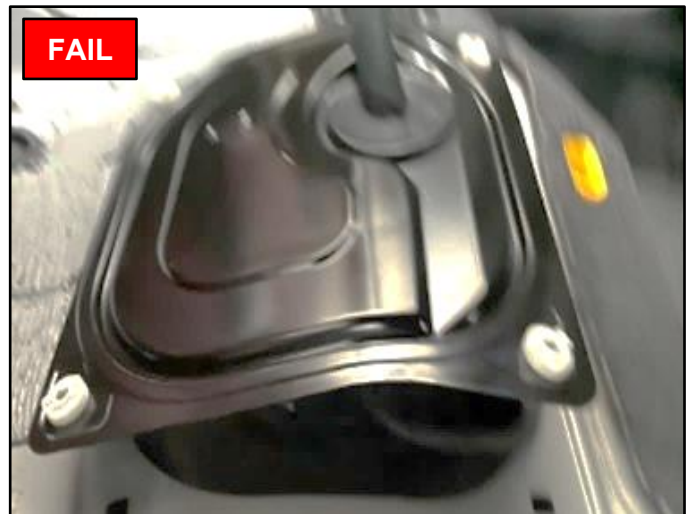
5. Inspect the fuel pump service cover and surrounding areas for the following items:
- Damage or deformation of the sheet metal.
  - Evidence of a previous sheet metal repair or repair attempt.
  - Gap between the fuel pump service cover (D) and surrounding sheet metal.

**PASS:** If all of the items above are **NOT** present:

**FAIL:** If any of the items are present:

6. Submit a Prior Approval (PA) Request with the following information:
- Repair Group: **Other**
  - Claim Type: **Recall/Campaign**
  - Required Attachment: **Fuel Pump Cover Area**

Do **NOT** continue with the remaining service procedure in this TSB. Hold the vehicle until otherwise directed by PA.

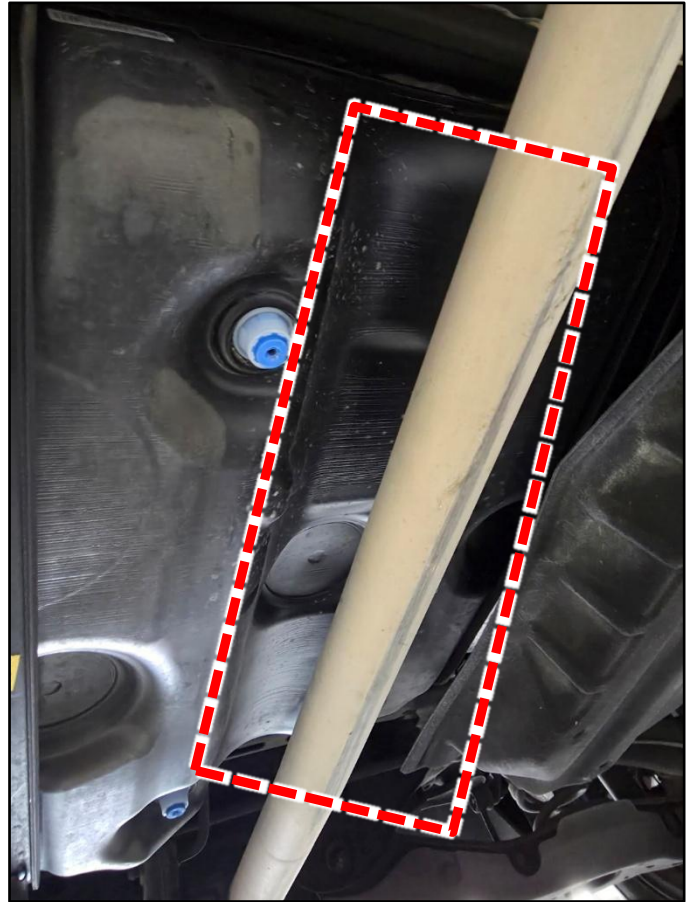
4. Inspect the fuel tank surface for any melted plastic or damage.

6. **PASS:** If the fuel tank does **NOT** show signs of melting or damage, re-install the heat protector and proceed to the [Fuel Tank Band Gap Inspection](#) procedure.

**FAIL:** If the fuel tank shows signs of melting or damage, proceed to the [Fuel Tank Replacement](#) procedure.

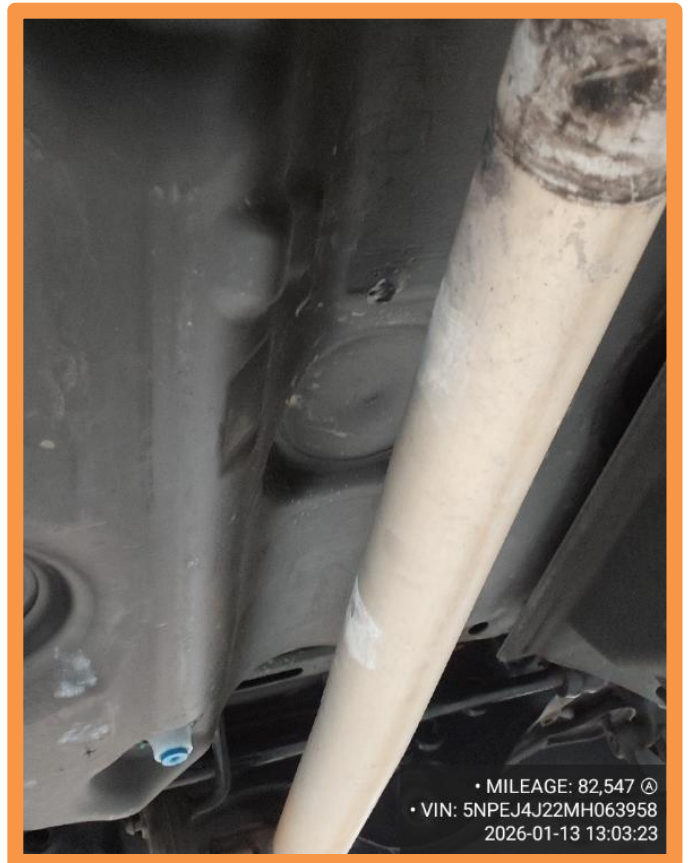
Using the STUI camera function, take a photo of the fuel tank area with the heatshield removed as shown.

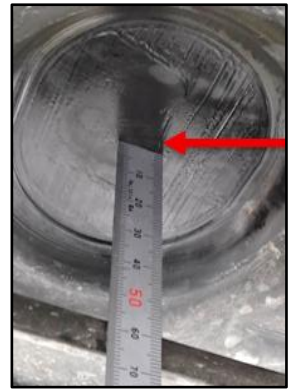
Be sure to measure from the center of the circular feature (C) in the fuel tank as shown.

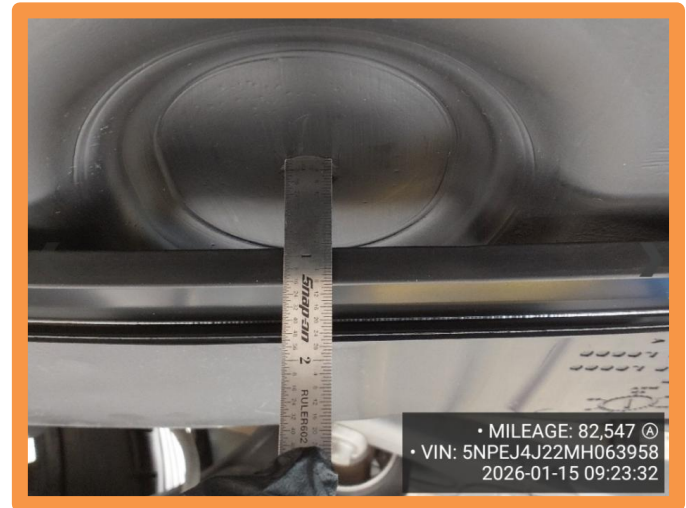
Using the STUI camera function, take a photo of the of gap showing the ruler and measurement clearly.

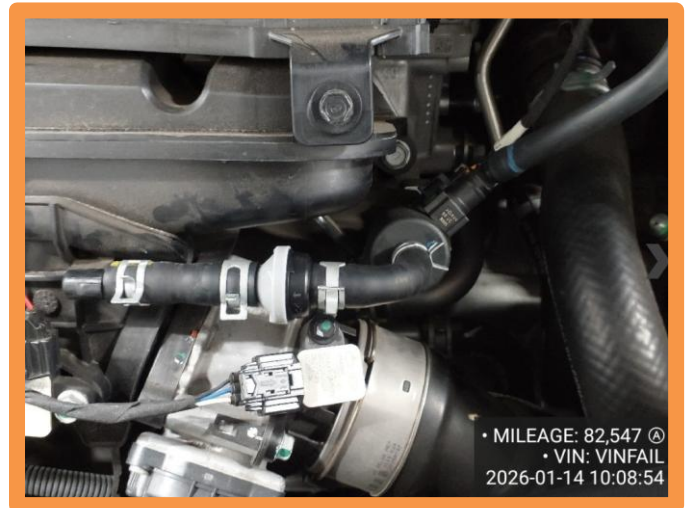
Using the STUI camera function, take a photo of the new check valve installed on the vehicle.

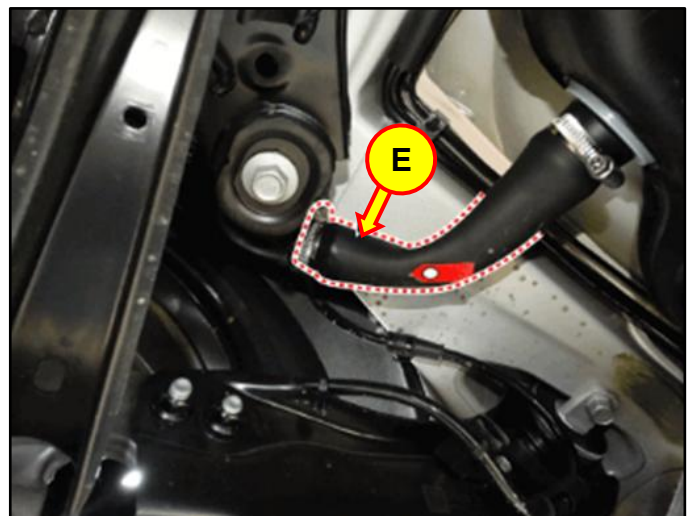
7. Disconnect the fuel filler hose (E).

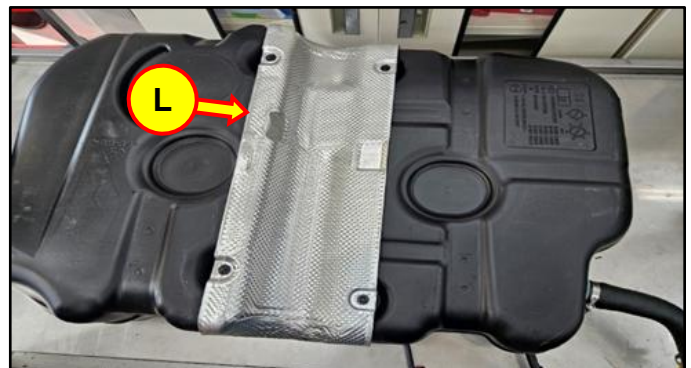
13. Attach the fuel tank heat protector (L) to the new fuel tank.
