**HYUNDAI**  
**Technical Service Bulletin**

NUMBER  
**26-01-023H**

MODEL(S)  
**SONATA  
(DN8, DN8A)**

**SUBJECT:** FUEL TANK EXPANSION - CHECK VALVE REPLACEMENT, FUEL TANK INSPECTION, & ECM UPDATE (RECALL 286)

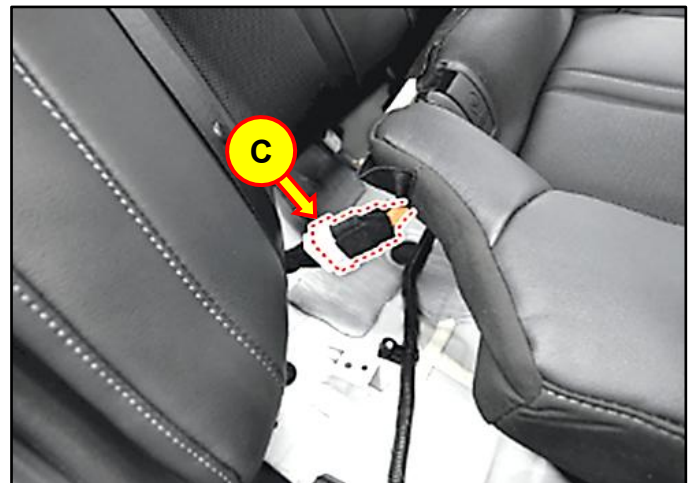
3. Disconnect the rear seat heater unit connector if equipped (C).

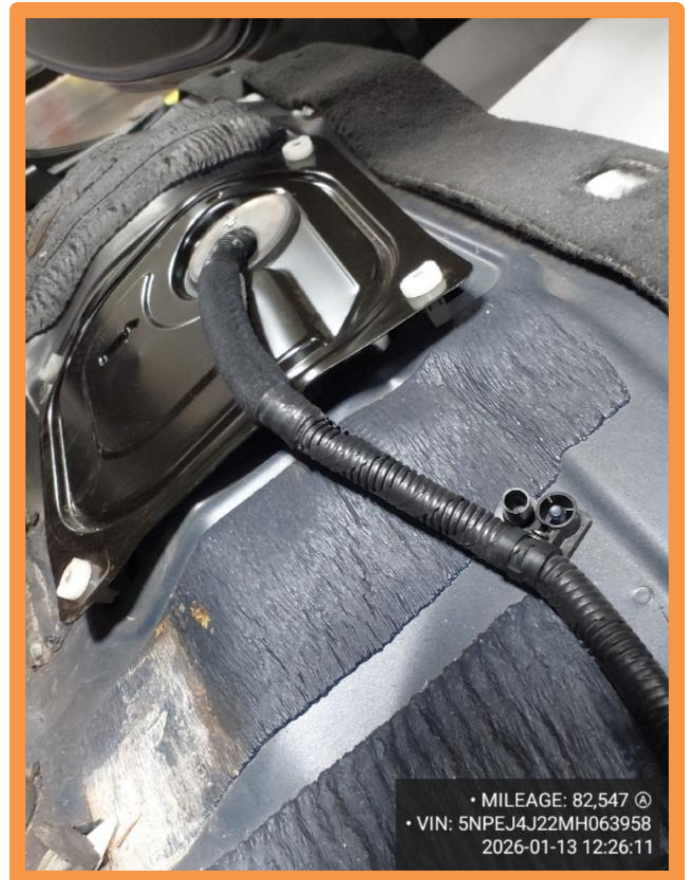
5. Inspect the fuel pump service cover and surrounding areas for the following items:
- Damage or deformation of the sheet metal.
  - Evidence of a previous sheet metal repair or repair attempt.
  - Gap between the fuel pump service cover (D) and surrounding sheet metal.

**FAIL:** If any of the items are present:

6. Submit a Prior Approval (PA) Request with the following information:
- Repair Group: **Other**
  - Claim Type: **Recall/Campaign**
  - Required Attachment: **Fuel Pump Cover Area**

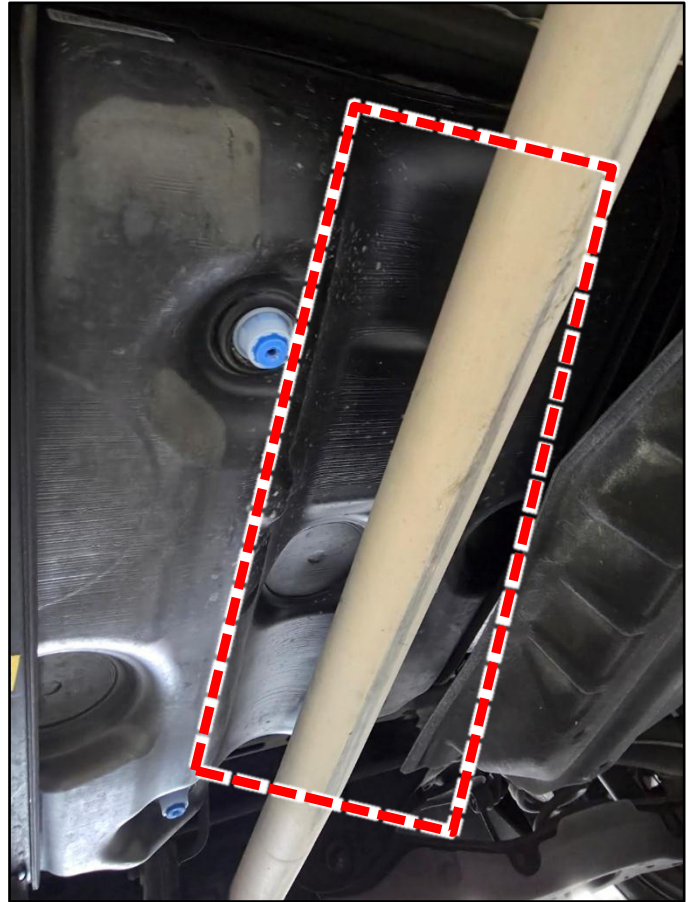
4. Inspect the fuel tank surface for any melted plastic or damage.

6. **PASS:** If the fuel tank does **NOT** show signs of melting or damage, re-install the heat protector and proceed to the [Fuel Tank Band Gap Inspection](#) procedure.

**FAIL:** If the fuel tank shows signs of melting or damage, proceed to the [Fuel Tank Replacement](#) procedure.

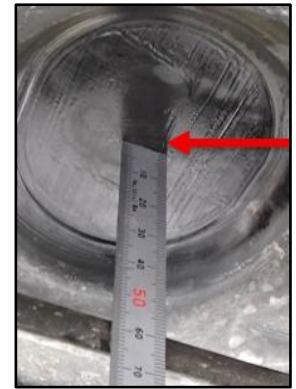
Be sure to measure from the center of the circular feature (C) in the fuel tank as shown.

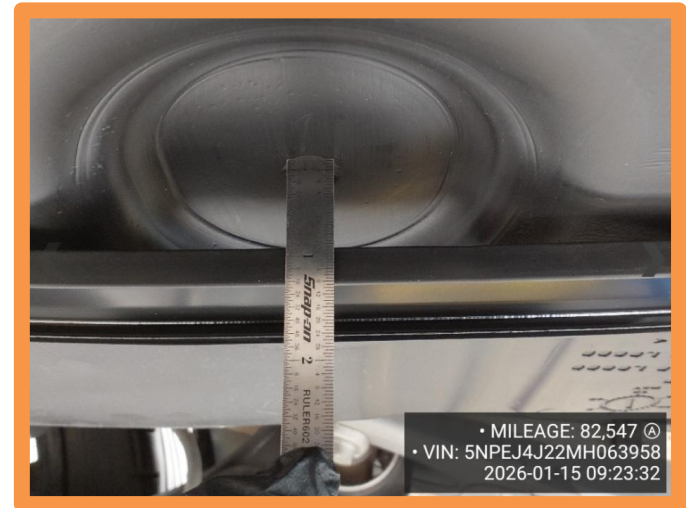
- **PASS:** If the gap is **25 mm (0.98 inch) or less:**
  - Lower the vehicle.
  - Reinstall and reconnect all seat cover components in the reverse order of the removal process.
  - Proceed to **step 5**.
- **FAIL:** If the gap is **more than 25 mm (0.98 inch):**  
Proceed to the [Fuel Tank Replacement](#) procedure.

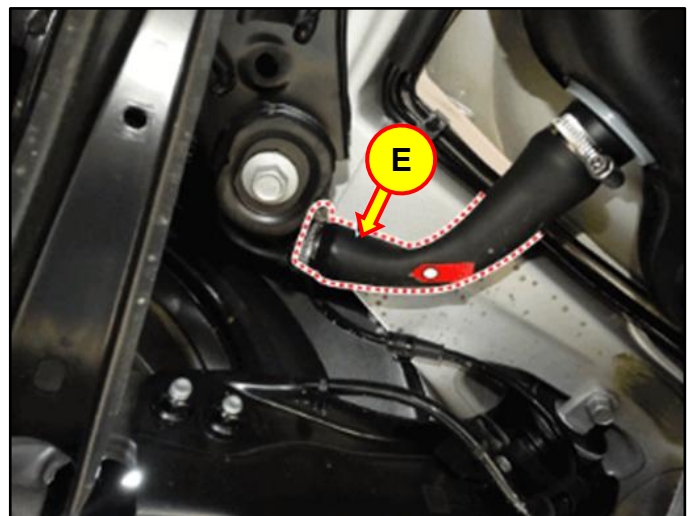
7. Disconnect the fuel filler hose (E).

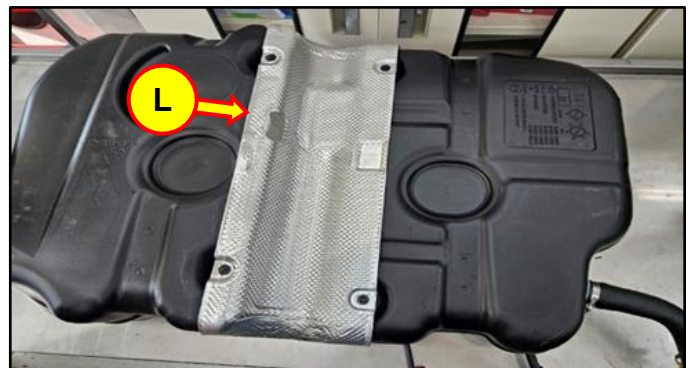
13. Attach the fuel tank heat protector (L) to the new fuel tank.

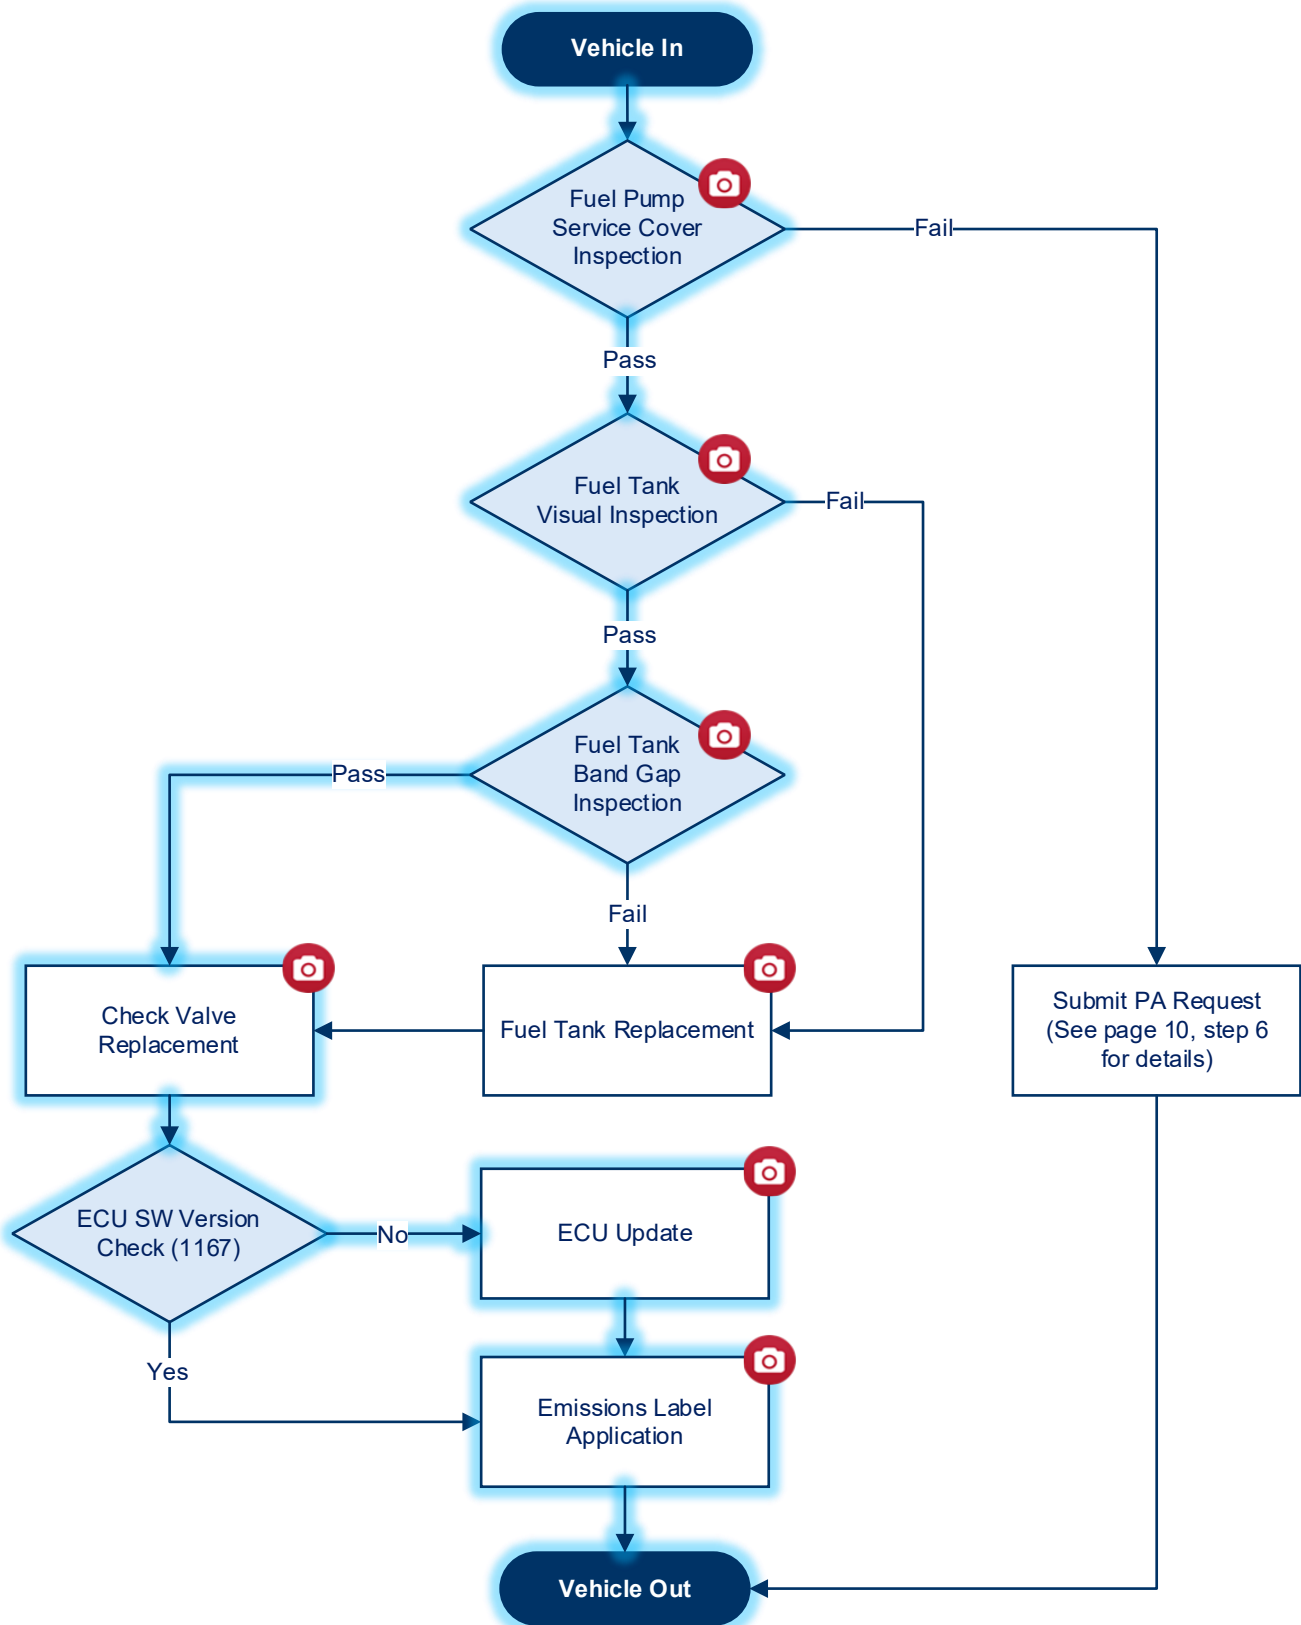
**SUBJECT:****FUEL TANK EXPANSION - CHECK VALVE REPLACEMENT,  
FUEL TANK INSPECTION, & ECM UPDATE (RECALL 286)**Op. Code **51D298R6** Flow Path:

| Model | Op. Code | Operation | Op. Time | Causal Part | Nature Code | Cause Code |
|---|---|---|---|---|---|---|
| | 51D298R6 | Fuel Pump Cover Inspection ( <b>PASS</b> ),<br>Fuel Tank Visual Inspection ( <b>PASS</b> ),<br>Fuel Tank Band Gap Measurement ( <b>PASS</b> ),<br>Check Valve Replacement,<br>ECU S/W Check/Update, and Emissions<br>Label Application | 0.7<br>M/H | | | |
