## 25V-799 WAY-105 Incorrect Cargo Carrying Capacity Label

**Purpose:** Replace incorrect OCCC label with a correct OCCC label.

**Models:** 2026 Open Trail Motorhomes

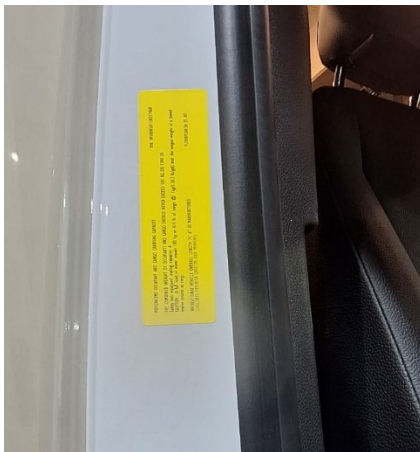
Figure 1

1. The yellow Cargo Carrying Capacity Label can be found on the driver's side door frame, Figure 1.
2. Wipe off the old label with isopropyl alcohol.
3. Carefully place the new label directly on top of the old label.
