SERVICE PROCEDURE

25526
February 2026

SUBJECT: SAFETY RECALL

Q'Straint® wheelchair securement in certain 2026 thru 2027 IC Bus™ CE Series school bus models built 05/13/2025 thru 11/19/2025 and 2026 IC Bus™ Electric CE Series school bus models built 07/07/2025 thru 09/29/2025 equipped with the following Q'Straint® wheelchair securement configurations (feature codes):

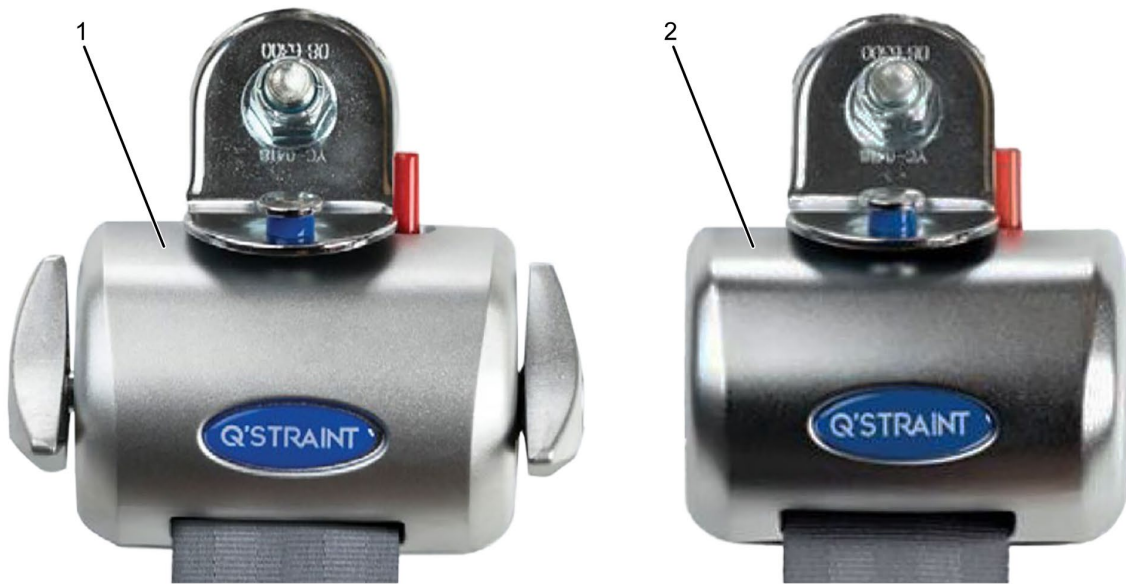
Figure 1. Q'Straint® Wheelchair Securement Retractor Type

1. QTR DELUXE Retractor with two knobs
2. QTR MAX Retractor without two knobs

NOTE: The Q'Straint® wheelchair securement retractors are located either in a pocket mounted to the interior wall of the bus where the wheelchair would be situated, or fastened to the bus floor.

5. Determine Q'Straint® wheelchair securement retractor type:
 - a. For retractor without two knobs (Figure 1, Item 2), go to Step 6.
 - b. For retractor with two knobs (Figure 1, Item 1), go to Step 12.

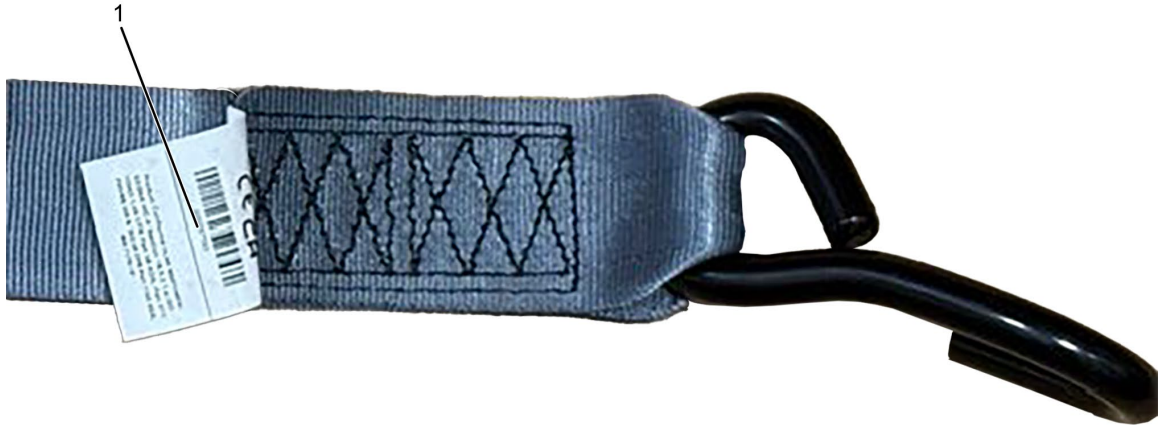
Figure 2. Identification Tag Location

1. Identification tag

6. Locate retractor identification tag (Figure 2, Item 1) on belt.

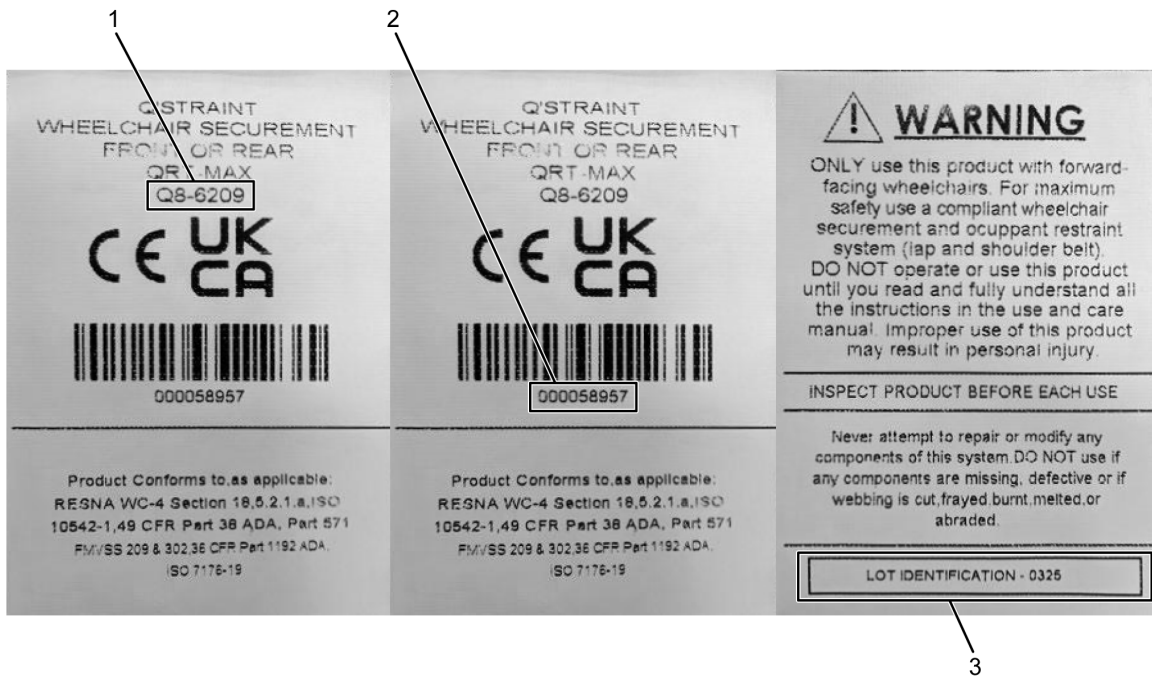
Figure 3. Requirement Numbers Without Knobs

1. Part number Q8-6209
2. Lot number 58957
3. Lot identification number 0325

7. Determine if identification tag numbers match all three requirement numbers on retractor without knobs:
 - a. If identification tag numbers do not match all three, two, or fewer requirement numbers (Figure 3, Items 1, 2, and 3), replacement is not required. Go to Step 17.
 - b. If identification tag numbers match all three requirements (Figure 3, Items 1, 2, and 3), replacement is required. Go to Step 8.

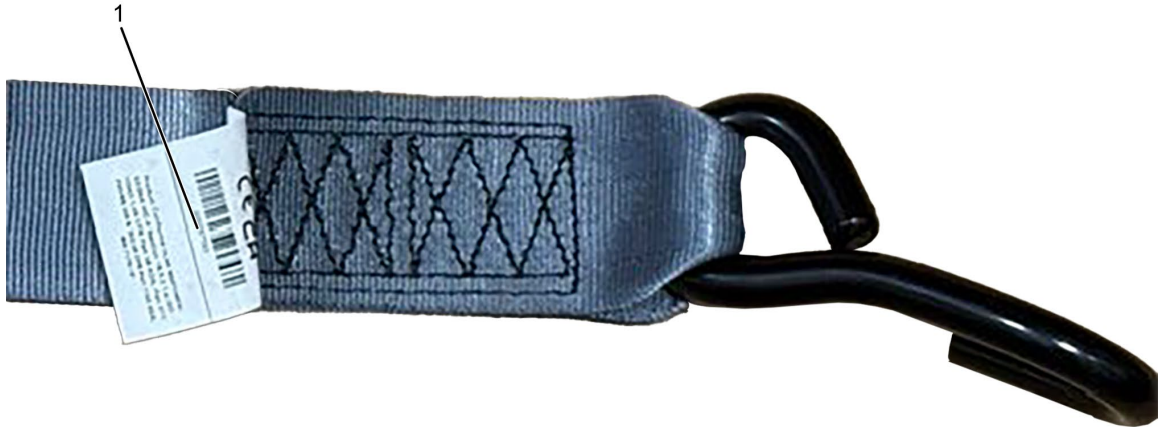
Figure 5. Identification Tag Location

1. Identification tag
12. Locate retractor identification tag (Figure 5, Item 1) on belt.

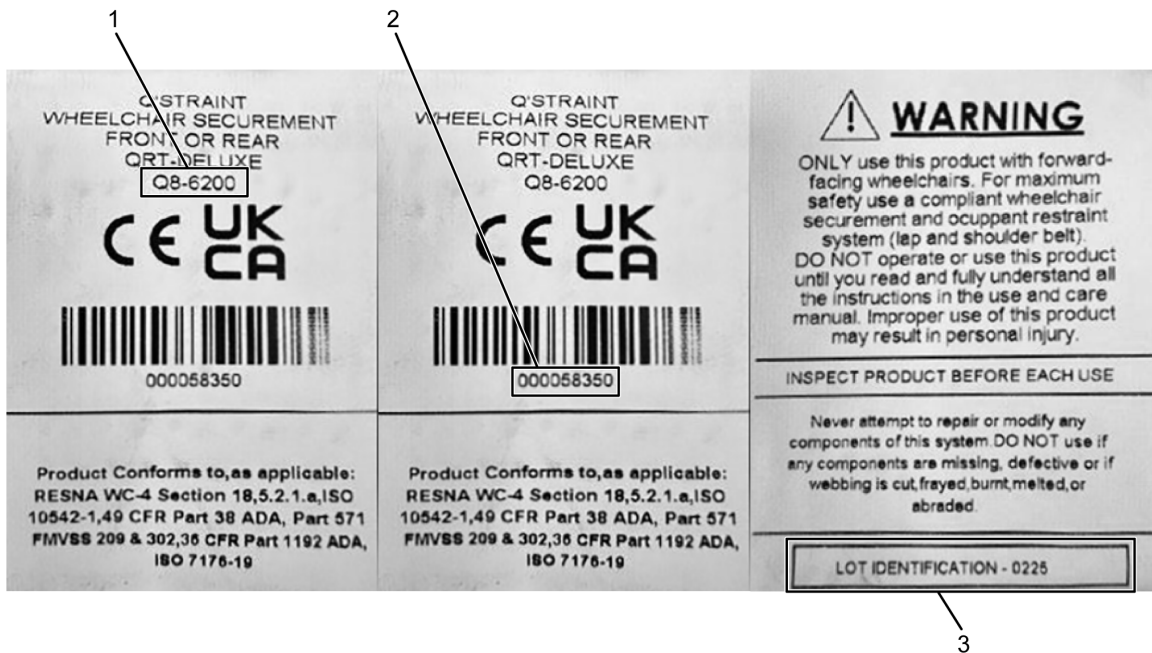
Figure 6. Requirements With Two Knobs

1. Part number Q8-6200
2. Lot number 58350
3. Lot identification number 0225

13. Determine if identification tag numbers match all three requirements on two-knob retractor:

- a. If identification tag numbers do not match all three, two, or fewer requirement numbers (Figure 6, Items 1, 2, and 3), replacement is not required. Go to Step 17.
- b. If identification tag numbers match all three requirements (Figure 6, Items 1, 2, and 3), replacement is required. Go to Step 14.

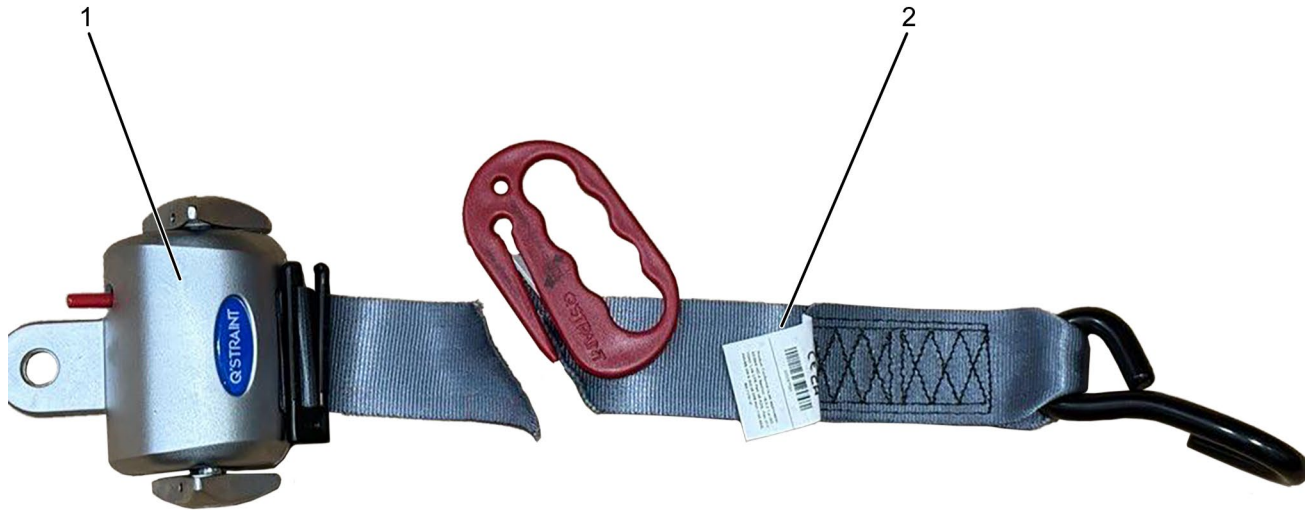
Figure 7. Hook and Identification Tag Section

1. Retractor
2. Hook and identification tag section

WARNING! To prevent personal injury and / or death, or damage to property, remove all appropriate retractors from service that match requirements. Do not use!

14. Using a belt cutter, cut webbing near hook and identification tag section (Figure 7, Item 2).
15. Repeat Steps 12 through 14 for all appropriate two-knob retractors.
16. Using Table 2 Parts Information, order appropriate two-knob retractor(s). Discard cut retractor(s).
17. Once all retractors have been inspected and verified, continue to next step.
18. Remove wheel chocks.
