Required Parts Kit

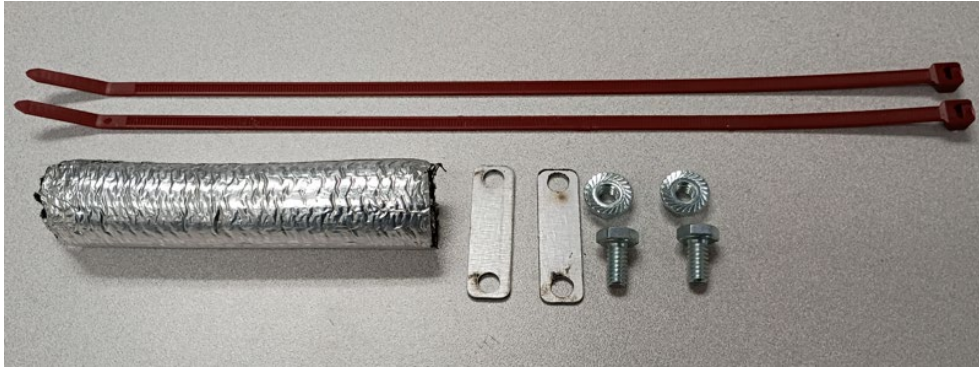
2 Red High Temp Plastic Ties

2 Additional 1 3/4" Brackets

2 1/4" Bolts and Locking Nuts

1 Foil Wrapped Protective Cover

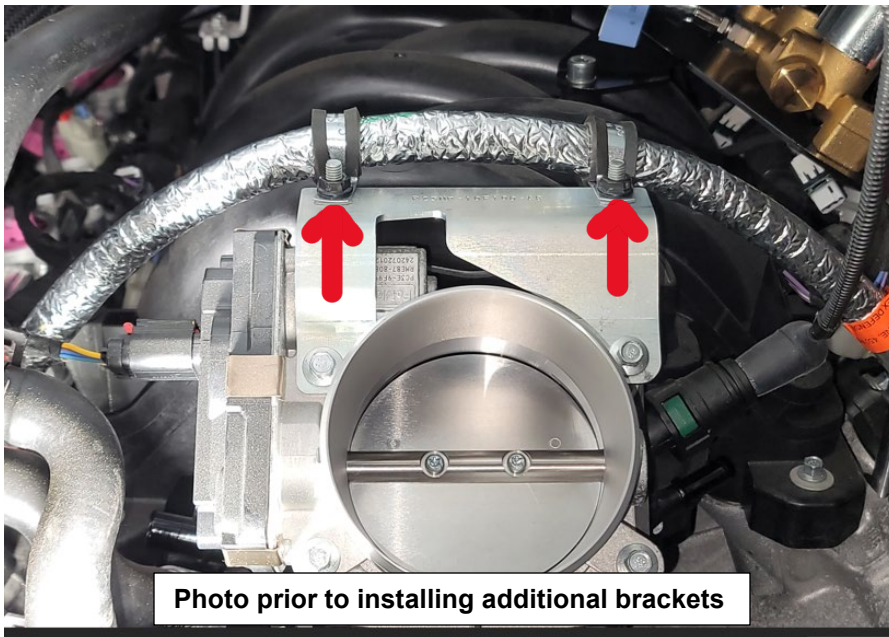
1 Remove the 2 nuts from the Front Crossover Fuel Line retention bracket.

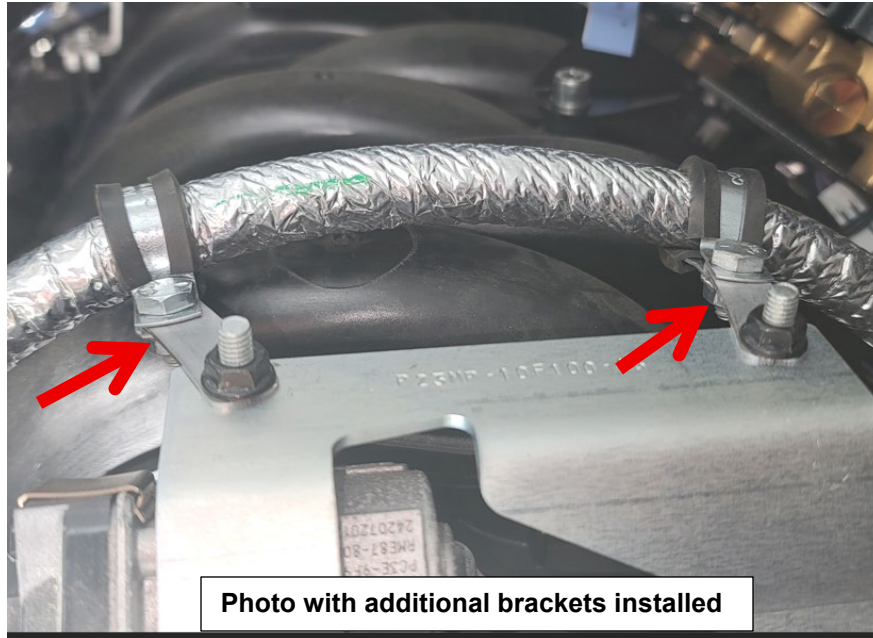
- 2** Add the 2 additional brackets to move the 2 P clamps holding the Front Crossover Fuel Line towards the rear of the engine. Align the additional brackets until proper clearance between the Front Crossover Fuel Line and the alternator is obtained, then tighten the fasteners in place at 10 NM +/-2.

- 3** Apply the foil wrapped protective cover with 2 high temp plastic ties to the concerned area of the Front Crossover Fuel Line as a precautionary measure.

- 4** Reinstall all removed components.
