# Compliance Recall

## Code: 69D8

**Rear Outboard Seat Belts**

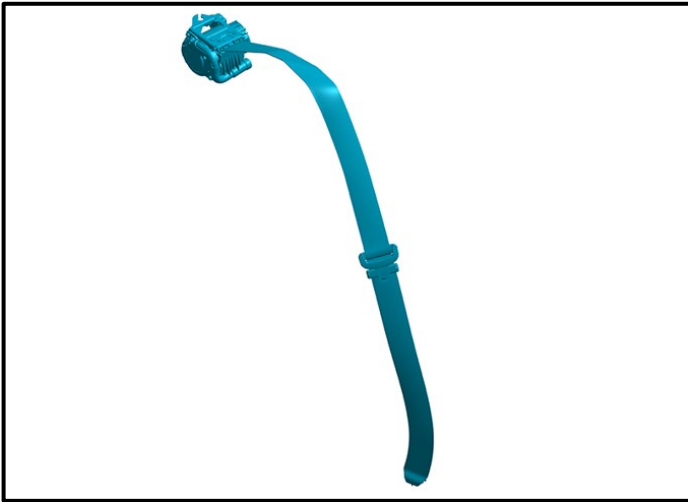
## Repair Overview

- **Criteria 01:** Inspect driver rear seat belt and replace if necessary.
- **Criteria 02:** Inspect passenger rear seat belt and replace if necessary.
- **Criteria 03:** Inspect both rear outer seat belts and replace if necessary.

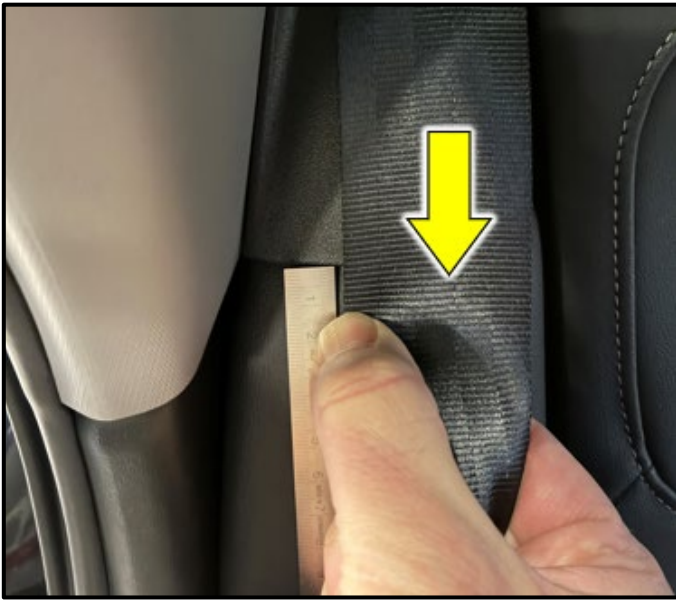
- Gently pull the seat belt in the direction indicated <arrow> until the belt retractor locks in place (seat belt cannot be pulled out further).
- Take note of how far the belt traveled before the locking mechanism engaged.
