**R26DX**

**DATE:** July 30, 2026  
**TO:** Blue Bird Owners  
**Subject:** R26DX: Missing Wheel Chair Lift Support Brace

NHTSA Recall Number: 25V-852 School Bus

## R26DX: Missing Wheel Chair Lift Support Brace

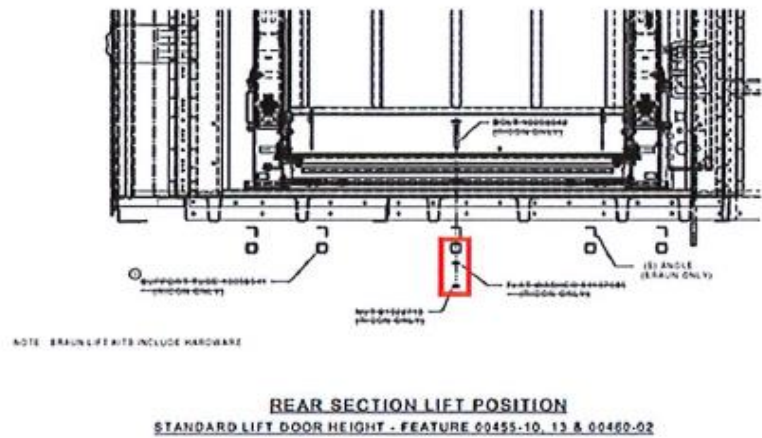
**Issue:** Certain Blue Bird Vision School Buses equipped with Ricon Wheel Chair Lifts may have been installed with a quantity of four (4) braces/reinforcements instead of the required five (5).

- 1. If four braces/reinforcements are present, install a 5<sup>th</sup> brace/reinforcement using two (2) bolts, two (2) washers and two (2) nuts (**28 ft-lbs.**) per Diagram A and Photo A.
