IMPORTANT SAFETY RECALL

Ref: Safety Recall - (NHTSA Recall No. 25V805)

Cemen Tech C60 Volumetric Mixer-2020-2025; Cemen Tech C60E Volumetric Mixer 2020-2025; Cemen Tech C60T Volumetric Mixer 2023-2024; Cemen Tech Custom M60 Volumetric Mixer 2018-2025

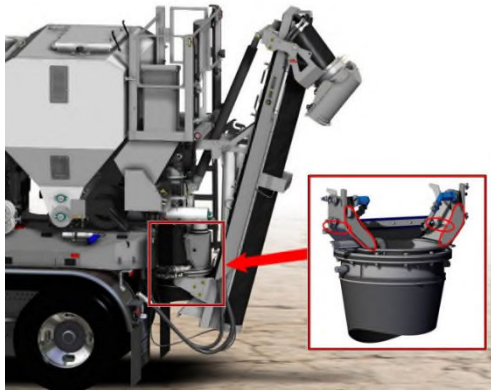
The mount plate and gusset of the mixer swivel hopper ring may crack or separate from the unit due to fatigue. This can cause the mixer hopper assembly (with the attached mixer) to separate from the conveyor frame of the vehicle.

Until the repair can be made, we ask you perform daily inspections of the gussets and mount plates of the inner ring for signs of cracking or separation. See drawings below for location.

The repair will involve replacing the existing mixer hopper assembly with a new one made of different steel with a modified design of the inner ring. You will be contacted again once the new mixer hopper assembly is available with instructions on how and/or where to have your unit(s) repaired.

If cracks or separation of the mixer hopper with the main mounting on the conveyor frame weldment are visible, the vehicle should be put out of service and not used until repairs can be made. Please also contact Cemen Tech immediately if you locate visible cracks or separation.
