Service Engineering Operations
Customer Service Division

SUBJECT: **NEW VEHICLE DEMONSTRATION / DELIVERY HOLD**
Safety Recall 26S13
Certain 2025-2026 Model Year F-250 - F-350 Vehicles Equipped with Aluminum Rear Driveshaft
Rear Driveshaft Inspection

CERTAIN 2025-2026 MODEL YEAR F-250 – F-350 VEHICLES EQUIPPED WITH ALUMINUM REAR DRIVESHAFT — REAR DRIVESHAFT INSPECTION

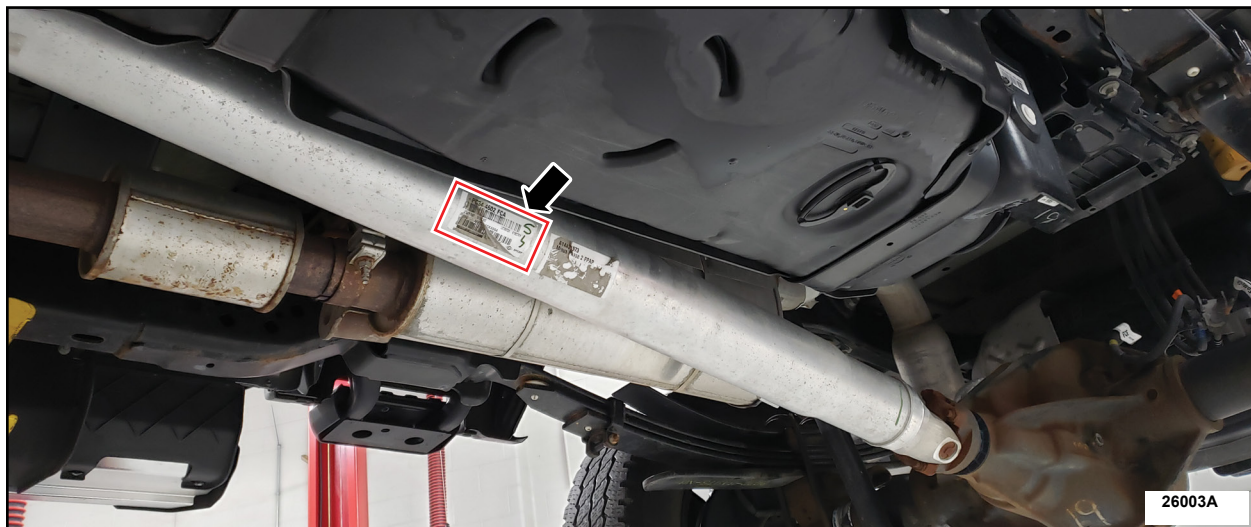
FIGURE 1

1. With the vehicle in NEUTRAL, position it on a hoist. Follow WSM procedures in Section 100-02.
2. Locate the rear driveshaft serial number on the midpoint label. If needed, gently clean the label with a small, dry cloth. Do not use brake cleaner, as it may remove the ink. See Figure 1.

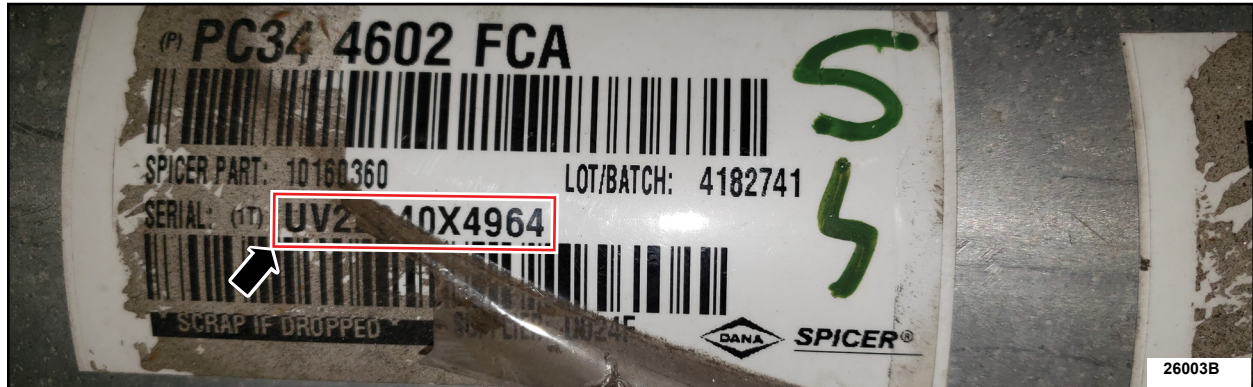
FIGURE 2

3. Is the serial number on the rear driveshaft label legible? See Figure 2.

No - Does not pass inspection. Proceed to Step 5.

Yes - Proceed to Step 4.

5. Capture a clear image of the driveshaft midpoint label. See Figure 2. Photo approval from the Special Service Support Center (SSSC) is required to order the restricted parts. Proceed to Page 3 for photo requirements.
