# SAFETY RECALL

Communication #: I-26-01

## SUBJECT: CHIEF VINTAGE VIN DECAL

## REASON FOR THIS RECALL

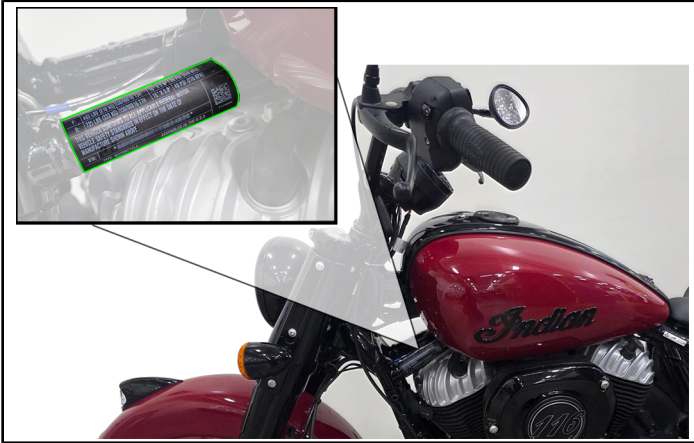
1. Park motorcycle on a flat surface, fully extend side stand, and make sure vehicle is stable.
2. Turn key or ignition switch to OFF position and remove key. If equipped with keyless fob, remove fob from proximity of vehicle.
3. Locate the VIN decal on the left-hand frame tube of the motorcycle.

4. Clean the surface of the VIN decal using a mild cleaner or rubbing alcohol.
