**To:** All Subaru Retailers

**From:** Subaru of America, Inc. – Service Quality

**Re:** WRH-26 Certification Label Non-Compliance Recall- Parts update and Repair Procedure

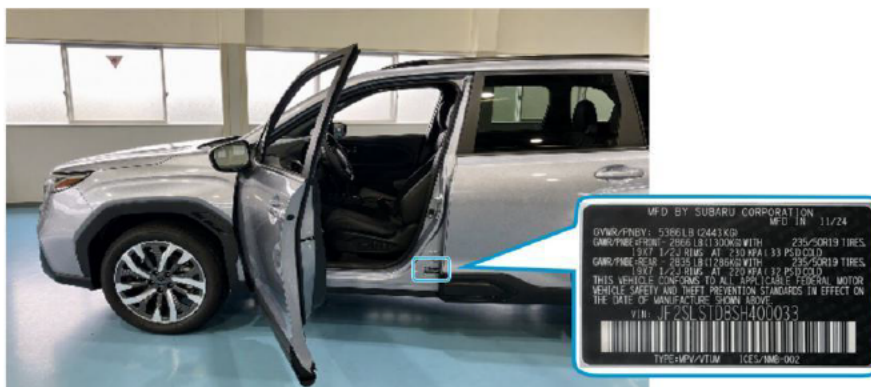
**Step 1:** Locate the label on the bottom of the driver’s B-pillar.

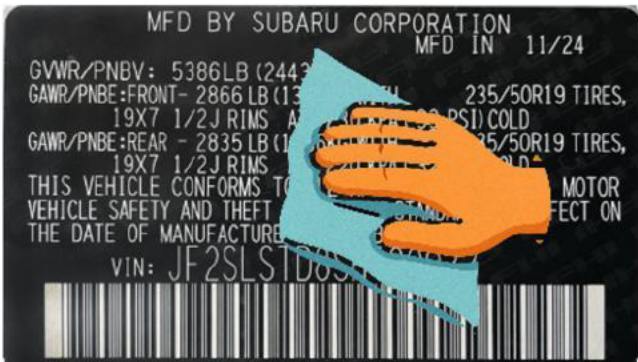
**Step 2:** Moisten a small area of a clean cloth with isopropyl alcohol and clean the surface of the original label. **NEVER** attempt to peel off the original label as it includes the Vehicle Production Date and label damage will occur. Dry the label thoroughly.

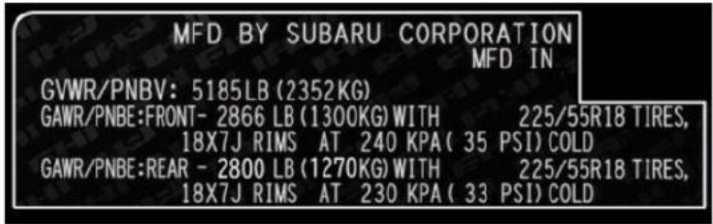
**Step 3:** Prepare the overlay label. Carefully peel the overlay label from its backing sheet, taking care not to damage the label.

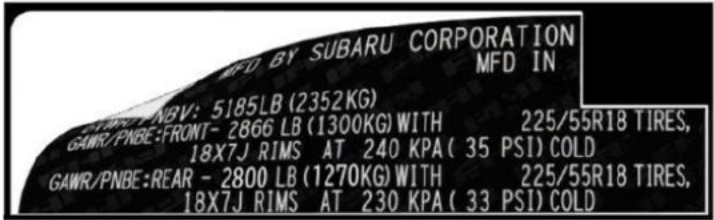
Peel the overlay label off its backing sheet.

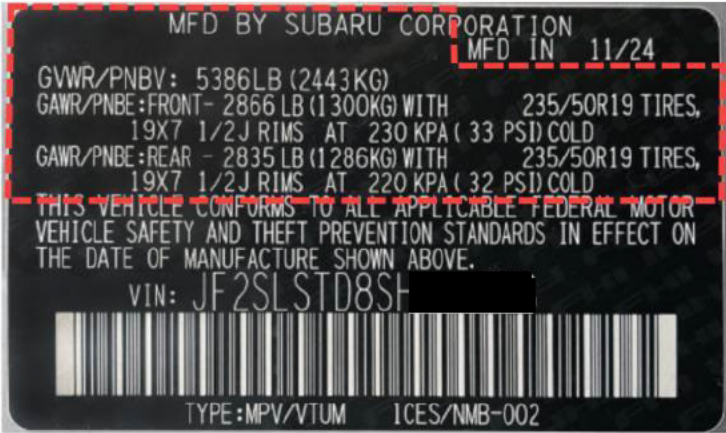
**Step 4:** Align the overlay label with the position indicated by the dashed line, and slowly apply the label from one edge to the other to avoid trapping air.

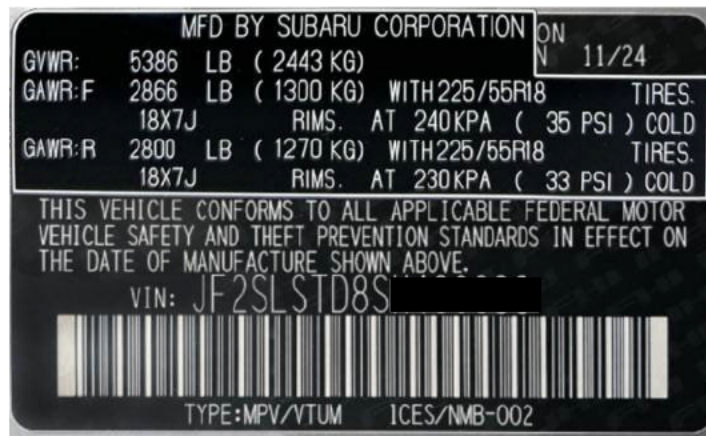
**Step 5:** Press firmly on the overlay label to ensure it adheres completely to the label.
