## **IMPORTANT SAFETY RECALL**

**NHTSA Recall No. 26V010**

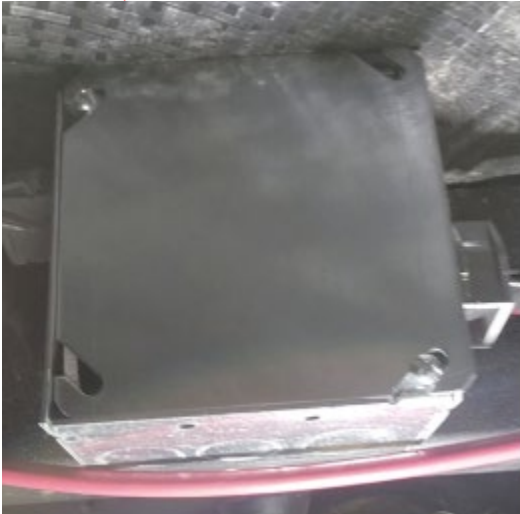
- 1. Confirm Tail lights / Turn signals are working incorrectly.**
- 2. Locate junction box on trailer frame on left front corner of trailer.**

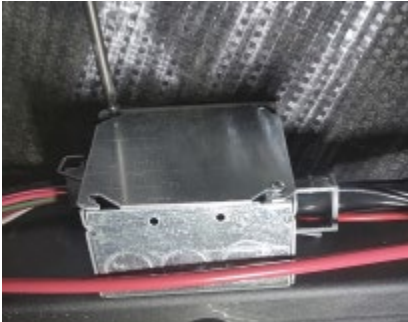
- 3. Remove two screws to take off cover of junction box**

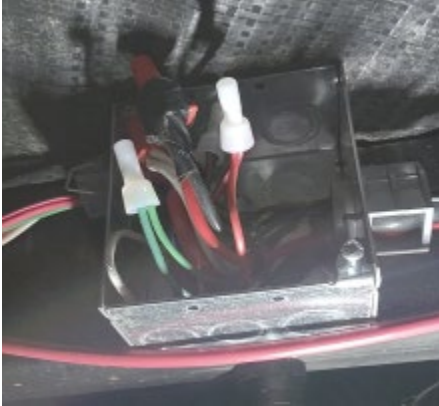
- 4. Locate red/ black rip wire. This wire is half black and half red, has a solid red wire attached to it.**

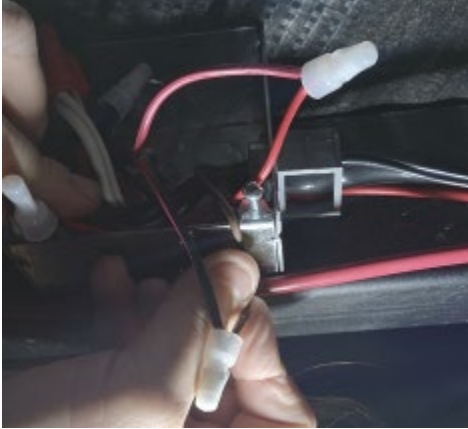
- 5. Locate the black wire attached to a brown wire**

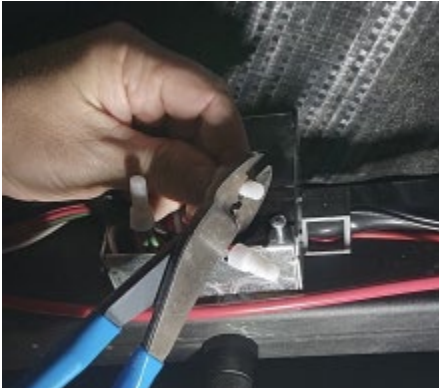
- 6. Cut one side of the red wire, and cut the black wire.**

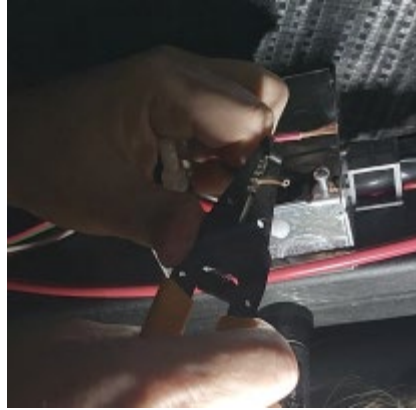
**7. Strip coating off of both wires**

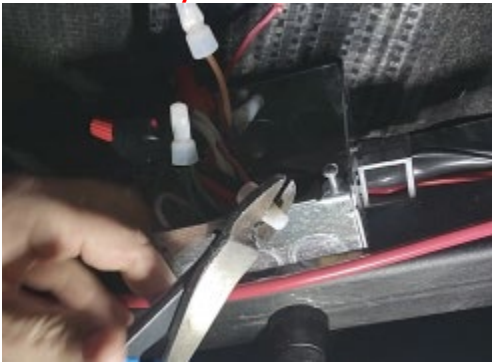
**8. Attach red/ black wire to the black wire replace wire nut**

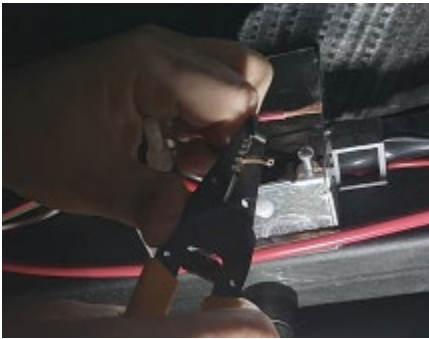
**9. Do the same with the other brown wire and red wire**

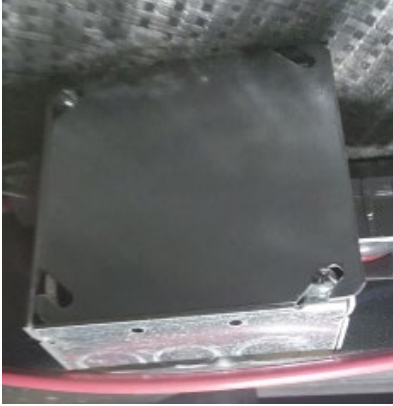
**11. Reinstall the two screws you removed with the cover.**
