# NHTSA Safety Recall 26v-058

## *Claim Preparation & Repair Instructions*

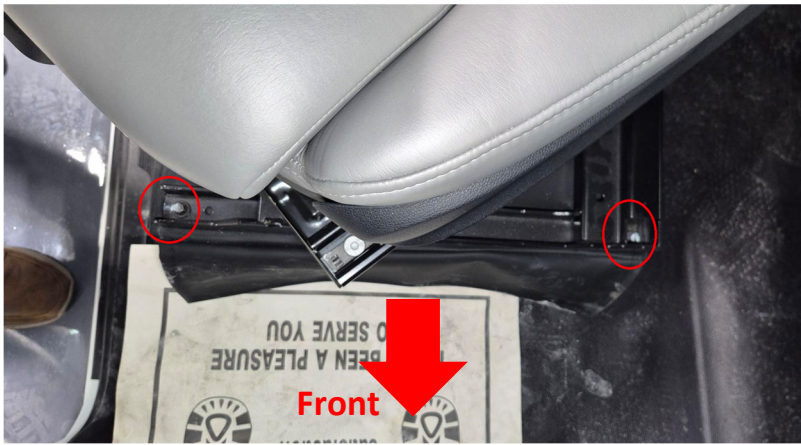
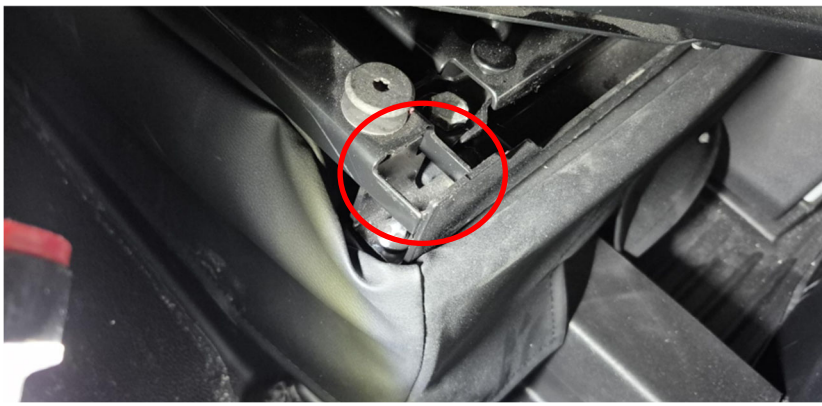
- 1) Run both driver and passenger seats all the way forward
- 2) Torque the 1st 2 bolts closest to the door to 29 ft lbs
- 3) Pivot seat ¼ of a turn towards the door to expose the 2 bolts on the inside of the seat
- 4) Enter the motorhome through the entry door to easily access the inside bolts
- 5) Torque the inside 2 bolts to 29 ft lbs
- 6) Repair Complete
