# VOLUNTARY RECALL CAMPAIGN

Classification: EM25-011E	Reference: NTB25-054E	Date: April 13, 2026
------------------------------	--------------------------	-------------------------

## VOLUNTARY SAFETY RECALL CAMPAIGN 2024 ROGUE; KR15DDT ENGINE INSPECTION

**CAMPAIGN ID #:** R25A9  
**APPLIED VEHICLES:** 2024 Rogue (T33)

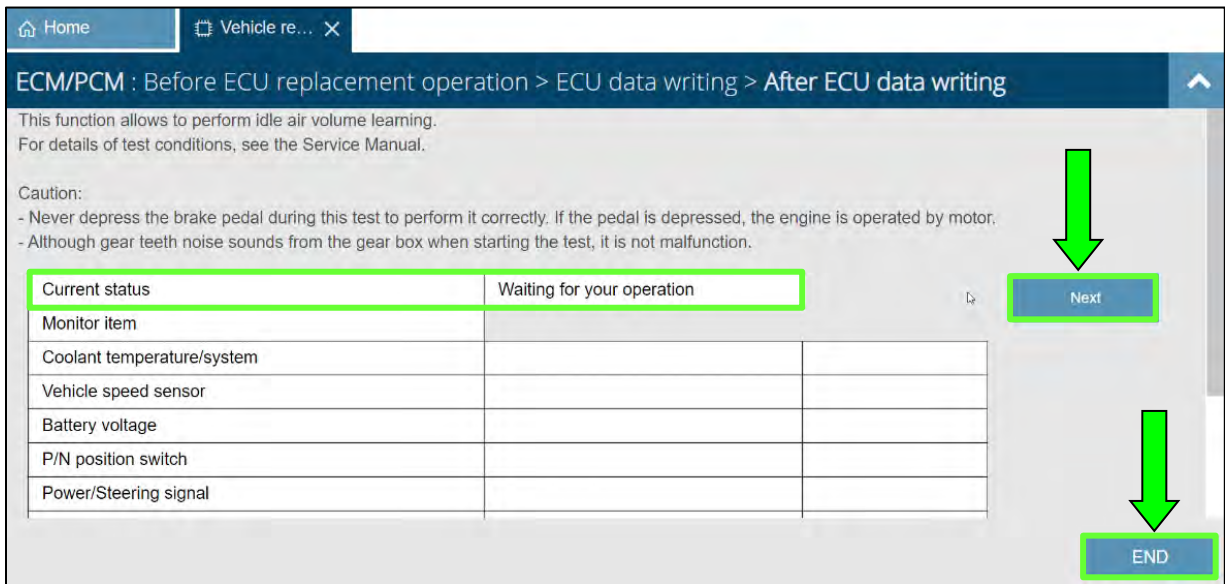
26. When the screen in Figure 24 is shown (Idle Air Volume Learning (IAVL), press and hold the push button ignition switch for 5 seconds to turn the ignition OFF.
  - Wait 10 seconds and then start the engine by depressing the brake pedal and pressing the push button ignition switch one-time.
27. Follow the on-screen instructions to perform IAVL (Figure 24).
  - In order for IAVL to initiate, select **Next**, and then select **Start**.
  - **Current status** will change to “Complete” when IAVL has finished.
  - After IAVL completes, select **END** and skip to step 32 on page 19.
  - If IAVL does **NOT** complete, continue to step 28.

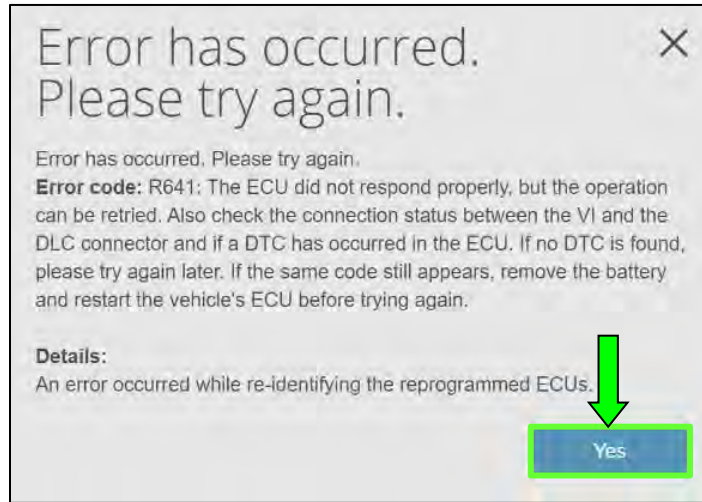
Figure 26

29. If the Error code R641 appears (Figure 26), Select **Yes** and continue to step 30.
- If the Error code R641 does NOT appear, skip to step 32 on page 19.

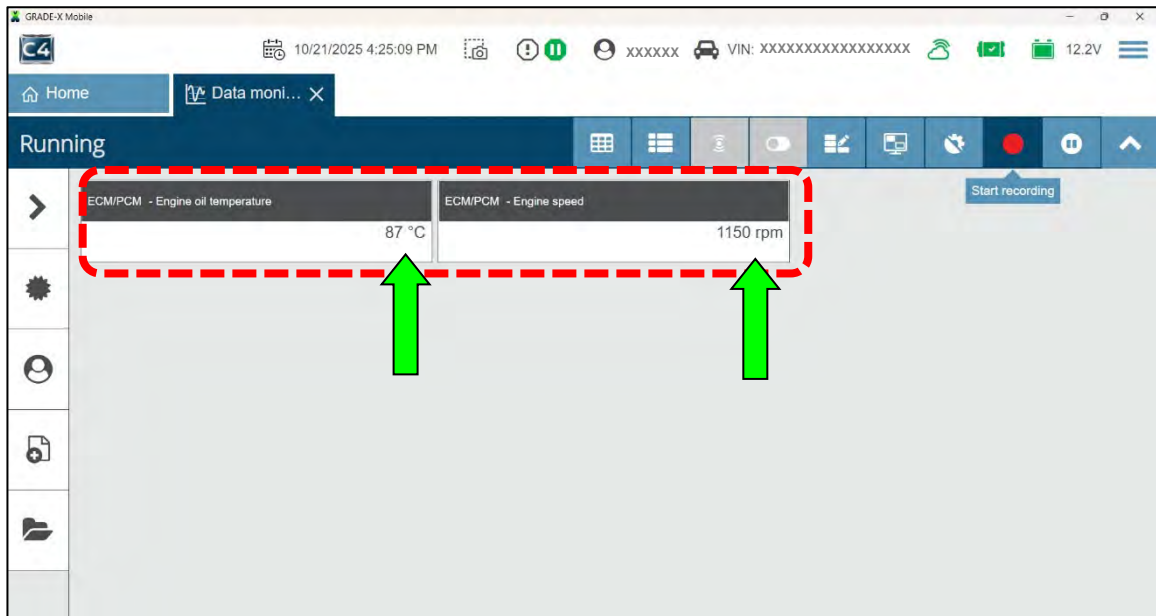
Figure 42

**HINT:** ECM data monitor is shown in Figure 42.

- a. Drive the vehicle to warm the Engine oil temperature to 187° F (86° C) or higher.
- b. Once Engine oil temperature is to 187° F (86° C), drive the vehicle under conditions where engine rpm exceeds 1000 rpm continuously for more than 10 seconds.
- c. Monitor combination meter for Engine MIL.

47. Did the **Engine MIL** come on during the test drive pattern?
  - **NO - Skip to step 49.** No further repairs are required, NO need to send a case to the Warranty Contact Center (WCC). Return the vehicle to the customer.
  - **YES - Continue to step 48.**
48. Check for ENGINE DTC, is DTC P0524-00 ENGINE OIL PRESSURE stored?
  - **NO** - DTC P0524 **is not** stored, follow normal DTC diagnosis using ESM.
  - **YES** - DTC P0524 **is** stored, **Skip to Step 52** to replace the Long Engine Assembly. Engine replacement **MUST be Preauthorized by Warranty Contact Center (WCC).**
49. Close CONSULT 4.
50. Turn the ignition OFF.
51. Disconnect the VI3 from the vehicle. **No further repair is required. Return the vehicle to the customer.**
