# Safety Recall

## N252542620 Tire Sidewall May Be Damaged

**Release Date:** March 2026

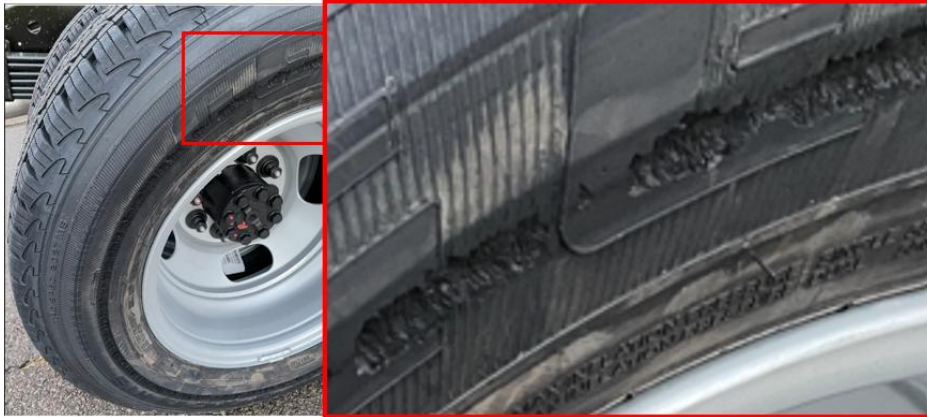
7096914

**IMPORTANT:** Pictured above is the chunking damage that may be present on one of the tires. The damage is characterized by a nearly uniform ring around the outboard sidewall of the tire with deep gouges. The damage will be deep chunking, tires **MUST NOT** be replaced for light curb rash.

1. Inspect all tires for chunking as shown in the above image. The damage is most likely at the RR wheel. For vehicles with a dual rear axle, inspect all six tires. If no damage is found, no further action is required.
2. If chunking damage is found, replace the affected tire.

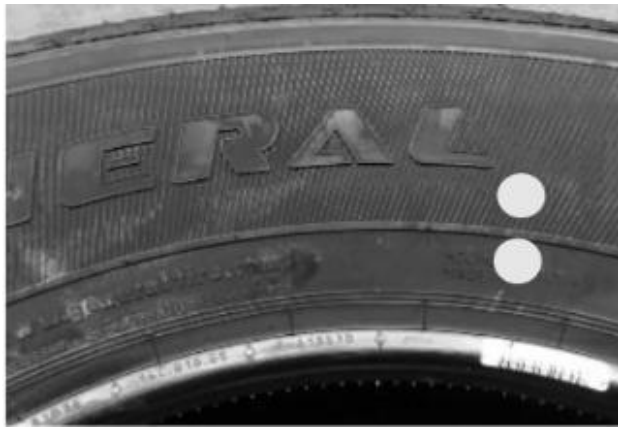
5682490

**IMPORTANT:** Federal regulations require all recalled tires to be completely disabled within 24 hours of removal. The tire needs to be rendered completely inoperable immediately after it is removed.

3. Drill two 13mm (1/2 inch) holes in the replaced tire sidewall to ensure it is not put back into service.
4. Attach all pictures to the repair order and attach them to the claim in Global Warranty Management. Please ensure the total file size of the images is less than 10 Mb.
5. Dispose of the damaged tire following your normal tire disposal process.

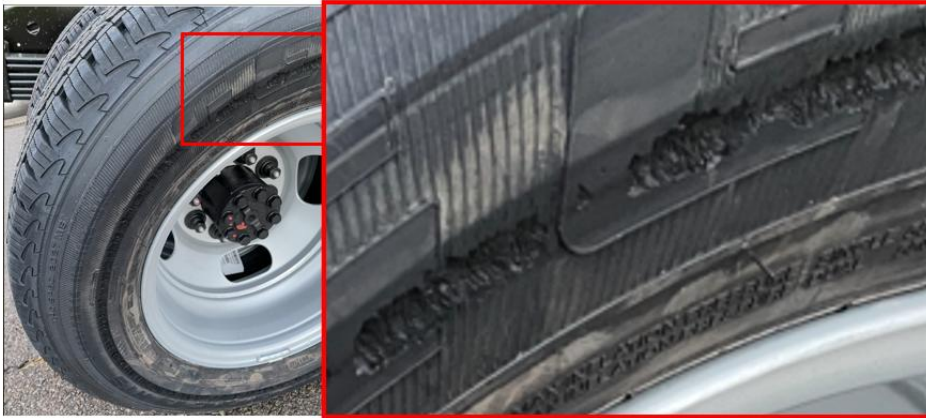
7096914

**IMPORTANT:** Pictured above is the chunking damage that may be present on one of the tires. The damage is characterized by a nearly uniform ring around the outboard sidewall of the tire with deep gouges. The damage will be deep chunking, tires **MUST NOT** be replaced for light curb rash.

3. Inspect all tires for chunking damage as shown in the above image. For vehicles with dual rear wheels, ALL tires must be inspected.
4. Lower the spare tire. Inspect for the chunking damage shown in step 3.
5. If no damage is found, no further action is required.
6. If damage is found, replace the appropriate tire.
7. Measure the tread depth of the tire on the opposite side of the companion tire. If the difference in tread depth between the new tire and the tire on the opposite side of the axle is greater than 2/32nds, replace the appropriate companion tire as well. If a companion tire must be replaced on vehicles with dual rear wheels, place both new tires at the front axle of the vehicle.

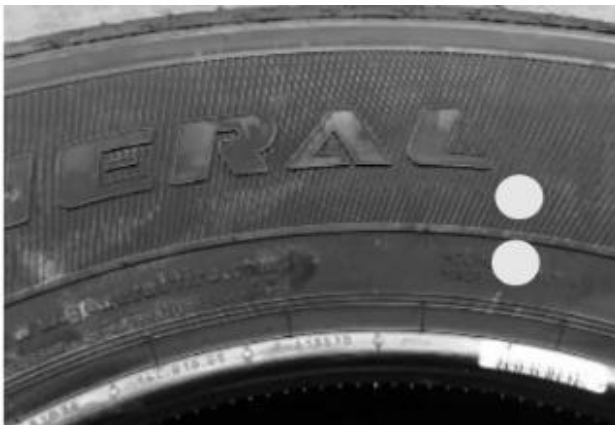
5682490

**IMPORTANT: Federal regulations require all recalled tires to be completely disabled within 24 hours of removal. The tire needs to be rendered completely inoperable immediately after it is removed.**

8. Drill two 13mm (1/2 inch) holes in each of the replaced tire sidewalls to ensure it is not put back into service.
9. Attach all pictures to the repair order and attach them to the claim in Global Warranty Management. Please ensure the total file size of the images is less than 10 Mb.
10. Dispose of the damaged tire(s) following your normal tire disposal process.
