# Safety Recall

## N252542620 Tire Sidewall May Be Damaged

**Release Date:** March 2026

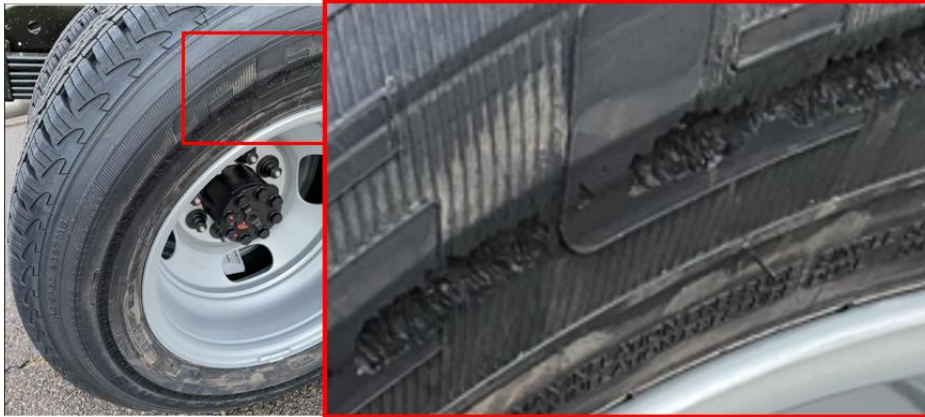
7096914

**IMPORTANT:** Pictured above is the chunking damage that may be present on one of the tires. The damage is characterized by a nearly uniform ring around the outboard sidewall of the tire with deep gouges. The damage will be deep chunking, tires **MUST NOT** be replaced for light curb rash.

1. Inspect all tires for chunking as shown in the above image. The damage is most likely at the RR wheel. For vehicles with a dual rear axle, inspect all six tires. If no damage is found, no further action is required.
2. If chunking damage is found, replace the affected tire.

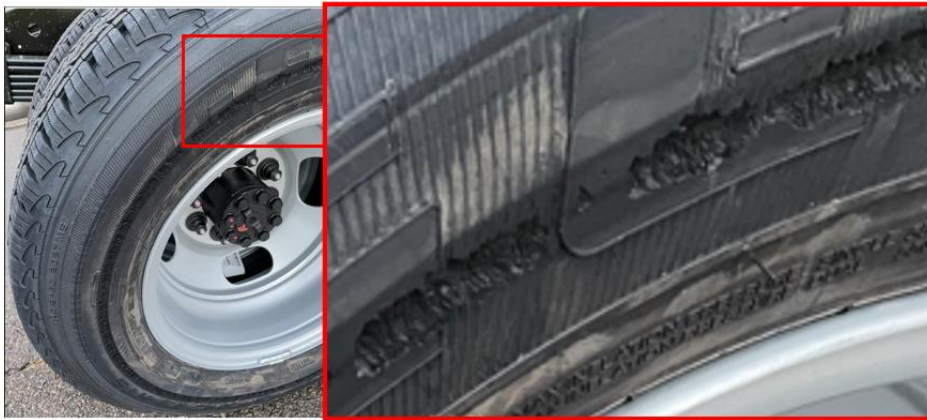
7096914

**IMPORTANT:** Pictured above is the chunking damage that may be present on one of the tires. The damage is characterized by a nearly uniform ring around the outboard sidewall of the tire with deep gouges. The damage will be deep chunking, tires **MUST NOT** be replaced for light curb rash.

3. Inspect all tires for chunking damage as shown in the above image. For vehicles with dual rear wheels, ALL tires must be inspected.
4. Lower the spare tire. Inspect for the chunking damage shown in step 3.
5. If no damage is found, no further action is required.
6. If damage is found, replace the appropriate tire.
7. Measure the tread depth of the tire on the opposite side of the companion tire. If the difference in tread depth between the new tire and the tire on the opposite side of the axle is greater than 2/32nds, replace the appropriate companion tire as well. If a companion tire must be replaced on vehicles with dual rear wheels, place both new tires at the front axle of the vehicle.
