Recall Repair Instructions

NHTSA Recall # 26V-156

Tiffin Recall # TIF-147

Purpose: Replace incorrect OCCC label with a correct OCCC label.

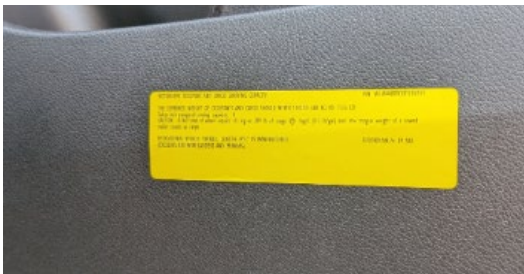
Figure 1

1. The yellow Cargo Carrying Capacity Label can be found on the passenger’s side door panel Figure 1.
2. Remove the old label and discard
3. Clean the passenger's side door jamb with isopropyl alcohol and carefully place the new label as shown
