VOLUNTARY RECALL CAMPAIGN

Classification: RS26-002	Reference: NTB26-028	Date: May 4, 2026
-----------------------------	-------------------------	----------------------

VOLUNTARY SAFETY RECALL CAMPAIGN 2009-2010 CUBE; TAKATA DRIVER AIR BAG MODULE

CAMPAIGN ID #: R26A1
APPLIED VEHICLES: 2009-2010 cube (Z12)

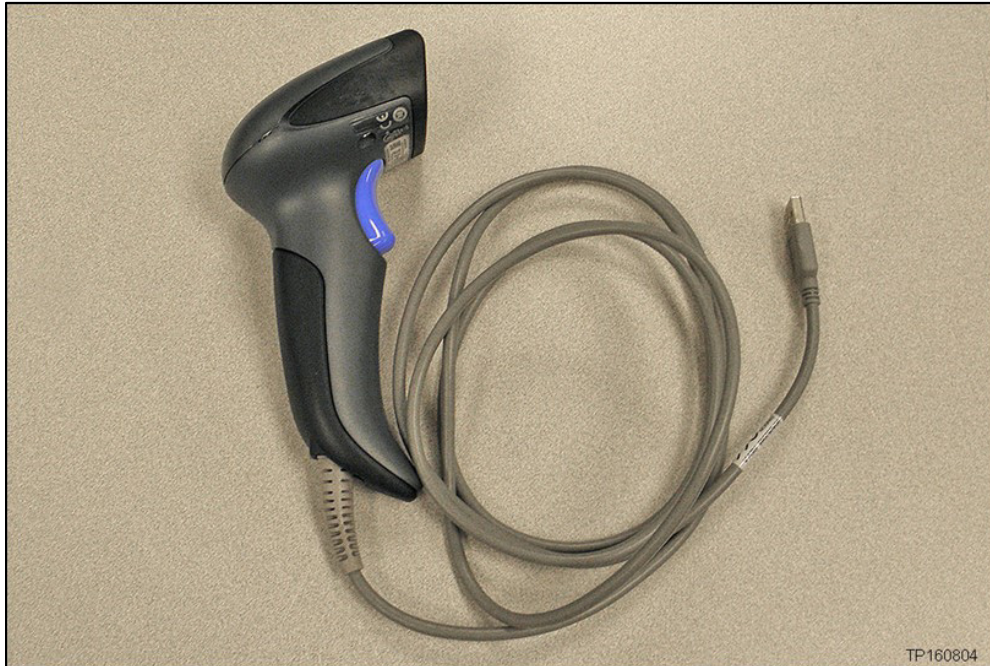
Figure 1

Quick Scan Tool (J-52352 / NI-52352)

- Each dealer has one essential Quick Scan Tool (J-52352).
- Additional tools can be obtained from Tech•Mate at 1-800-662-2001.

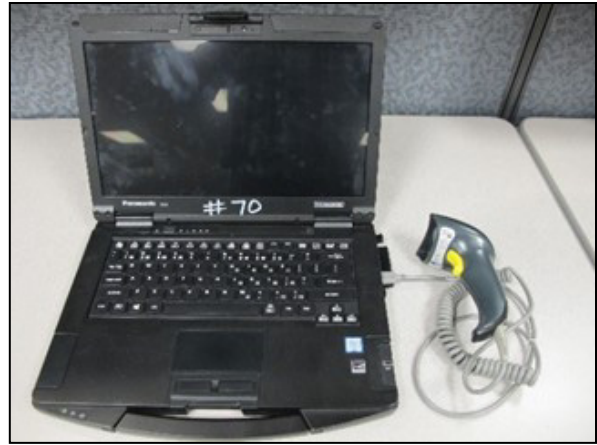
Figure 3

- Attach the Quick Scan Tool (J-52352) to a CONSULT PC's USB port (Figure 3).

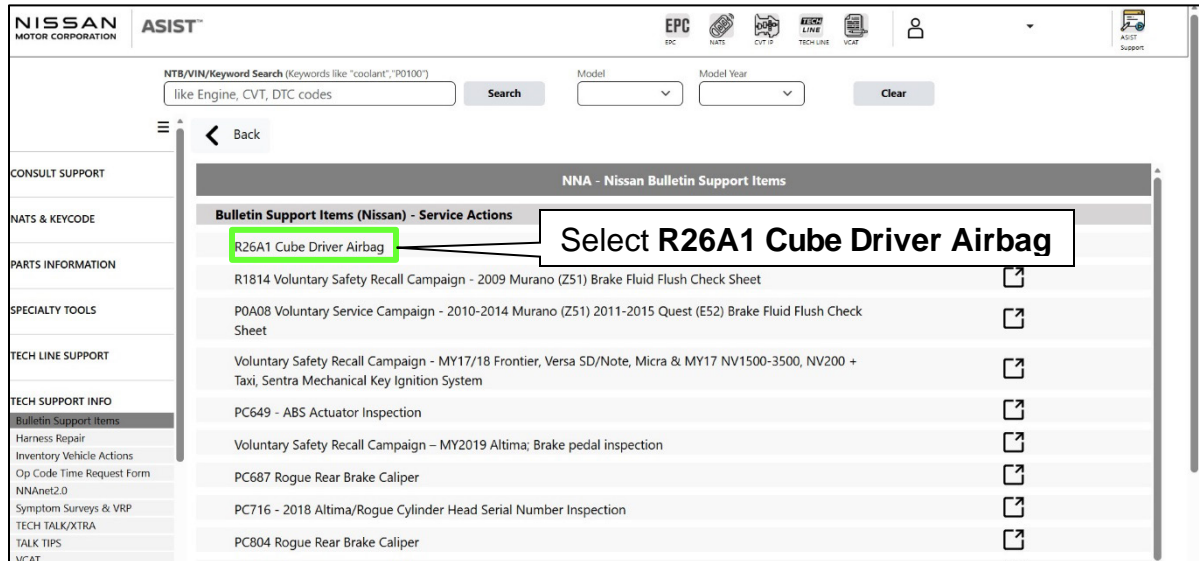
Figure 5

10. Select R26A1 Cube Driver Airbag.

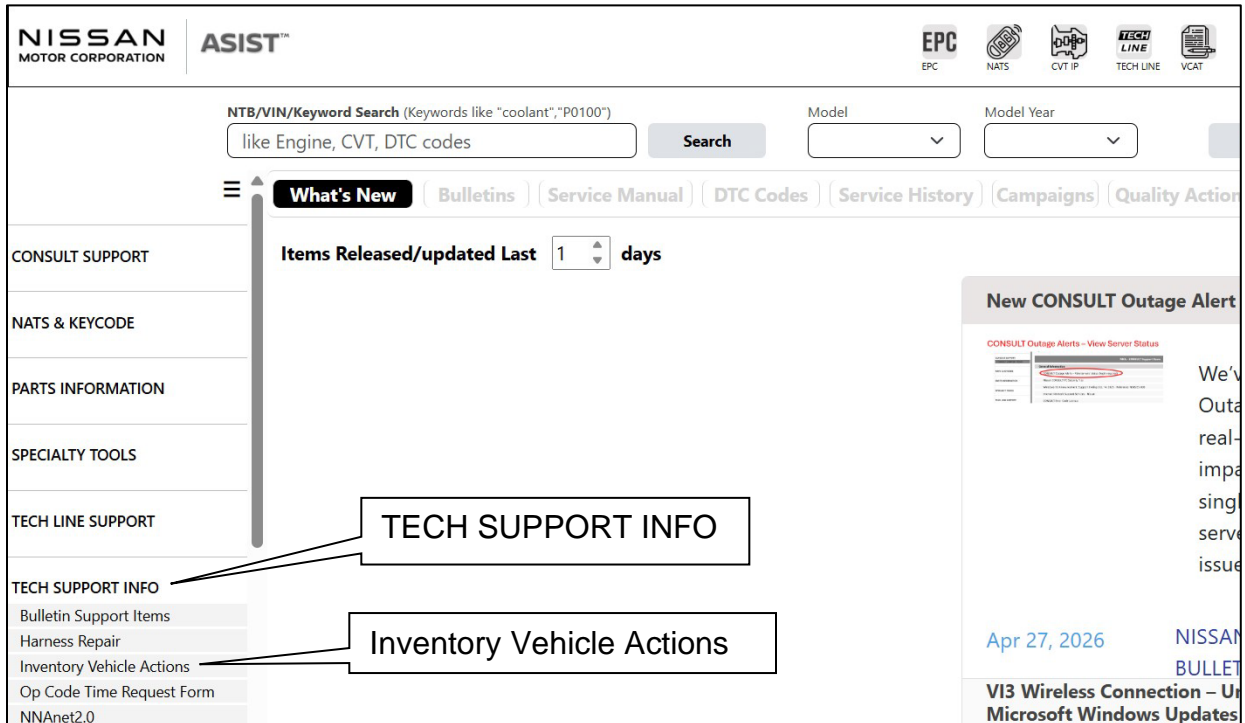
Figure 9

15. On the left side of the ASIST main menu, select **TECH SUPPORT INFO**, then **Inventory Vehicle Actions**.

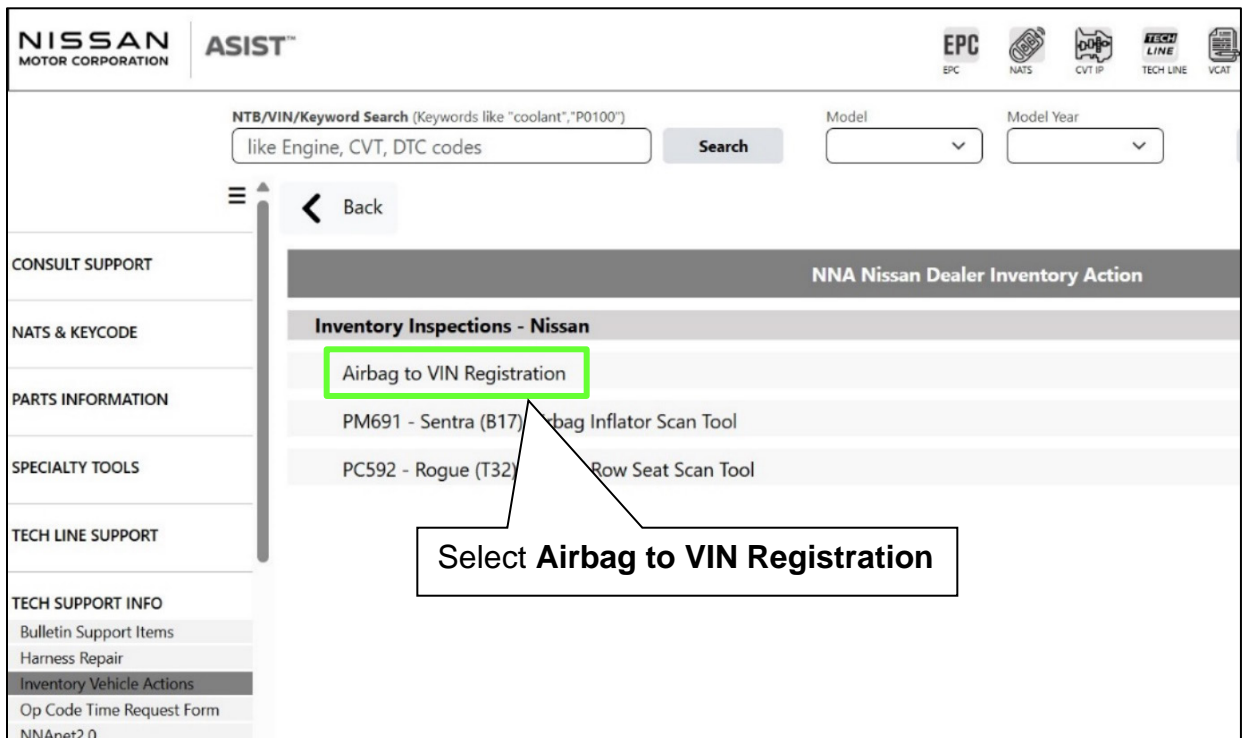
Figure 10

16. Select **Airbag to VIN Registration**.

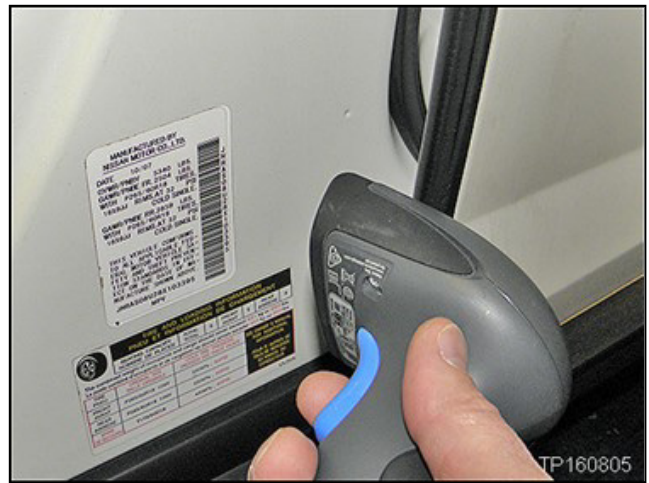
Figure 11

17. Use the quick scan tool to scan the bar code (VIN) on the vehicle B-pillar label.

- Some labels may not scan quickly.
- Hold the scan tool approximately 6 inches away from the label.
- Hold the trigger down until the label is read (this may take several seconds).
- VIN will automatically populate (Figure 12).
- If needed, VIN can be entered manually.
