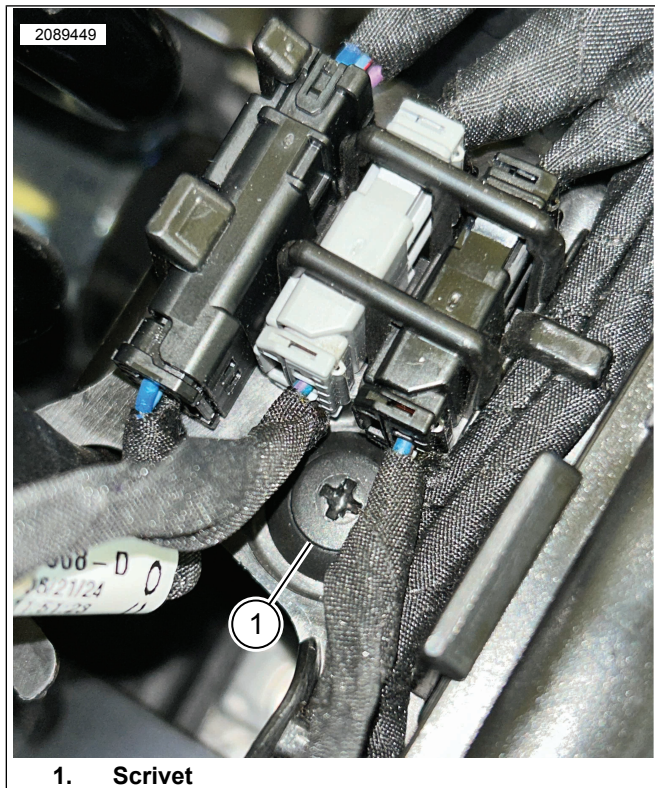
Figure 2. Rear Lighting Caddy Scrivet

8. See Figure 2. Remove scrivet (1) from rear lighting caddy.

9. Move rear lighting caddy and frame crossmember out of the way toward the left side of the vehicle.
 - a. Take care as not to scratch vehicle frame or other painted components.
10. Remove mud guard. See service manual.
11. Remove Electronic Control Module (ECM). See service manual.
12. Remove ECM caddy. See service manual.
