## Repair Procedure

1. Verify that the vehicle is included in Recall 0193. Refer to Vehicle Recall Verification.
2. Verify that the vehicle is equipped with the Original Equipment (OE) Airbox Assembly (Part No. 29000373).
  - a. If the vehicle has been equipped with a Parts and Accessories (P&A) or aftermarket air cleaner, file the appropriate claim for Inspection Only per Credit Procedure. Refer to Credit Procedure.
3. Remove outer cover of air cleaner.
4. Remove breather hose from transmission breather.
5. See Figure 1. Gently apply air to breather hose in the direction of the air cleaner backing plate, using an air gun with a rubber tip with a rubber tip to ensure proper sealing.
  - a. Applying too much air pressure in bursts could push the hose off the backing plate and falsely indicate a blockage.

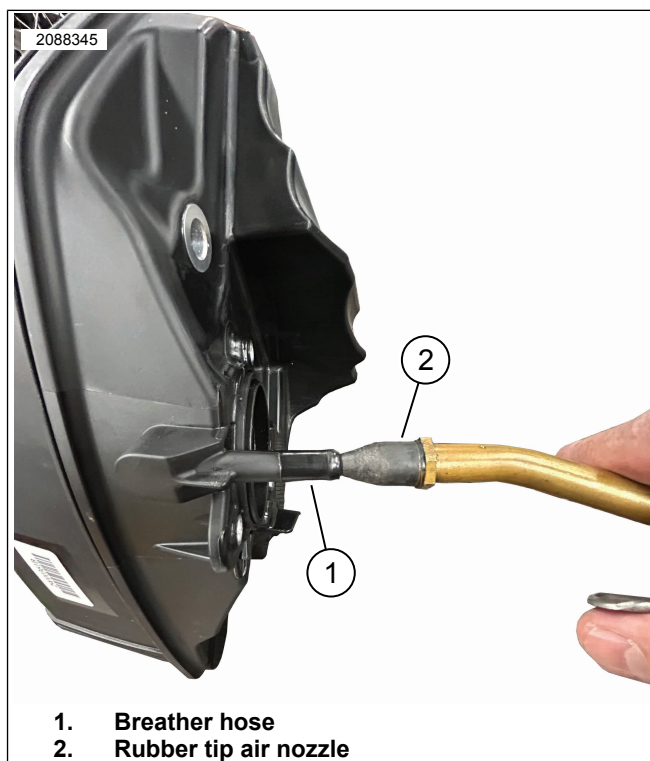
Figure 2. Backing Plate

6. Verify that air flows through the hose and into air box backing plate.
  - a. Make sure that the hose did not blow off the backing plate when applying air. If the hose does come off, the backing plate could indicate a blockage.
  - b. If no blockage is found, file the appropriate claim for Inspection Only per Credit Procedure. Refer to Credit Procedure.
7. If initial testing indicates the air box **IS NOT** flowing air, see the service manual to remove the air box backing plate.
8. See Figure 2. With the air box removed, apply air to the backing plate directly. A blockage will be indicated by no air flow.

9. If the air box backing plate port is blocked, rework the breather passage:
  - a. See Figure 2. Using a 3/16-inch drill bit, from the backside of the backing plate, drill the port open.
