NHTSA Safety Recall 26v-277

TC Safety Recall 2026-215

Claim Preparation & Repair Instructions

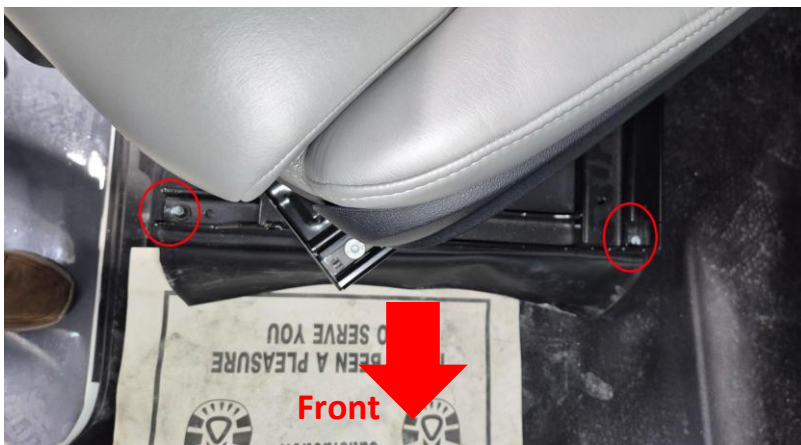
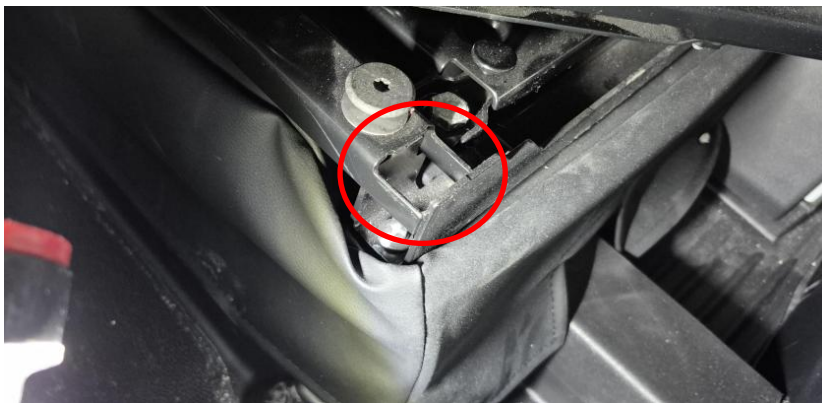
- 1) Run both driver and passenger seats all the way forward
- 2) Torque the 1st 2 bolts closest to the door to 35 ft lbs
- 3) Pivot seat ¼ of a turn towards the door to expose the 2 bolts on the inside of the seat
- 4) Enter the motorhome through the entry door to easily access the inside bolts
- 5) Torque the inside 2 bolts to 35 ft lbs
- 6) Repair Complete
