## Taillight Dash Error Message – Resistors

| <b>Bulletin Type:</b> | Recall | <b>Publication Date:</b> | June 2026 |
| <b>Bulletin #(s):</b> | 26V-361 USA<br>2026-269 CANADA | <b>Make(s):</b> | Jayco & Entegra Coach |

| <b>Incident:</b> | Dash is displaying taillight warning messages for right and left taillights when lights are functioning correctly. |

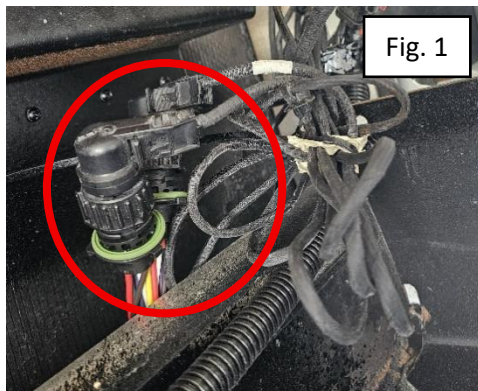
Fig. 1

1. Disconnect the two 7-Way cavity plugs under the chassis. It is near the rear drive side leveling leg. (Figure 1)

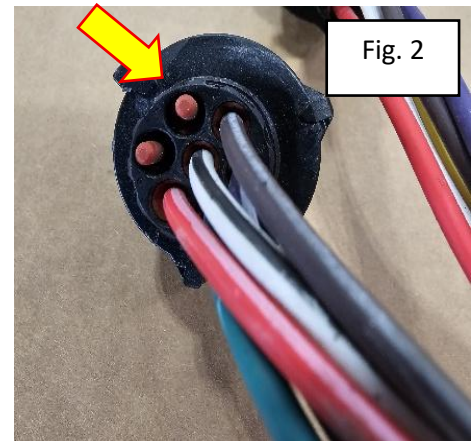
Fig. 2

2. On one of the plugs Locate Pin 7. Using Wire Strippers, remove the plug in pin 7. (Figure 2)
3. Insert one of the pins from the resistor harness into pin 7. (Figure 3)
4. Locate pin 7 on the second connector, remove the plug from pin 7. (Figure 2)
5. Insert the second pin from the resistor harness into pin 7 of the second connector. (Figure 3)
6. Re-connect the two 7-Way cavity plugs underneath the coach. (Figure 1)
7. Remove the bolt for the chassis ground near the driver side rear leveling jack using a ½" wrench and ratchet with ½" socket. Attach the chassis frame ground from the resistor harness to the bolt and re-install.
  - a. **Note: When adding the ground to the chassis frame ground stud, ensure there is a star washer on the stud and if not add one.** (Figure 4)
8. Mount the resistors to the frame rail. (Figure 5)
9. Secure any loose wiring using cable/zip ties or p-clamps
