# SAFETY RECALL

## Electric Hydraulic Power Steering Pump

Reference: 21D / NHTSA 26V-363

2021-2025 (JL) Jeep Wrangler

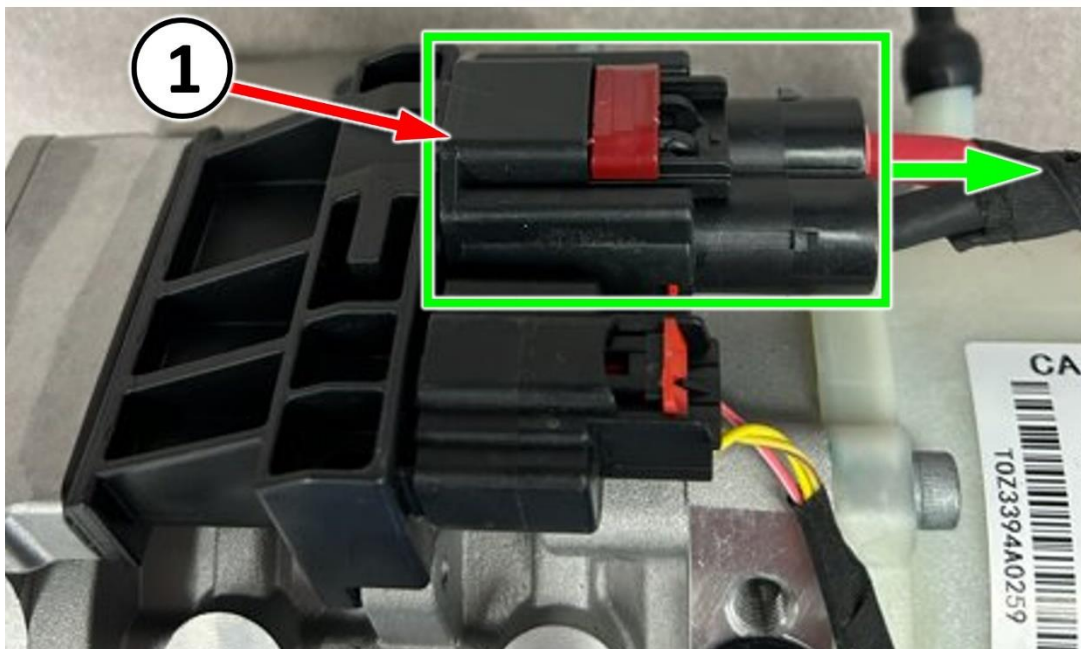
**Figure A2 – EHPS Electrical Connector Pull Test**

- b. Grasp the EHPS connector ONLY (not the wires) and pull to determine if it is securely connected to the EHPS pump. If connector releases, take photos to attach to repair claim. If connector does not detach, push on connector to ensure it is fully seated (Figure A2).

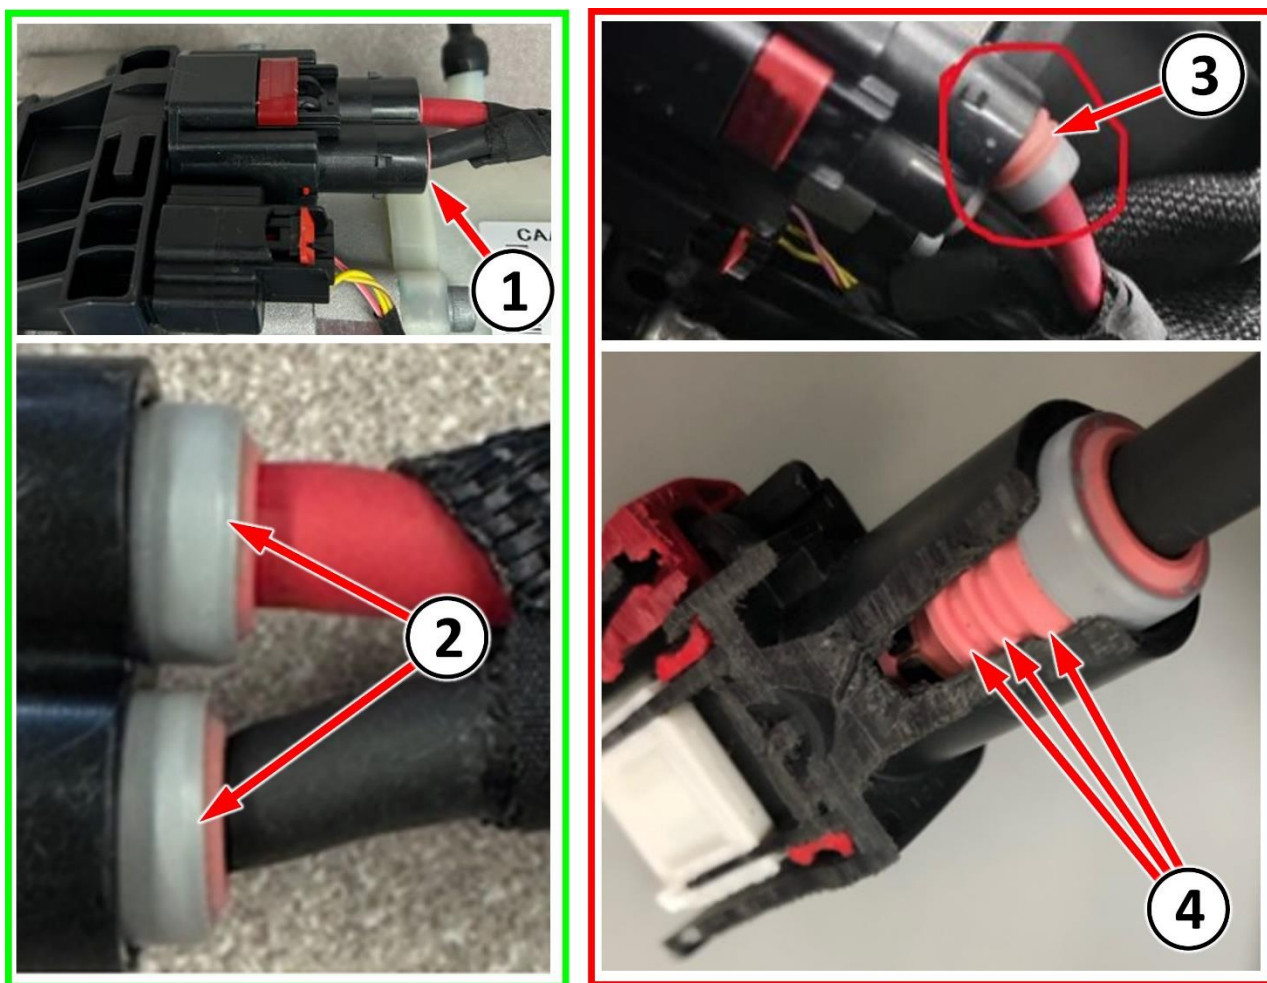
- c. Inspect the wire harness for any wires that are not fully inserted into the connector as shown in the following images. If the sealing ribs are exposed, take photos to attach to repair claim (Figure A3).
- d. Visually inspect for any visible damage to harness bundle and EHPS connector. If damage is observed, take photos to attach to repair claim.

Correctly Inserted Terminals - OK

Ribs Exposed - Not OK Condition

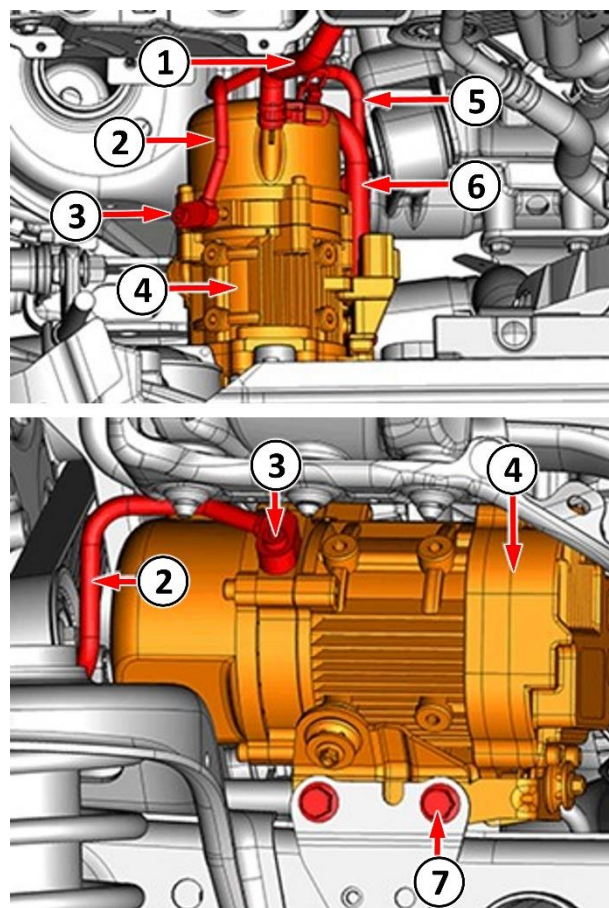
**Figure A9 – EHPS Pump**

29. With the hose clamp released, disconnect the supply hose from the EHPS pump and position the hose end higher than the power steering pump reservoir to prevent leaking while disconnected (Figure A9).

30. Remove the EHPS pump from the vehicle and set aside for return for analysis (Figure A9).

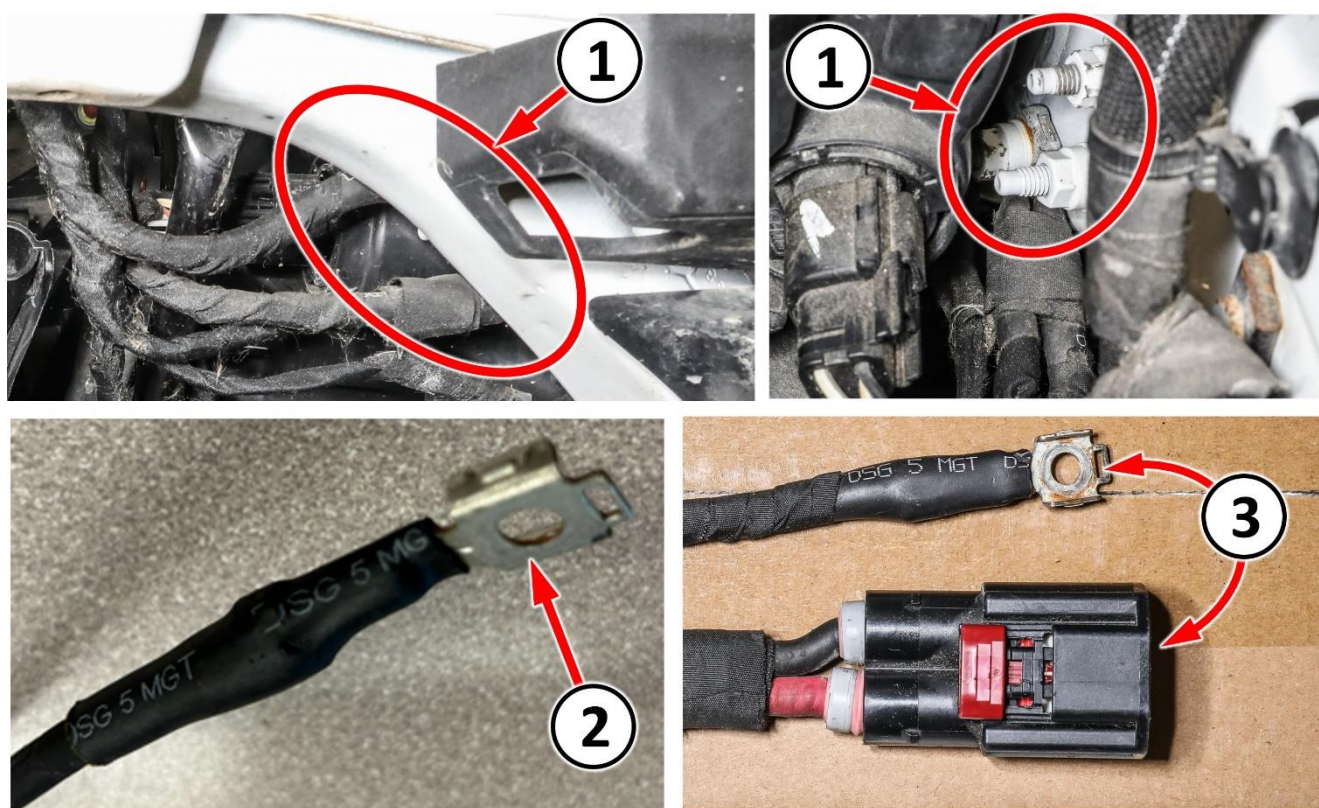
**Figure A10 – EHPS Ground G908A - Near Right Side Headlamp**

32. Locate EHPS ground G908A on body of vehicle near the right-side headlamp on one of three studs (Figure A10).  
**NOTE: The EHPS ground connection is often located on the lower stud but may vary depending on vehicle build configuration so MUST be verified.**
33. Remove the ground nut and eyelet off the stud then verify continuity with a multimeter between G908A ground eyelet and EHPS connector D2704A cavity 1 black wire. Also verify the EHPS ground circuit is isolated from chassis ground (Figure A10). **NOTE: If a continuity reading is still present between the EHPS ground circuit wire and chassis ground, the wrong wire has been selected.**

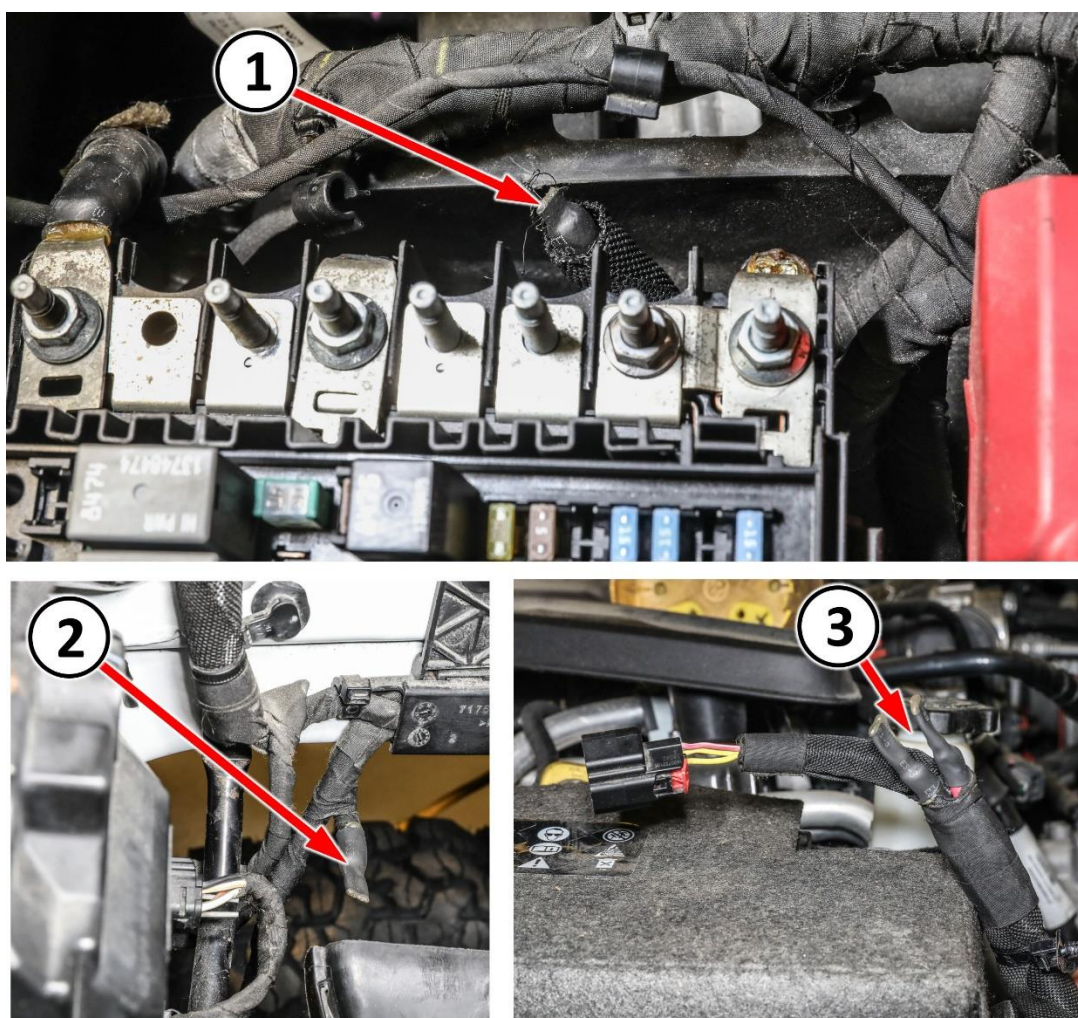
**Figure A13 – Seal Exposed Ends of Cut EHPS Wires**

40. Use locally sourced heat shrink tubing to seal the exposed end where EHPS power supply eyelet D6630J was removed (Figure A13).
41. Use locally sourced heat shrink tubing to seal the exposed end where EHPS ground eyelet G908A was removed (Figure A13).
42. Use locally sourced heat shrink tubing to seal the exposed ends where EHPS connector D2704A was removed (Figure A13).

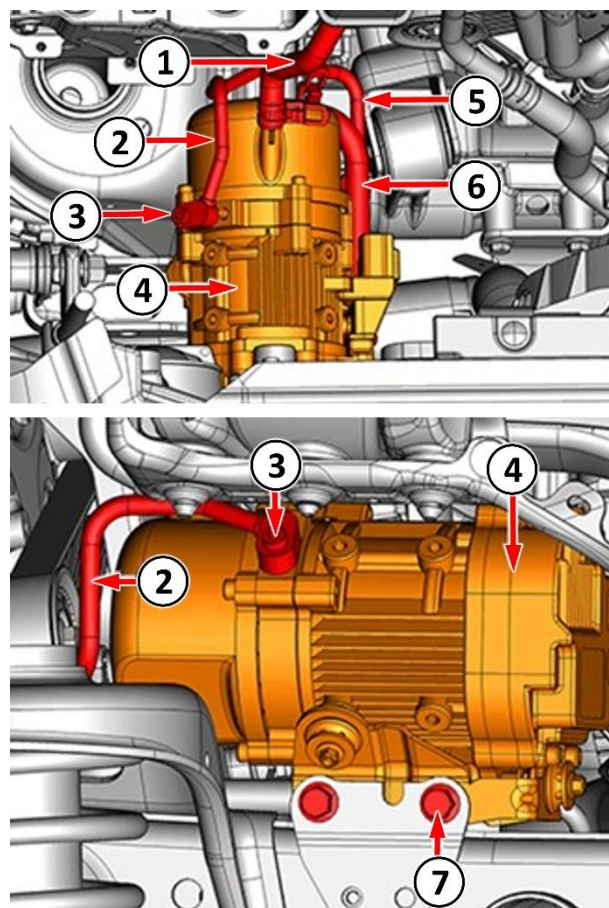
**Figure A15 – EHPS Pump**

48. Install the EHPS pressure pipe to the EHPS pump then install the EHPS pump pressure pipe bolt (Figure A15). Tighten the pressure pipe bolt to:  
2024 and prior: 20 N·m (15 Ft. Lbs.)  
2025 and later: 25 N·m (18 Ft. Lbs.)

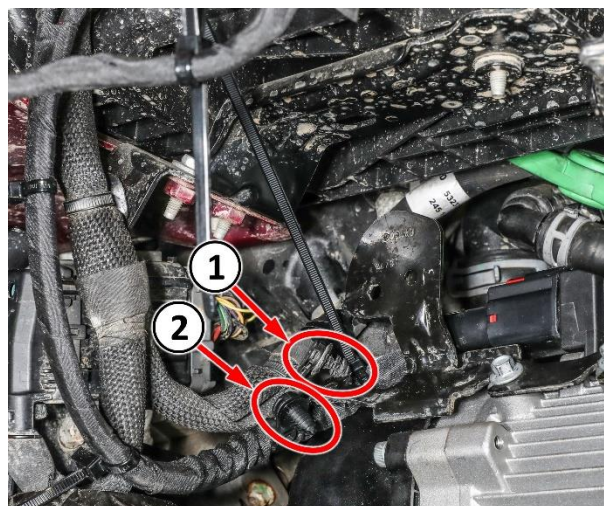
**Figure A16 – Fir Tree Clips**

**NOTE:** When two fir tree clips exist in the same location on both the new EHPS overlay harness and original EHPS harness, remove the old fir tree clip in favor of using the new fir tree clip (Figure A16).

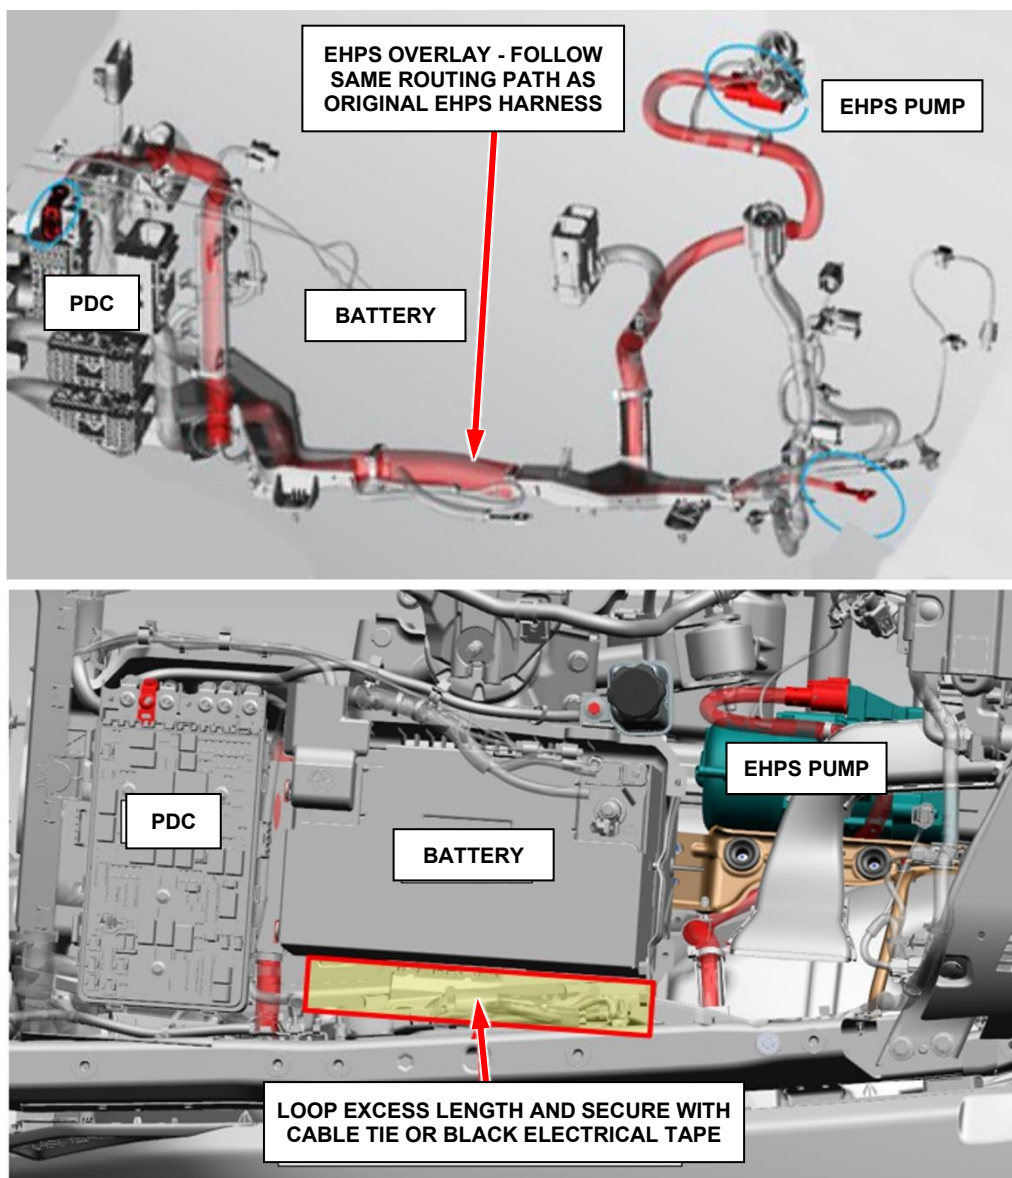
**Figure A19 – Power Steering Pump Wire Harness Overlay Routing**

52. Route remainder of EHPS overlay harness along existing dash harness bundle routing, securing double tie strap clips to existing dash harness wiring bundle. Make sure overlay is not in direct contact with sharp edges. Reference routing pictures below (Figure A19).
53. Loop and secure with cable tie or black electrical any excess overlay jumper wire length outboard of battery.

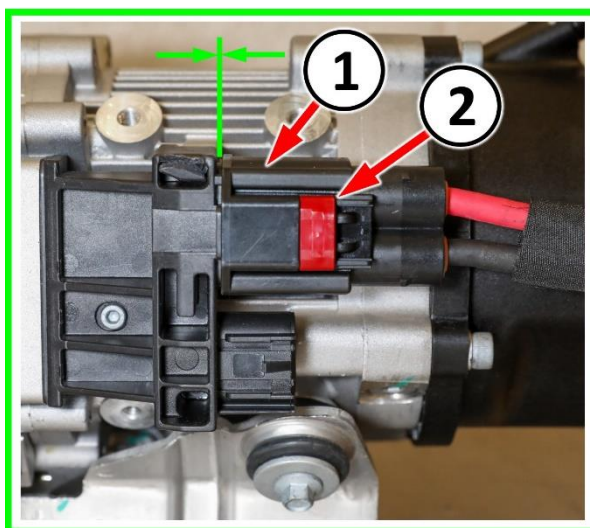
- a. Visually verify Electric Hydraulic Power Steering (EHPS) connector is fully mated to the pump interface with CPA fully engaged on the connector latch. If electrical connector is not fully mated or CPA is not engaged, take photos to attach to repair claim (Figure B2).

**Electrical Connector and CPA  
Fully Engaged, No Gap**

**Electrical Connector and/or CPA  
Not Fully Engaged, Gap Observed**

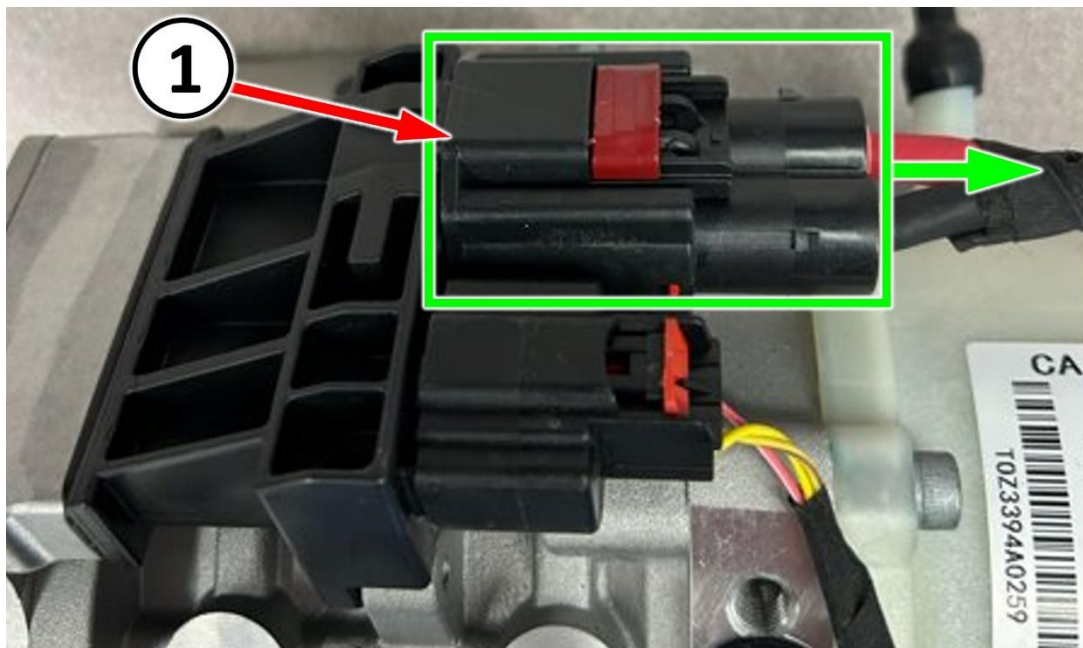
**Figure B3 – EHPS Electrical Connector Pull Test**

- b. Grasp the EHPS connector ONLY (not the wires) and pull to determine if it is securely connected to the EHPS pump. If connector releases, take photos to attach to repair claim. If connector does not detach, push on connector to ensure it is fully seated (Figure B3).

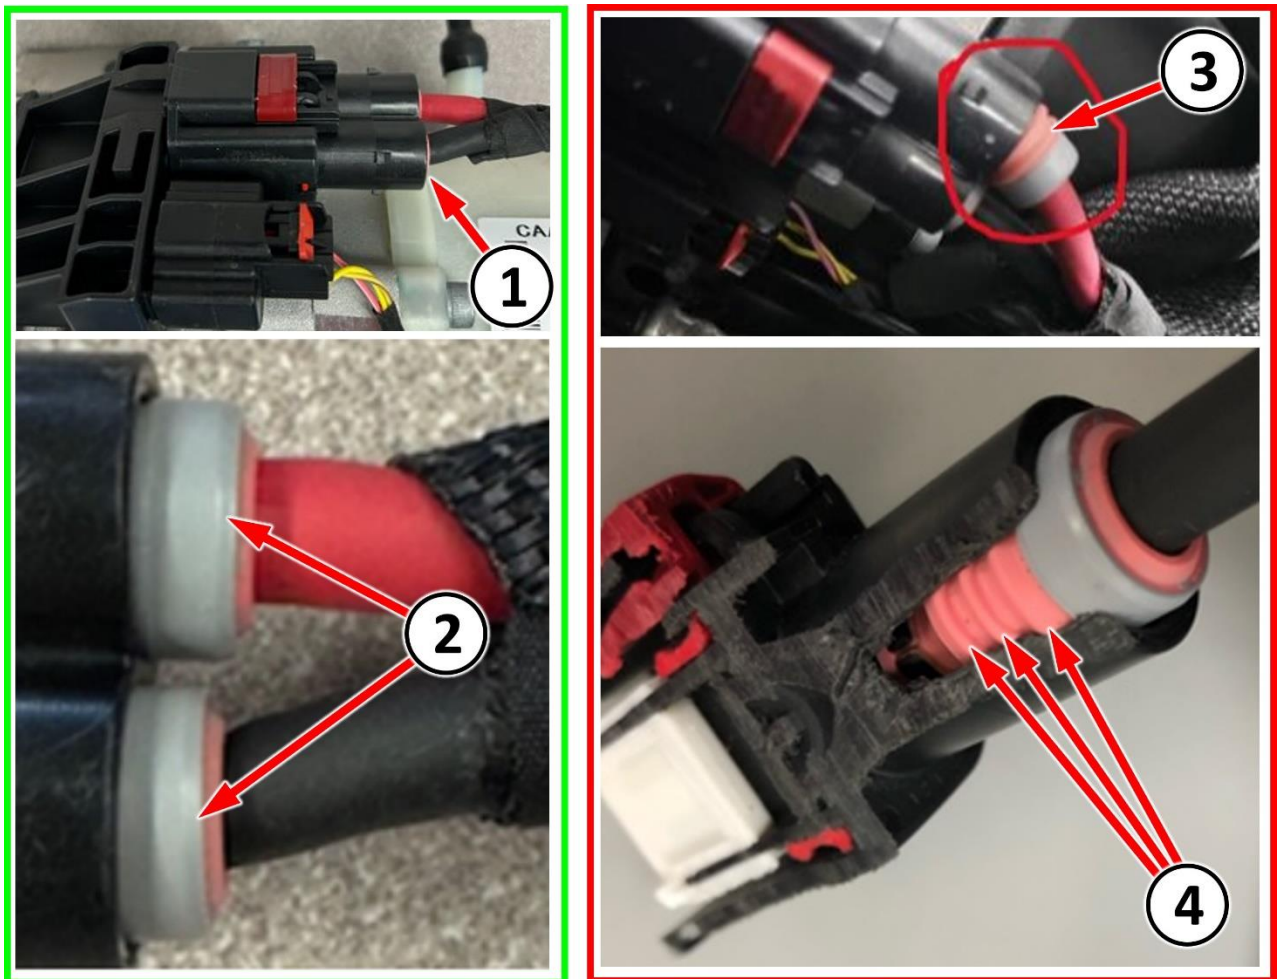
- c. Inspect the wire harness for any wires that are not fully inserted into the connector as shown in the following images. If the sealing ribs are exposed, take photos to attach to repair claim (Figure B4).
- d. Visually inspect for any visible damage to harness bundle and EHPS connector. If damage is observed, take photos to attach to repair claim.

**Correctly Inserted Terminals - OK**

**Ribs Exposed - Not OK Condition**

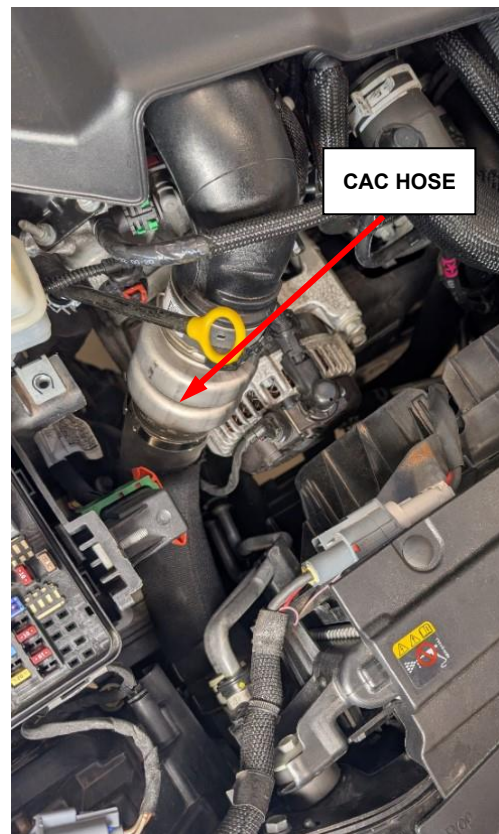
**Figure B6 – CAC Hose**

13. (3.0L Only) Remove the Charge Air Cooler (CAC) Hose (Figure B6). Refer to the detailed service procedures available in DealerCONNECT/ Service Library under: Service Info> 09 - Engine, 3.0L Turbo Diesel / Turbocharger System / COOLER and HOSES, Charge Air / Removal and Installation.

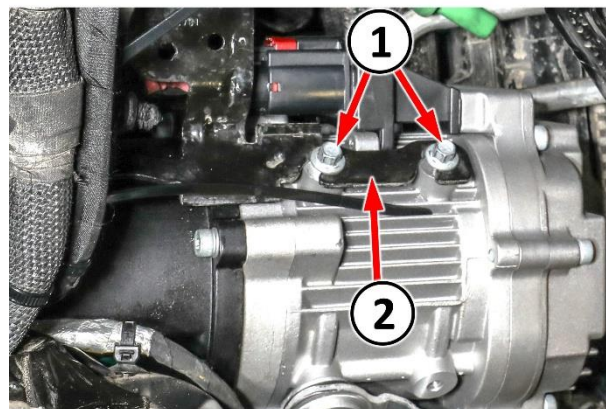
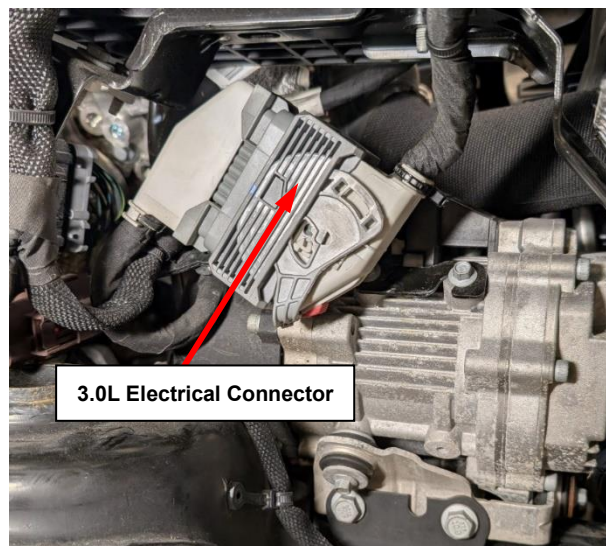
**Figure B11 – Wire Harness Bracket**

**NOTE:** For 3.0L vehicles, disconnect the electrical harness connector to gain bolt access (lower image in Figure B11).

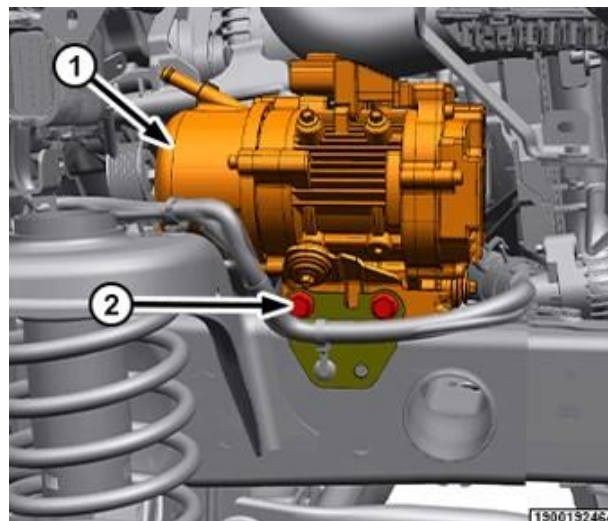
**Figure B12 – EHPS Pump**

23. Remove the EHPS pump frame bracket bolts (Figure B12).
24. Remove the EHPS pump from the vehicle with reservoir attached (Figure B12).
25. Obtain the **NEW** EHPS pump and transfer the reservoir to the **NEW** pump.
26. Set aside the replaced EHPS pump from the vehicle for return for analysis.

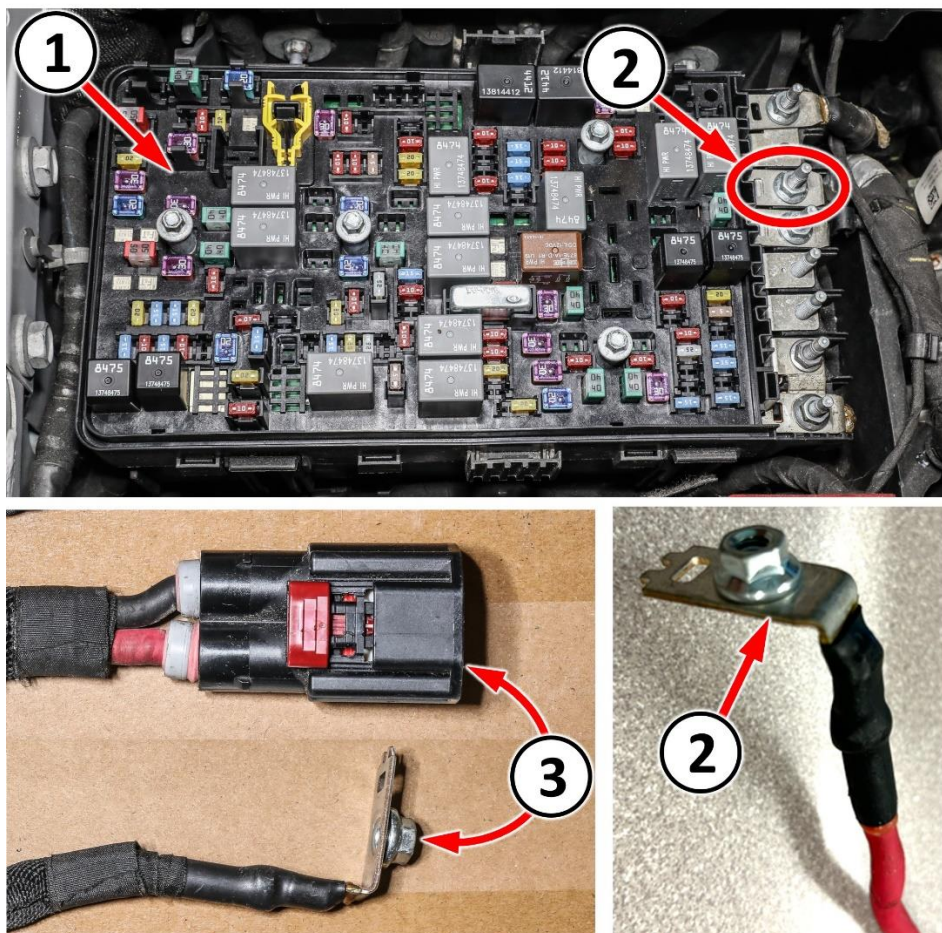
**Figure B14 – EHPS Power Supply Eyelet D6630J in PDC**

29. Remove the cover from the Power Distribution Center (PDC) under hood fuse box.
30. Locate the EHPS power supply eyelet D6630J on post #6 and remove eyelet off or the stud.
31. Verify continuity with multimeter between D6630J eyelet and D2704A connector cavity 2 red wire. Also verify the EHPS power circuit is isolated from the vehicle power circuit (Figure B13). NOTE: If a continuity reading is still present between the EHPS power circuit wire and other vehicle power circuits, the wrong wire has been selected.

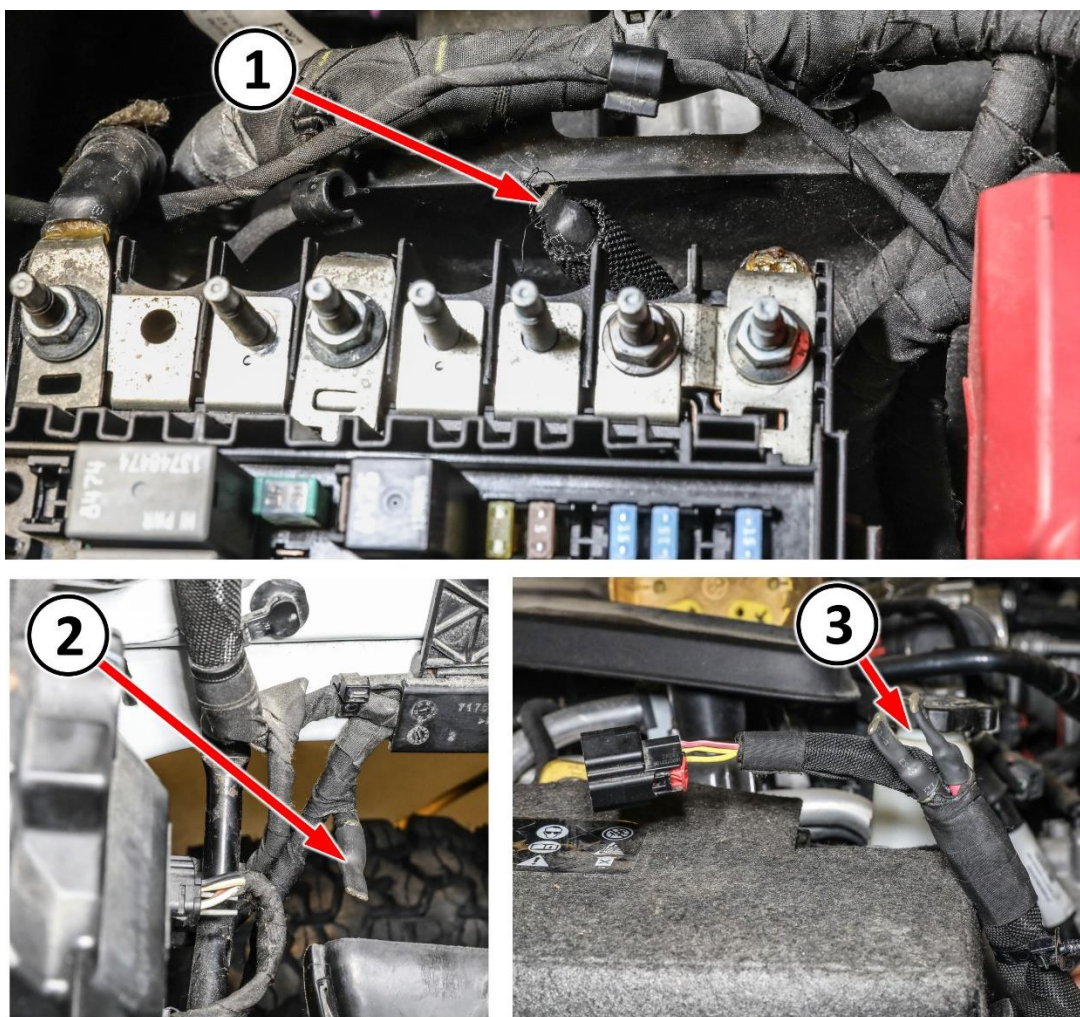
**Figure B16 – Seal Exposed Ends of Cut EHPS Wires**

35. Use locally sourced heat shrink tubing to seal the exposed end where EHPS power supply eyelet D6630J was removed (Figure B16).
36. Use locally sourced heat shrink tubing to seal the exposed end where EHPS ground eyelet G908A was removed (Figure B16).
37. Use locally sourced heat shrink tubing to seal the exposed ends where EHPS connector D2704A was removed (Figure B16).

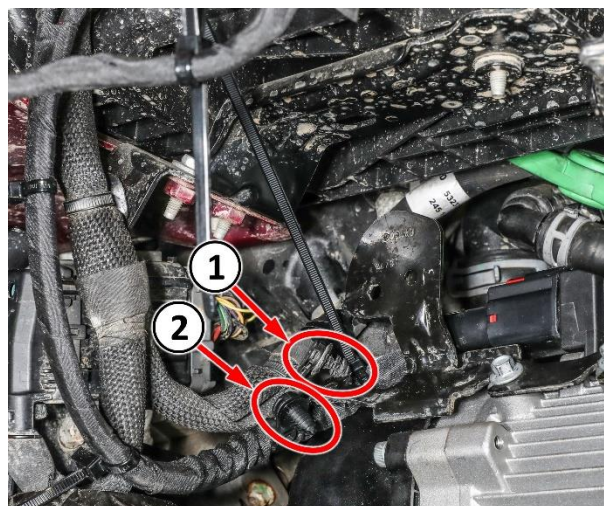
**Figure B18 – Fir Tree Clips**

**NOTE:** When two fir tree clips exist in the same location on both the new EHPS overlay harness and original EHPS harness, remove the old fir tree clip in favor of using the new fir tree clip (Figure B18).

1 – Old Fir Tree Clip  
2 – New Fir Tree Clip

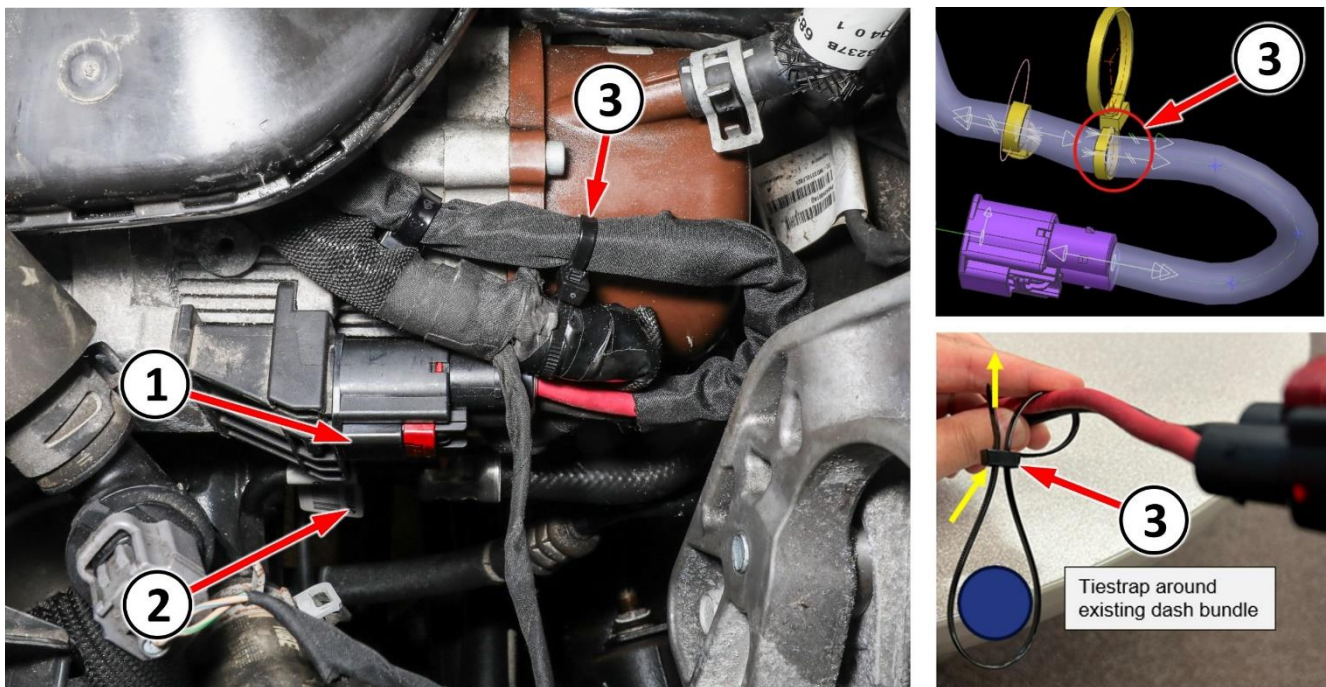
**Figure B20 – Power Steering Pump Wire Harness Routing and Clipping**

46. Connect the electrical connectors to the EHPS pump then engage the red CPA connector latch in locked position (Figure B20). Verify connection with Push-Pull-Push on connector, not on circuits.
47. Secure overlay to existing EHPS dash wiring bundle with double tie strap clip while making sure overlay is not in direct contact with sharp edges.

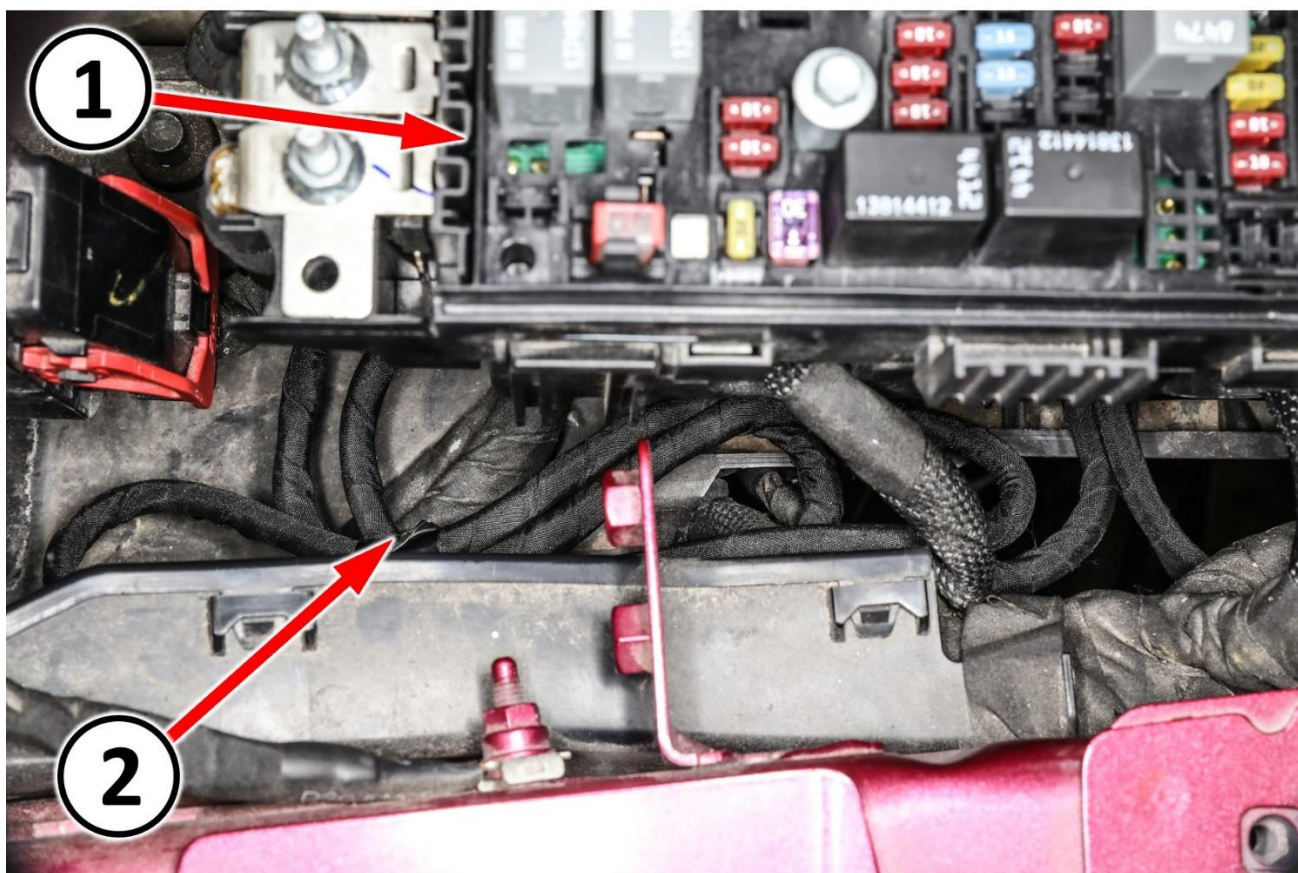
**Figure B21 – Power Steering Pump Wire Harness Overlay Routing**

48. Route remainder of EHPS service overlay jumper along existing dash harness bundle routing, securing double tie strap clips to existing dash harness wiring bundle. Make sure overlay is not in direct contact with sharp edges (Figure B17).
49. Loop and secure with cable tie or black electrical any excess overlay jumper wire length outboard of PDC (Figure B21).

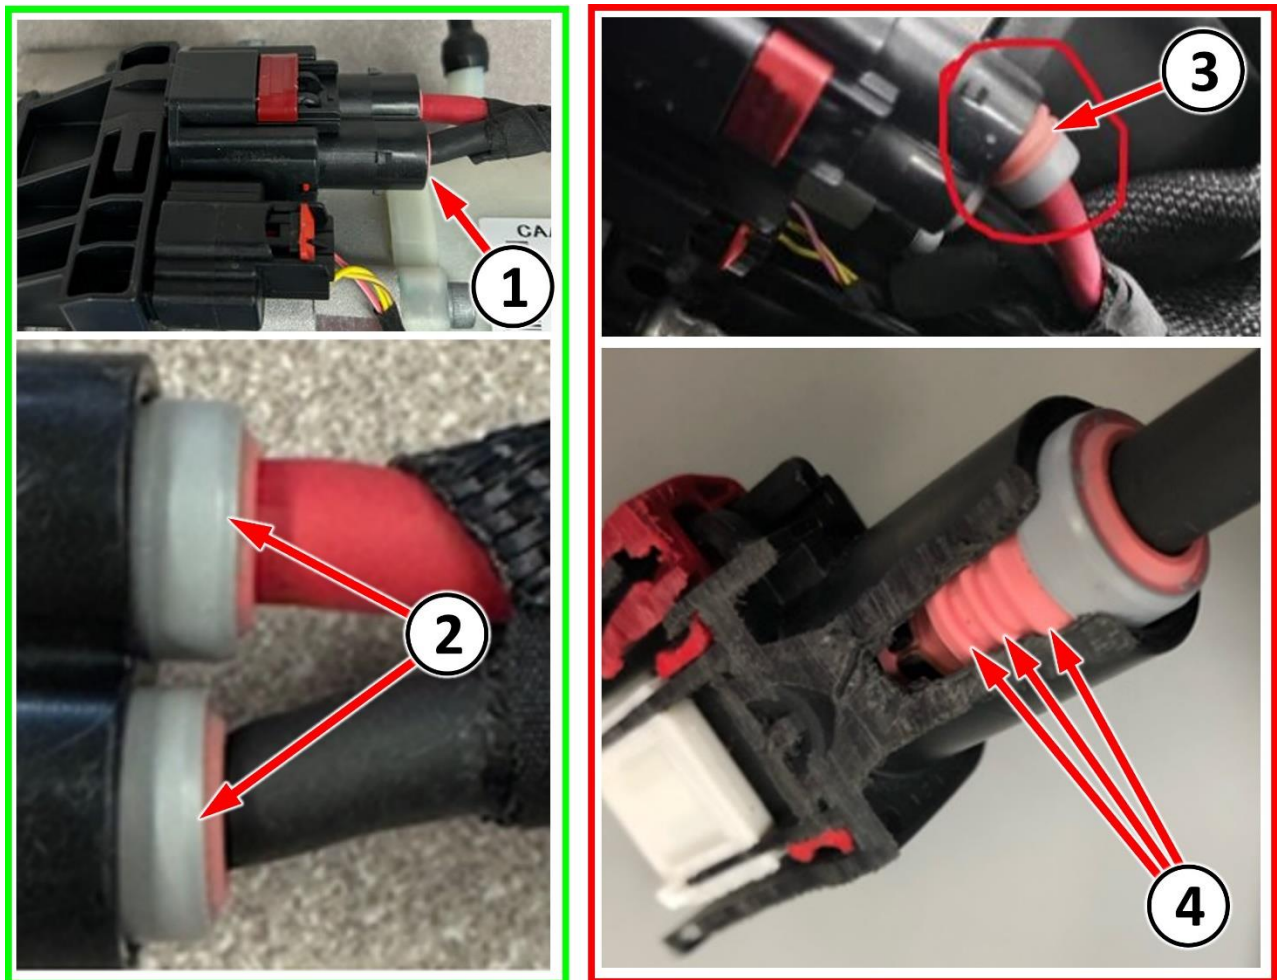
- c. Inspect the wire harness for any wires that are not fully inserted into the connector as shown in the following images. If the sealing ribs are exposed, take photos to attach to repair claim (Figure C3).
- d. Visually inspect for any visible damage to harness bundle and EHPS connector. If damage is observed, take photos to attach to repair claim.

Correctly Inserted Terminals - OK

Ribs Exposed - Not OK Condition

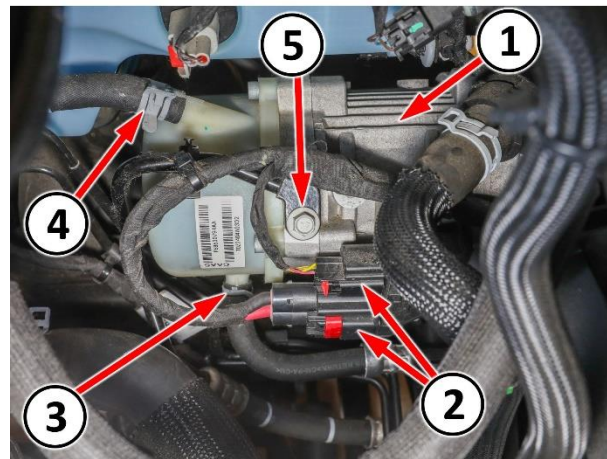
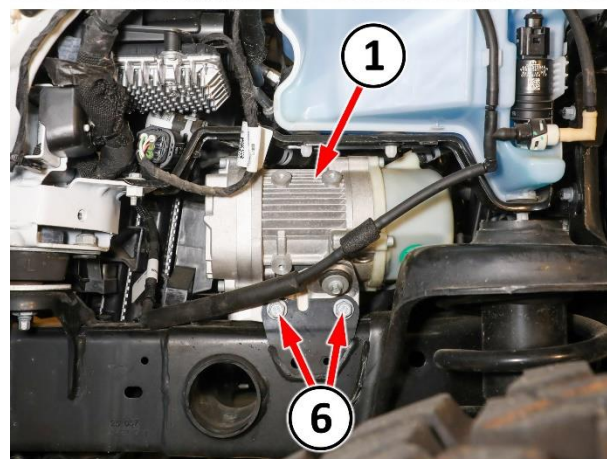
**Figure C5 – EHPS Pump**

15. Remove Disconnect the electrical connectors from the EHPS pump if not already done so, by sliding red CPA back and de-pressing connector latch (Figure C5).
16. Release wire harness retainers from the EHPS pump and pressure tube.
17. Position a drain pan before disconnecting pump hoses and pipes.
18. Remove the EHPS pump pressure pipe bolt and remove the EHPS pressure pipe from the EHPS pump (Figure C5).
19. With the hose clamp released, disconnect the return hose from the EHPS pump (Figure C5).
20. With the hose clamp released, disconnect the supply hose from the EHPS pump and secure the hose end higher than the power steering pump reservoir (Figure C5).
21. Remove the EHPS pump frame bracket bolts (Figure C5).
22. Remove the EHPS pump from the vehicle and aside for return for analysis.
