# SAFETY RECALL

## Electric Hydraulic Power Steering Pump

Reference: 21D / NHTSA 26V-363

2021-2025 (JL) Jeep Wrangler

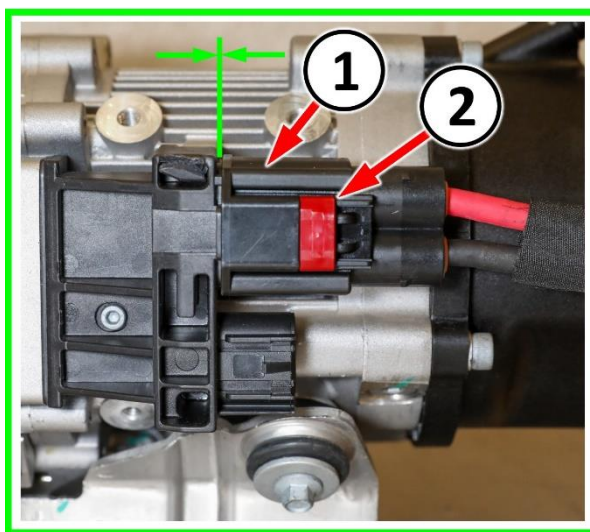
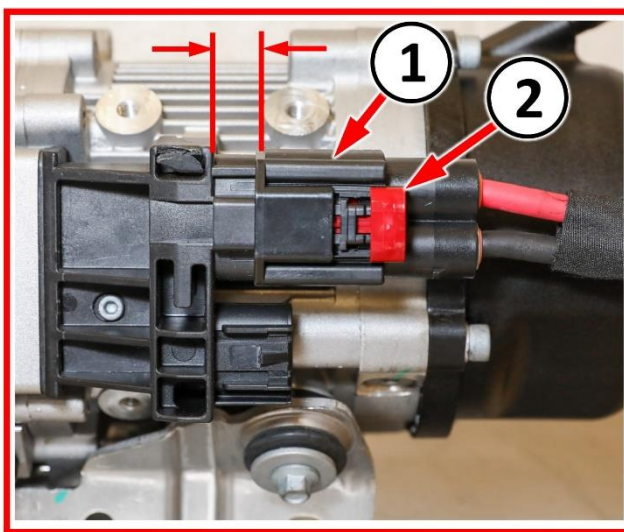
Electrical Connector and CPA

Fully Engaged, No Gap

Electrical Connector and/or CPA

Not Fully Engaged, Gap Observed

- a. Visually verify Electric Hydraulic Power Steering (EHPS) connector is fully mated to the pump interface with CPA fully engaged on the connector latch. If electrical connector is not fully mated or CPA is not engaged, take photos to attach to repair claim (Figure A1).

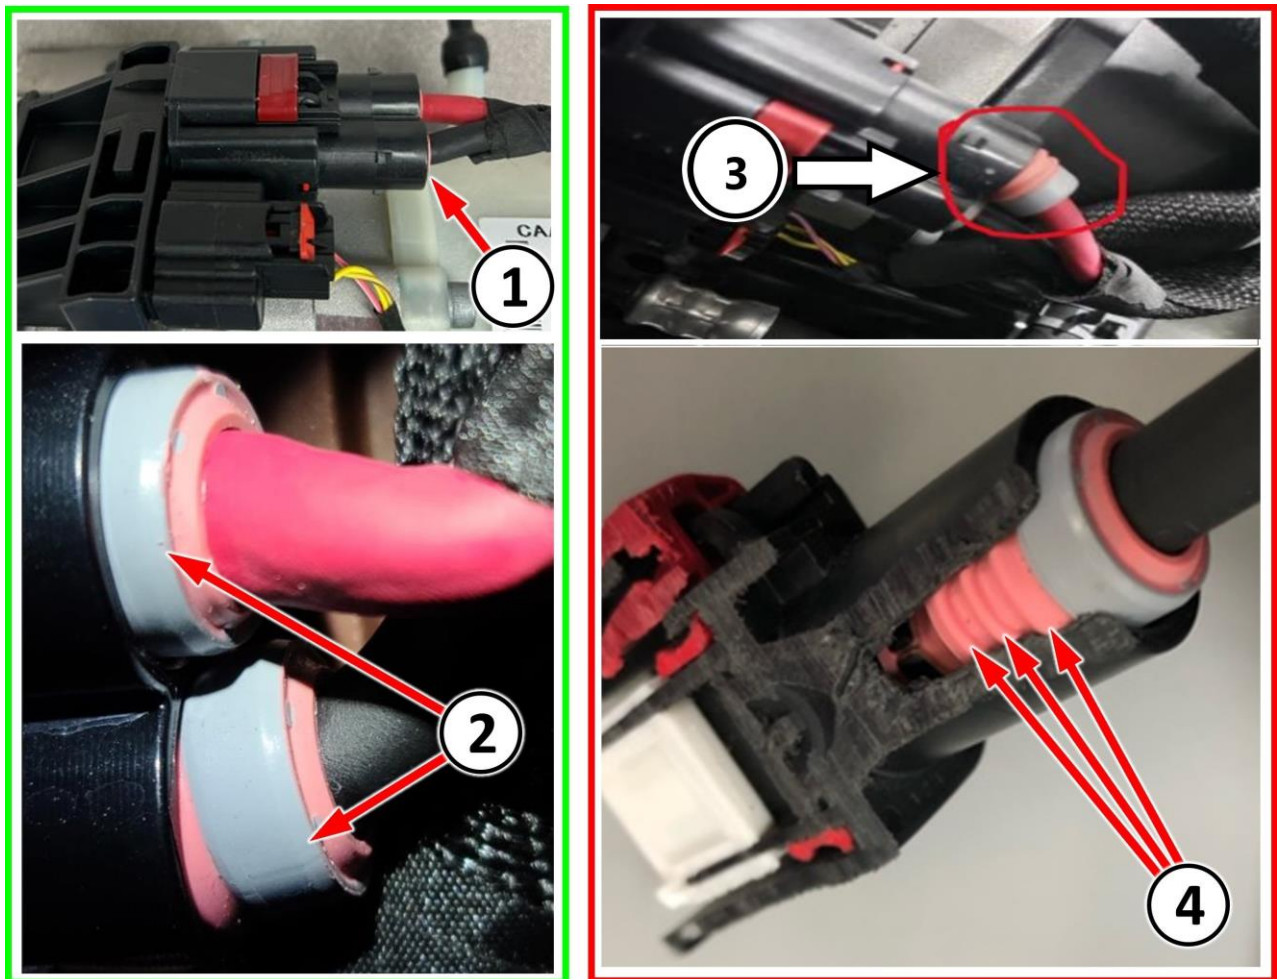
Correctly Inserted Terminals - OK

Ribs Exposed - Not OK Condition

- c. Inspect the wire harness for any wires that are not fully inserted into the connector as shown in the following images. If the sealing ribs are exposed, take photos to attach to repair claim (Figure A3).
- d. Visually inspect for any visible damage to harness bundle and EHPS connector. If damage is observed, take photos to attach to repair claim.

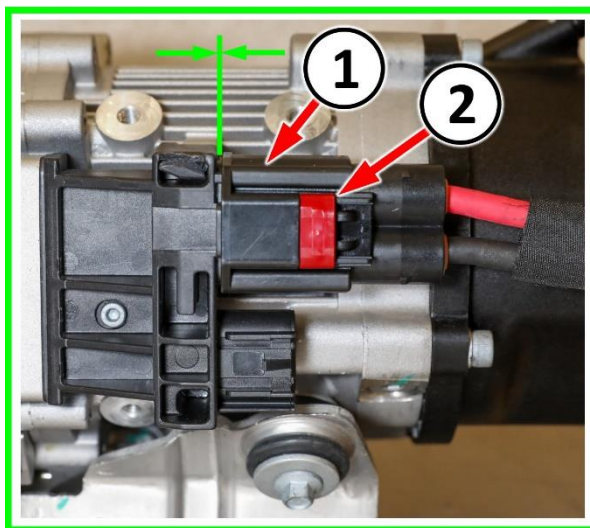
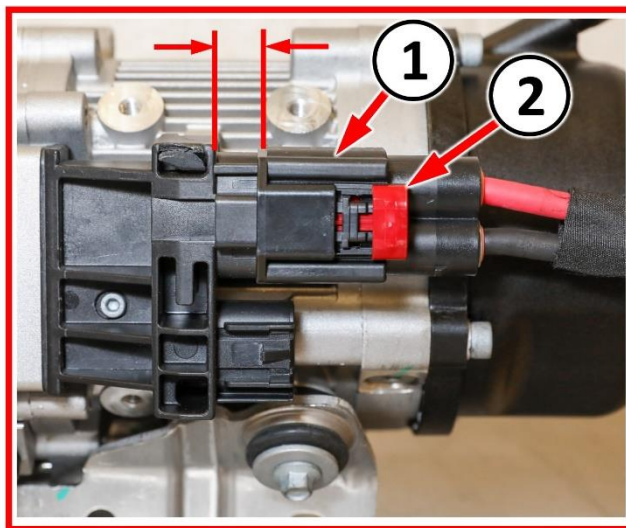
**Electrical Connector and CPA  
Fully Engaged, No Gap**

**Electrical Connector and/or CPA  
Not Fully Engaged, Gap Observed**

- a. Visually verify Electric Hydraulic Power Steering (EHPS) connector is fully mated to the pump interface with CPA fully engaged on the connector latch. If electrical connector is not fully mated or CPA is not engaged, take photos to attach to repair claim (Figure B2).

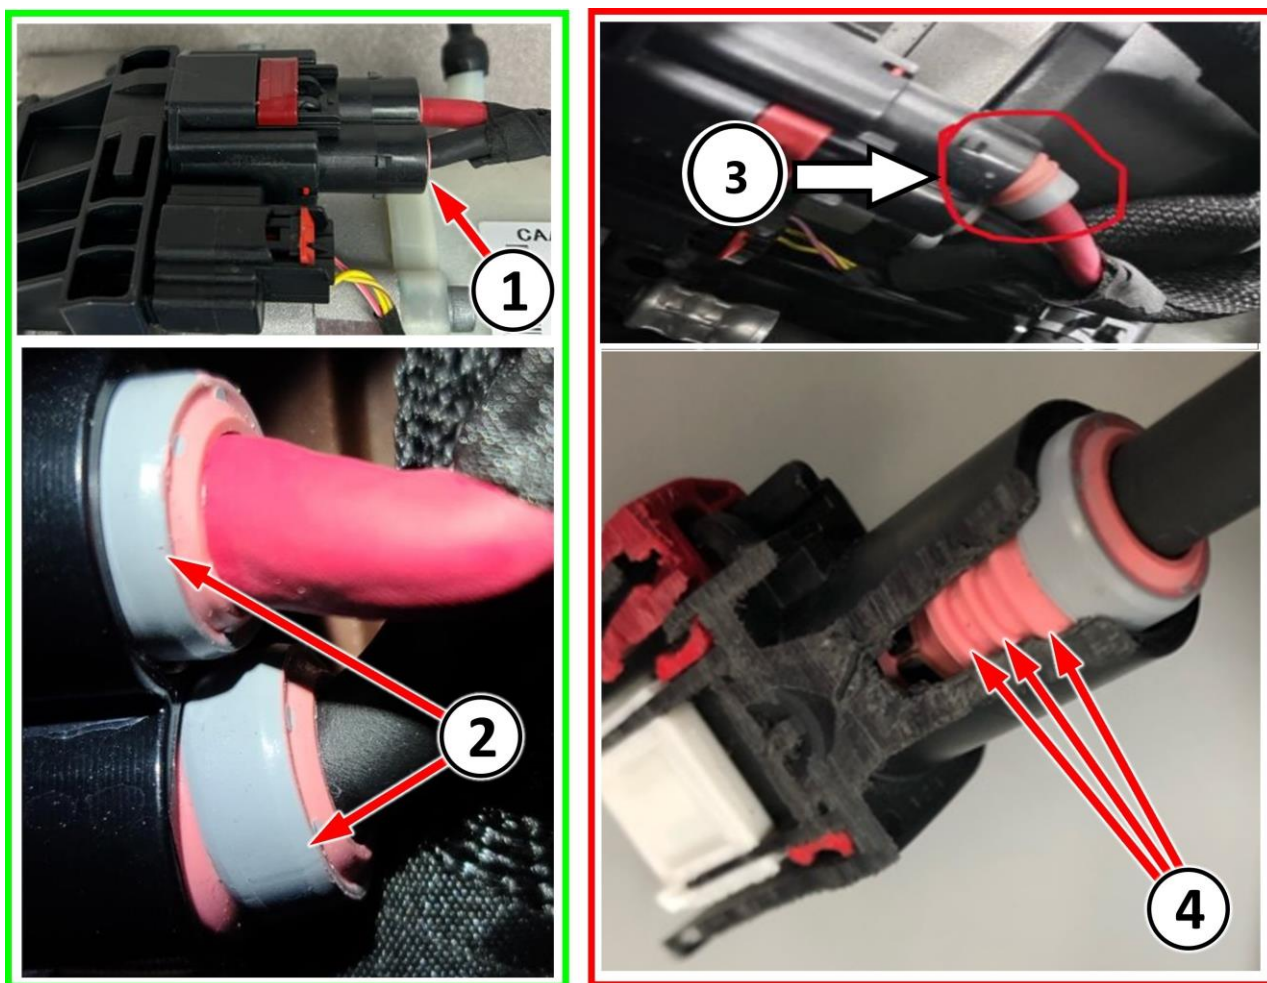
**Correctly Inserted Terminals - OK**

**Ribs Exposed - Not OK Condition**

- c. Inspect the wire harness for any wires that are not fully inserted into the connector as shown in the following images. If the sealing ribs are exposed, take photos to attach to repair claim (Figure B4).
- d. Visually inspect for any visible damage to harness bundle and EHPS connector. If damage is observed, take photos to attach to repair claim.

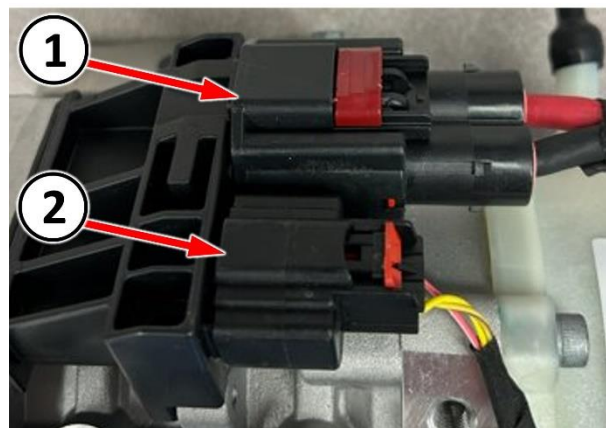
**Figure B7 – Electrical Connectors**

1 - 2way connector D2704A  
2 – 3way connector D2704B

16. Disconnect the electrical connectors from the EHPS pump if not already done so, by sliding red CPA back and de-pressing connector latch (Figure B7).

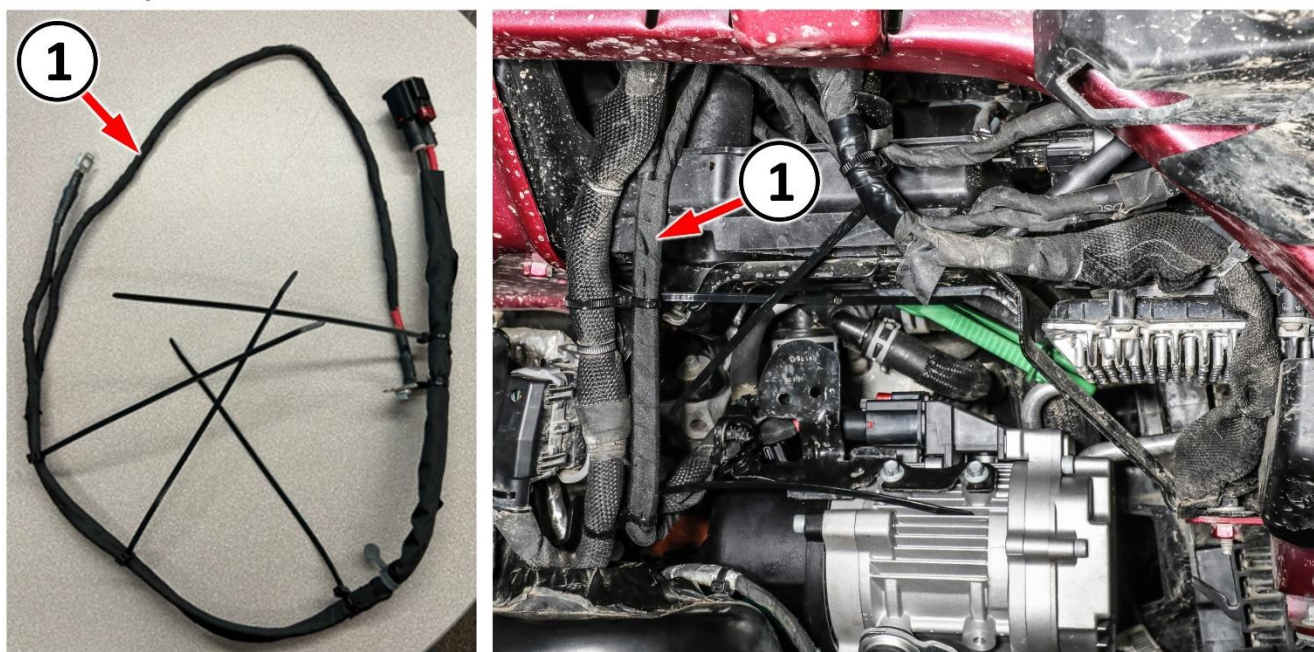
**Figure B17 – EHPS Overlay Harness**

1 - EHPS Overlay Harness

38. Obtain the **NEW** EHPS overlay harness and position it in the engine compartment following the routing path of the original harness (Figure B17).

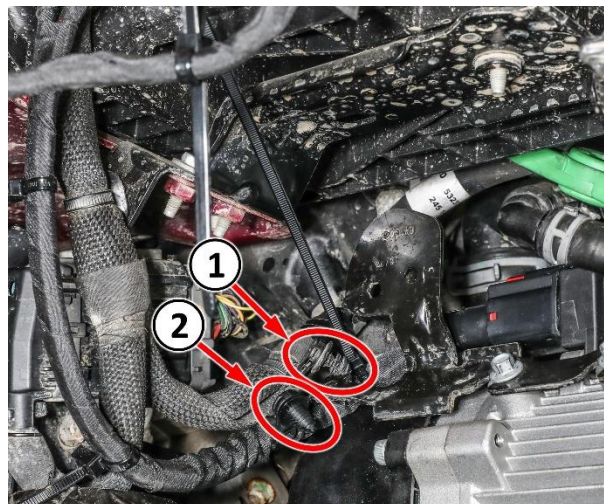
**Figure B18 – Fir Tree Clips**

1 – Old Fir Tree Clip  
2 – New Fir Tree Clip

**NOTE:** When two fir tree clips exist in the same location on both the new EHPS overlay harness and original EHPS harness, remove the old fir tree clip in favor of using the new fir tree clip (Figure B18).

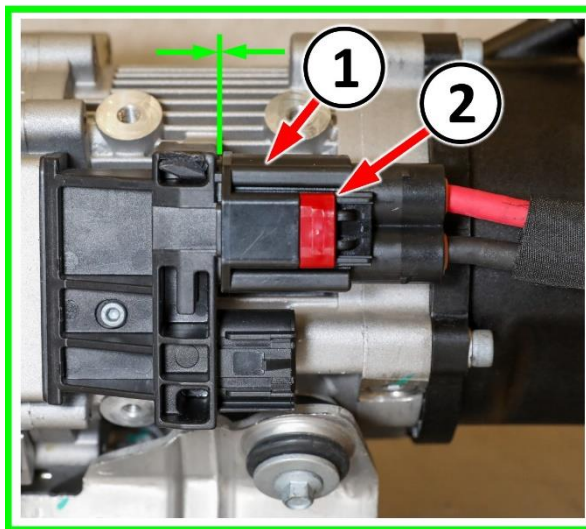
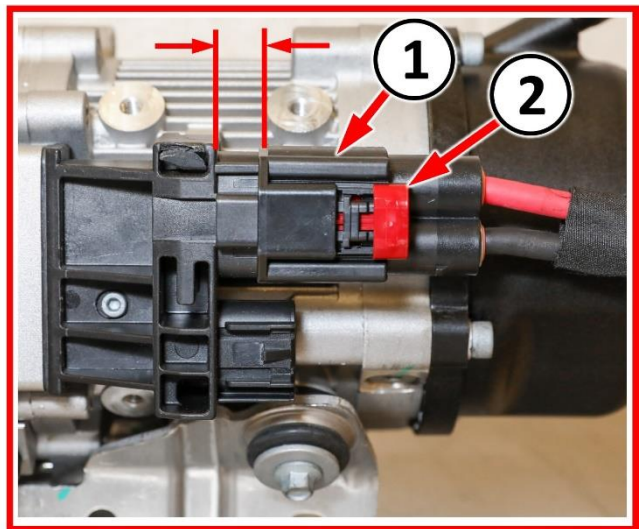
**Electrical Connector and CPA  
Fully Engaged, No Gap**

**Electrical Connector and/or CPA  
Not Fully Engaged, Gap Observed**

- a. Visually verify Electric Hydraulic Power Steering (EHPS) connector is fully mated to the pump interface with CPA fully engaged on the connector latch. If electrical connector is not fully mated or CPA is not engaged, take photos to attach to repair claim (Figure C1).

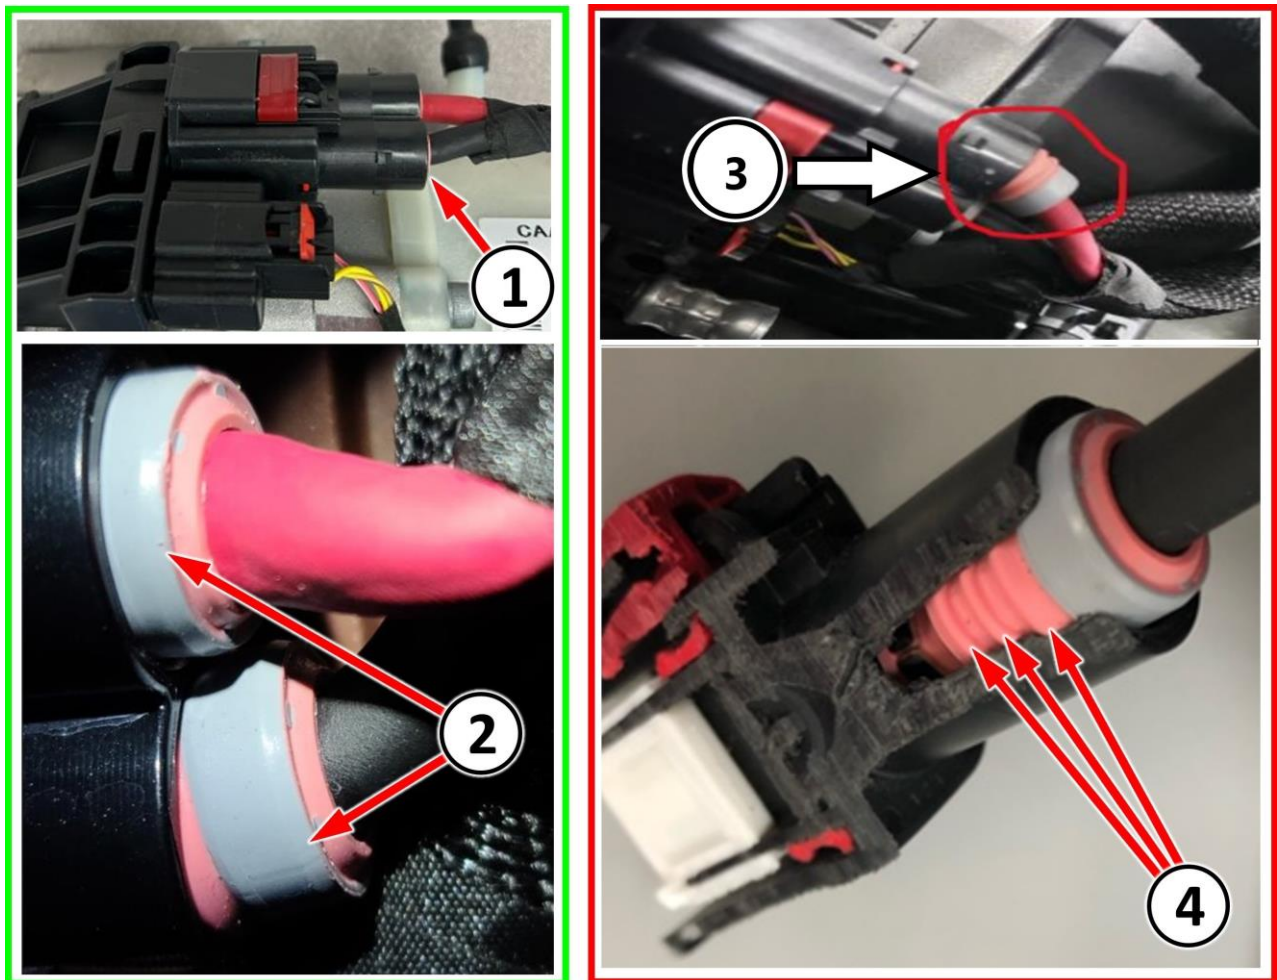
Correctly Inserted Terminals - OK

Ribs Exposed - Not OK Condition

- c. Inspect the wire harness for any wires that are not fully inserted into the connector as shown in the following images. If the sealing ribs are exposed, take photos to attach to repair claim (Figure C3).
- d. Visually inspect for any visible damage to harness bundle and EHPS connector. If damage is observed, take photos to attach to repair claim.

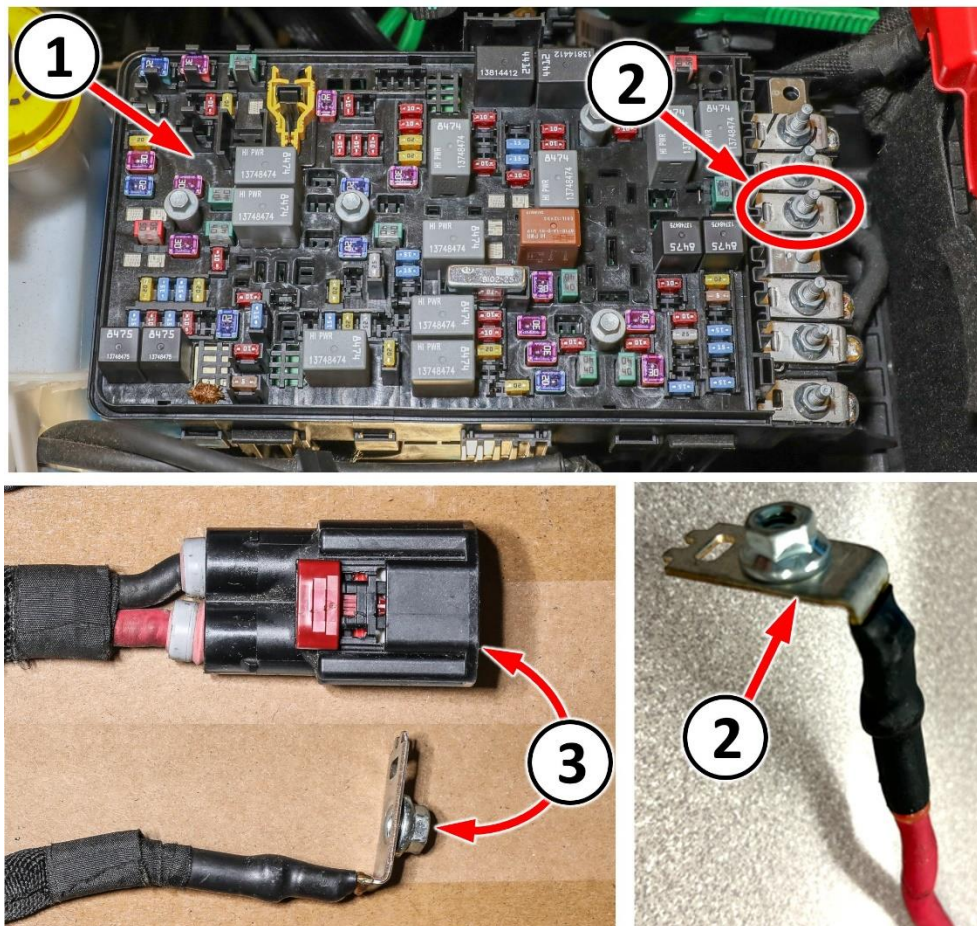
**Figure C7 – EHPS Power Supply Eyelet D6630J in PDC**

- 1 - PDC
- 2 – EHPS power supply eyelet D6630J
- 3 – Verify Continuity with a Multimeter (also verify circuit Isolation from other vehicle power circuit)

25. Remove the cover from the Power Distribution Center (PDC) under hood fuse box.
26. Locate the EHPS power supply eyelet D6630J on post #6 and remove eyelet off or the stud (Figure C7).
27. Verify continuity with multimeter between D6630J eyelet and D2704A connector cavity 2 red wire. Also verify the EHPS power circuit is isolated from the vehicle power circuit (Figure C7). NOTE: If a continuity reading is still present between the EHPS power circuit wire and other vehicle power circuits, the wrong wire has been selected.

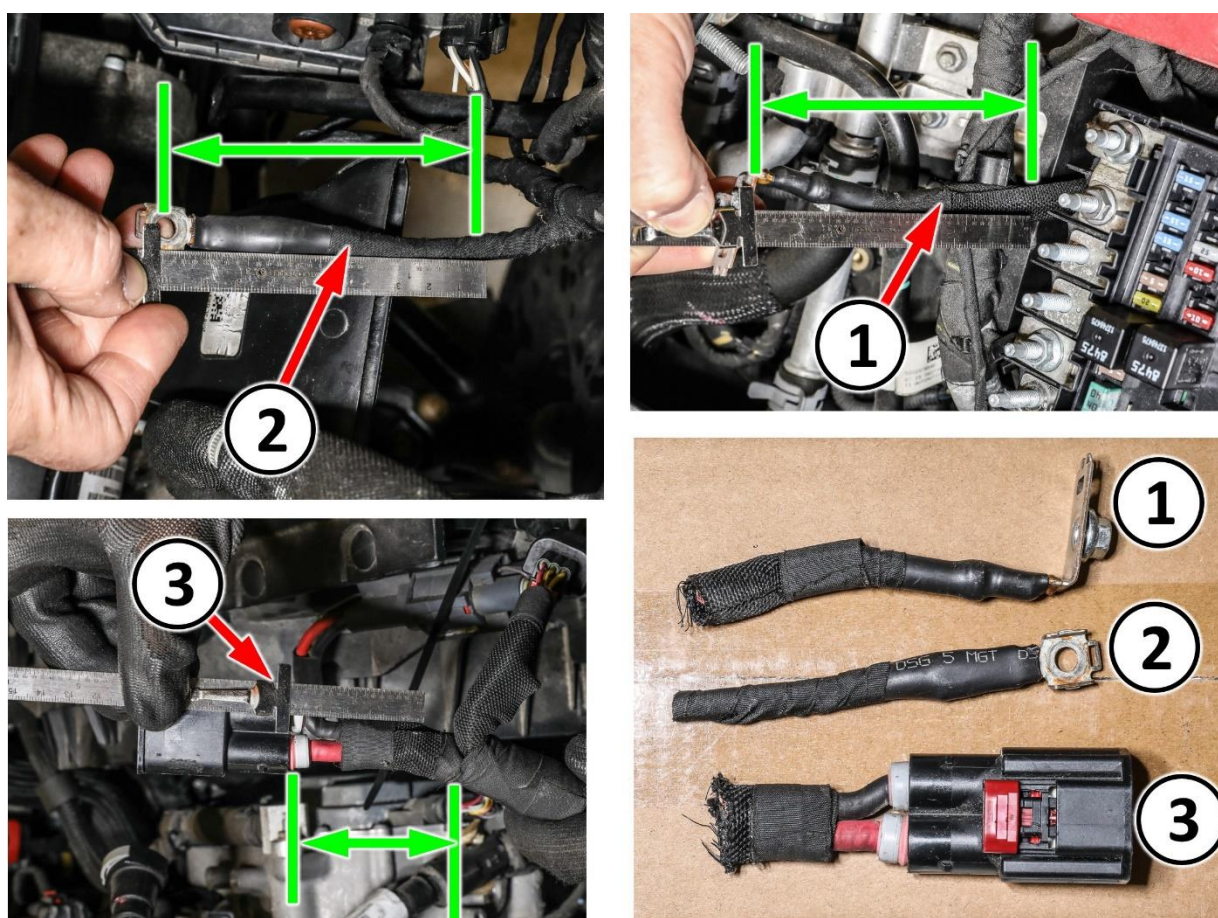
**Figure C8 – Remove EHPS Wire Harness Terminals**

- 1 – EHPS power supply eyelet D6630J
- 2 – EHPS ground eyelet G908A
- 3 – EHPS connector D2704A

28. After verification, cut EHPS power supply eyelet D6630J approximately 4 inches behind eyelet 90-degree bend and set aside for return **with pump** (Figure C8).
29. After verification, cut ground eyelet G908A approximately 4 inches behind center of eyelet hole and set aside for return **with pump** (Figure C8).
30. Cut 2way EHPS connector D2704A approximately 4 inches behind connector body taking special care not to cut through 3way connector D2704B circuits. Set aside for return **with pump** (Figure C8).

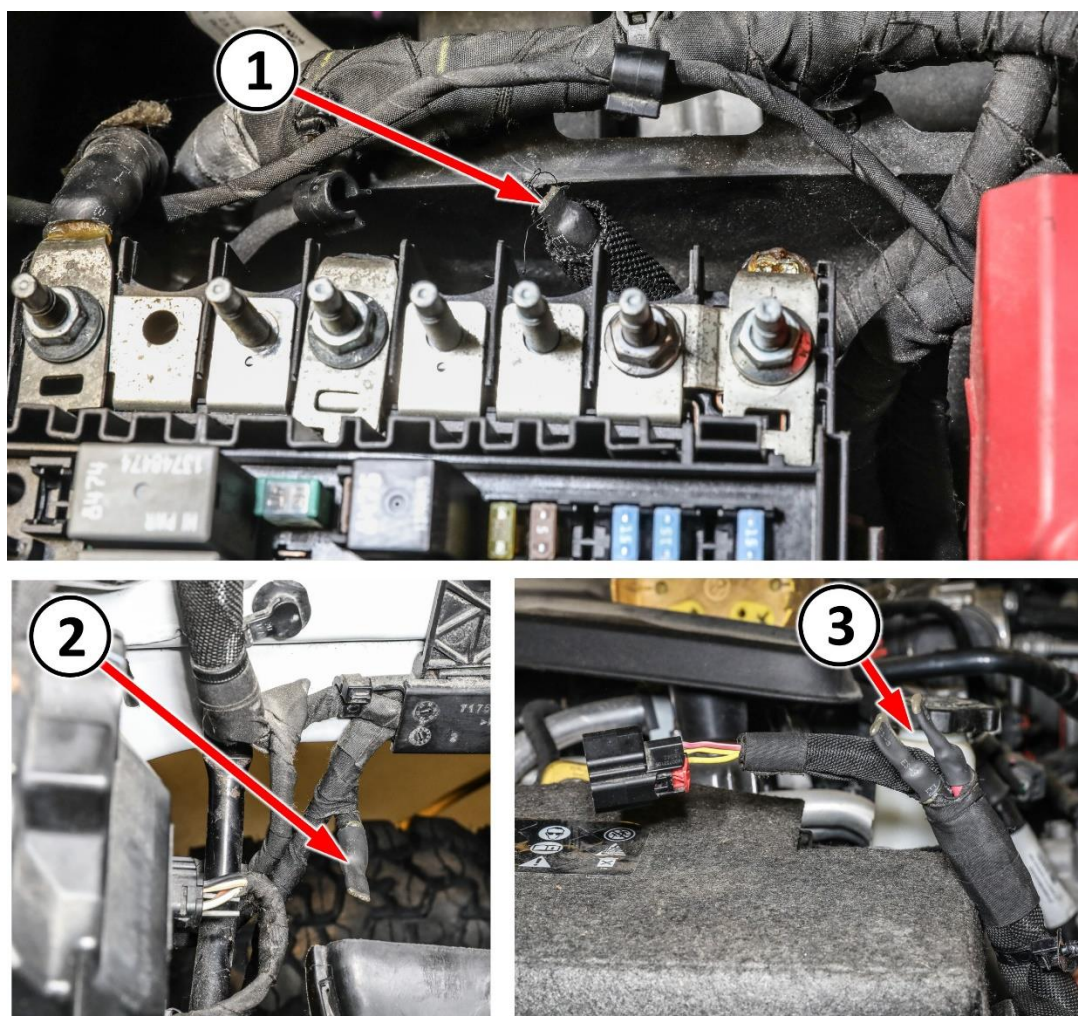
**Figure C9 – Seal Exposed Ends of Cut EHPS Wires**

- 1 – EHPS power supply eyelet D6630J
- 2 – EHPS ground eyelet G908A
- 3 – EHPS connector D2704A

31. Use locally sourced heat shrink tubing to seal the exposed end where EHPS power supply eyelet D6630J was removed (Figure C9).
32. Use locally sourced heat shrink tubing to seal the exposed end where EHPS ground eyelet G908A was removed (Figure C9).
33. Use locally sourced heat shrink tubing to seal the exposed ends where EHPS connector D2704A was removed (Figure C9).

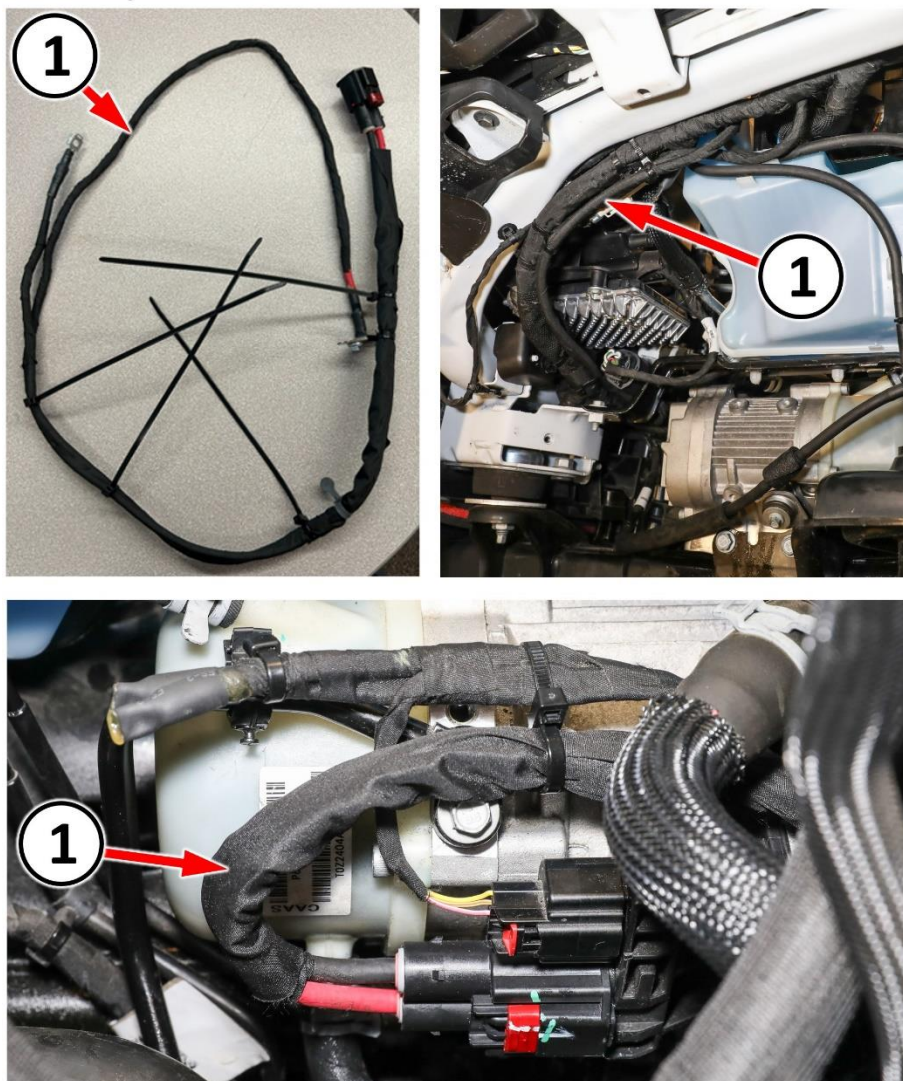
**Figure C10 – EHPS Overlay Harness**

1 - EHPS Overlay Harness

34. Obtain the **NEW** EHPS overlay harness and position it in the engine compartment following the routing path of the original harness (Figure C10).
