# SAFETY RELATED RECALL

Global Recall Action  
Number: **D120v3**

| <b>Subject:</b><br><br><b>Driver's Airbag Potential Non-Deployment</b> | Publication No.: D120v3 |

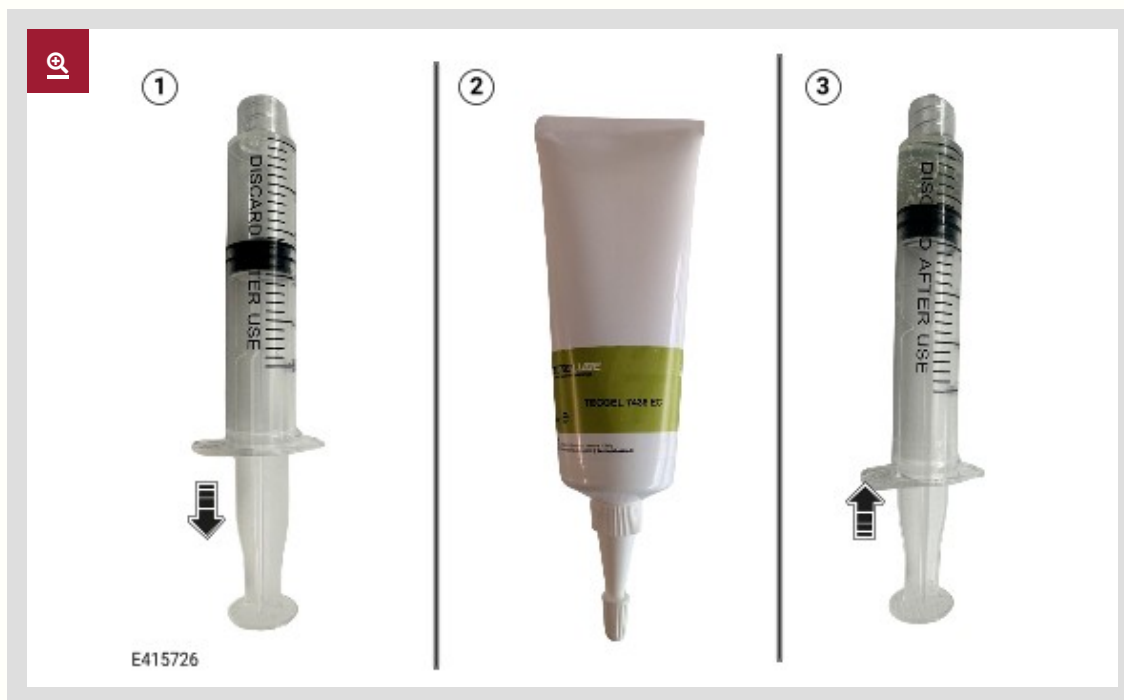
1. Apply TECGEL 7436 EC OR Nyogel 760G gel to the syringe body.

- Remove the plunger (1) from the syringe body.
- Open and dispense the TECGEL 7436 EC OR Nyogel 760G gel into the syringe body (2).
- Install the plunger (3) to the syringe body.

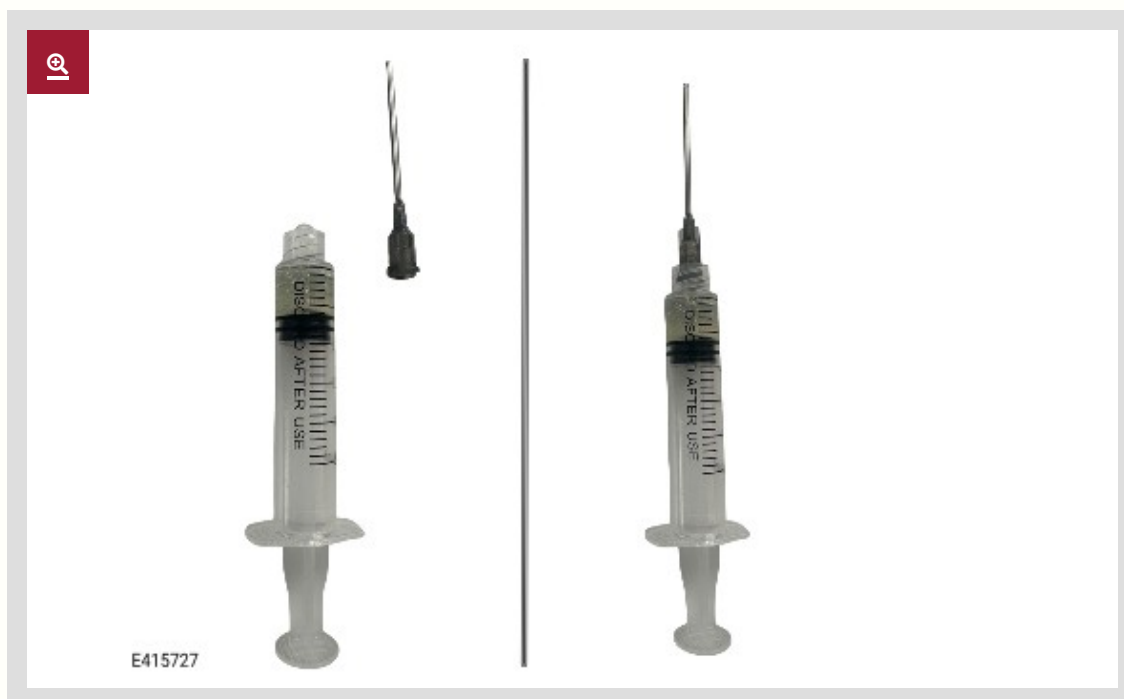
2. Install a suitable 18 gauge (Ga) blunt needle tip onto the syringe body.  
The needle tip must be secure.

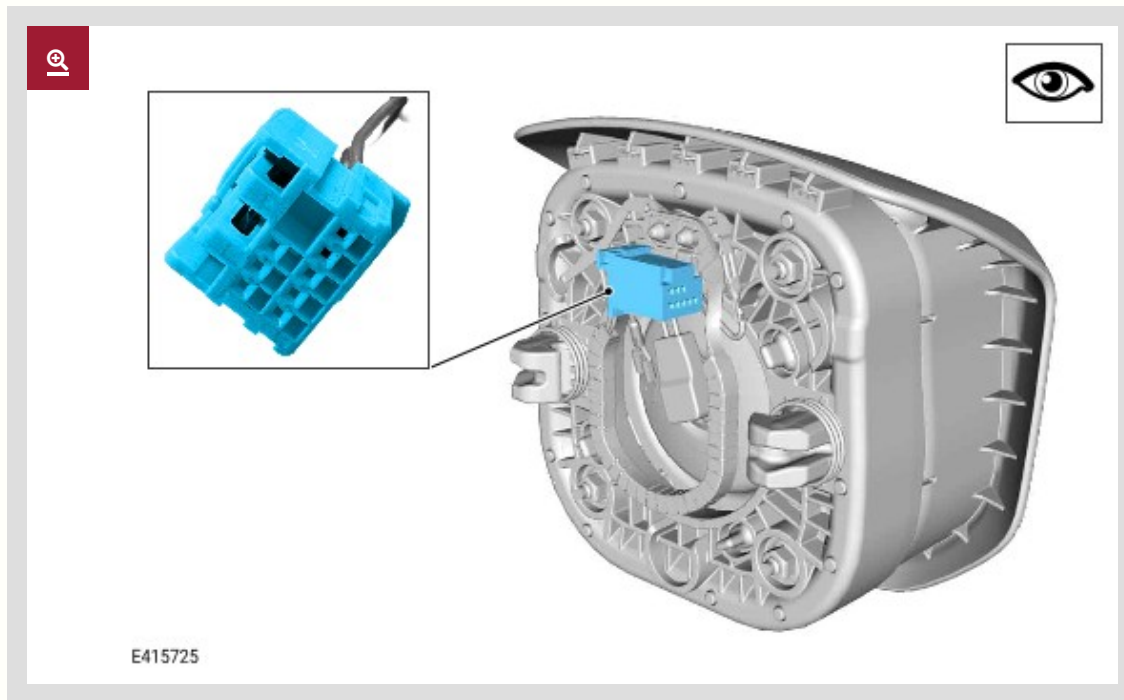
5. Locate the electrical connector shown in the illustration. The electrical connector is attached to the electrical wiring harness on the driver airbag.

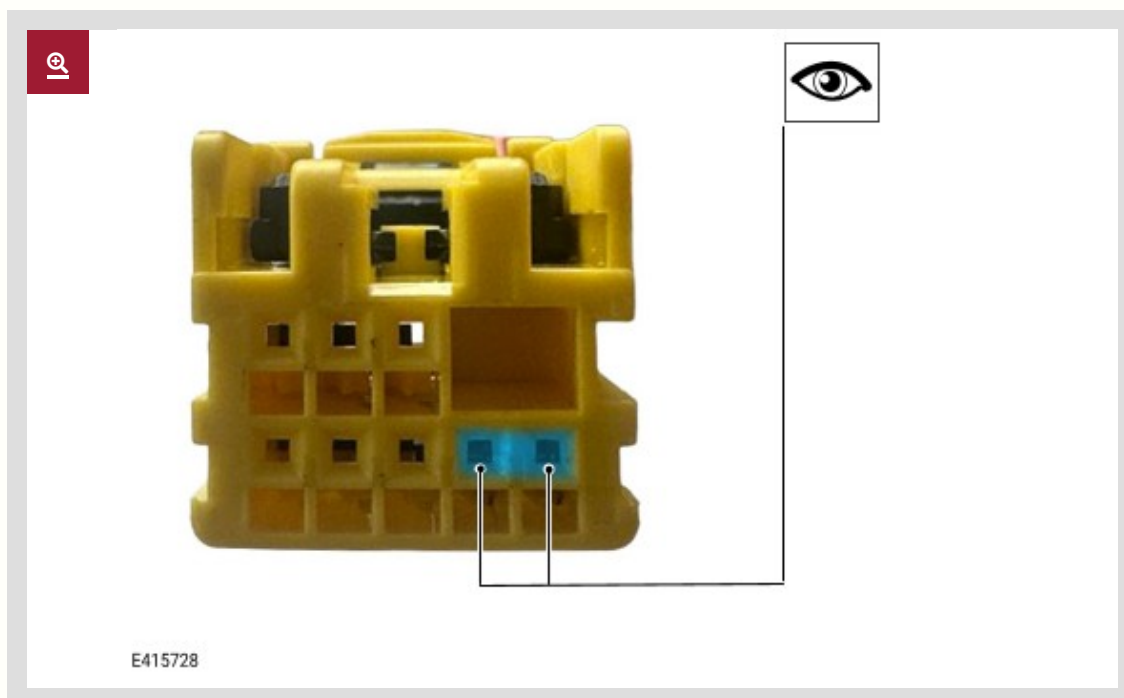
6. Inspect the electrical connector to identify which cavities contain terminals.

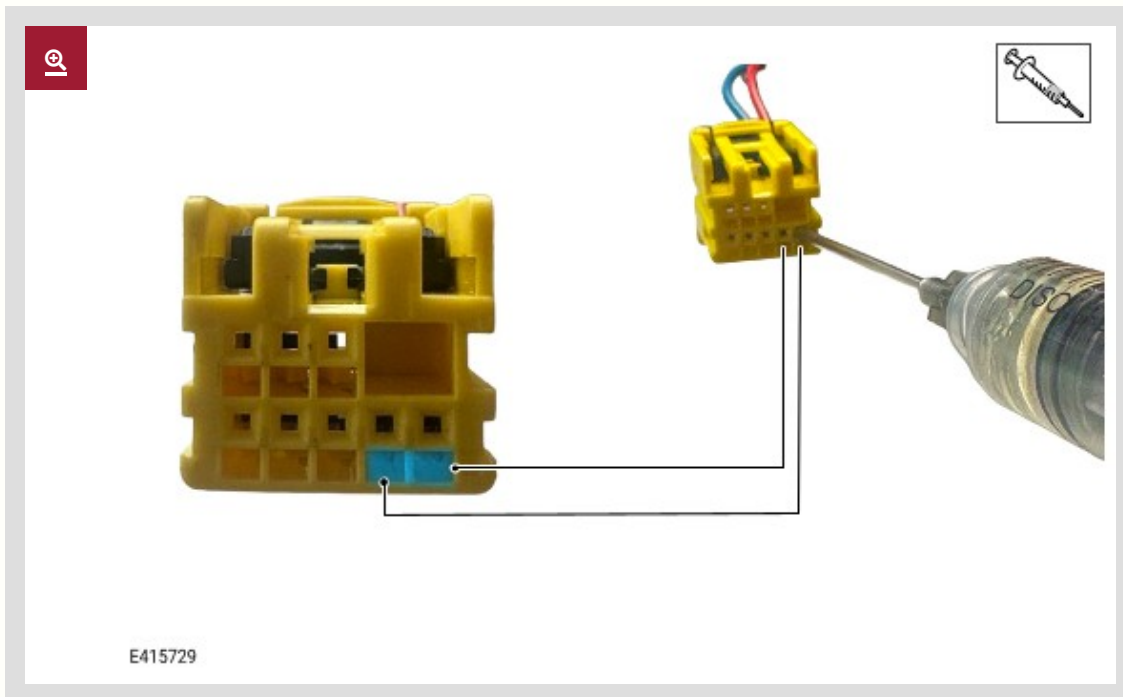
During application of TECGEL 7436 EC OR Nyogel 760G gel, it may be necessary to cover the terminal extraction holes, highlighted blue in the illustration, to prevent TECGEL 7436 EC OR Nyogel 760G gel from exiting through the extraction holes.

Apply a minimum of 0.2 grams of TECGEL 7436 EC OR Nyogel 760G gel into any cavity that contains a terminal.

- Extra care must be taken to NOT open or damage the terminals within the electrical connector.
- **DO NOT** apply TECGEL 7436 EC OR Nyogel 760G gel through the rear of the electrical connector.
- **DO NOT** disassemble the electrical connector in an attempt to gain improved access to the terminals.
- Only apply TECGEL 7436 EC OR Nyogel 760G gel as shown.

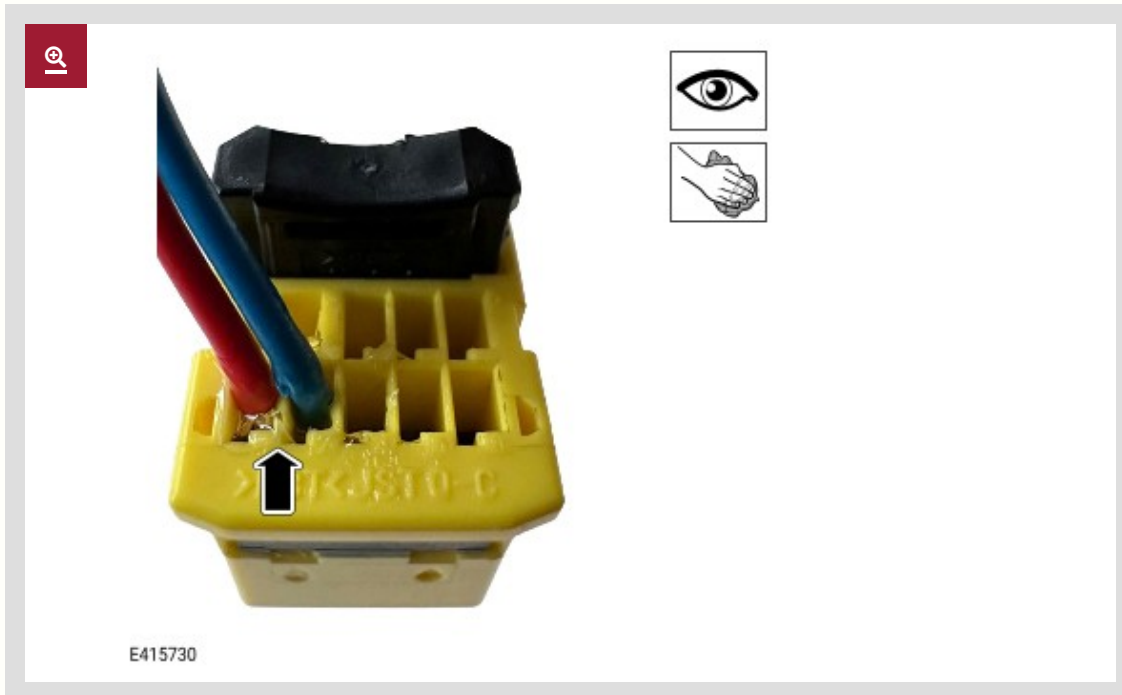
8. After applying a minimum of 0.2 grams of TECGEL 7436 EC OR Nyogel 760G gel into each cavity containing a terminal, inspect the rear of the electrical connector. Confirm that TECGEL 7436 EC OR Nyogel 760G gel is visibly present at the rear of the electrical connector, as shown in the illustration.

- If TECGEL 7436 EC OR Nyogel 760G gel **IS** visible at the rear of the electrical connector, wipe away any excess TECGEL 7436 EC OR Nyogel 760G gel from the front face and rear face of the electrical connector before continuing.
- If TECGEL 7436 EC OR Nyogel 760G gel **IS NOT** visible at the rear of the electrical connector, repeat steps 7 and 8.

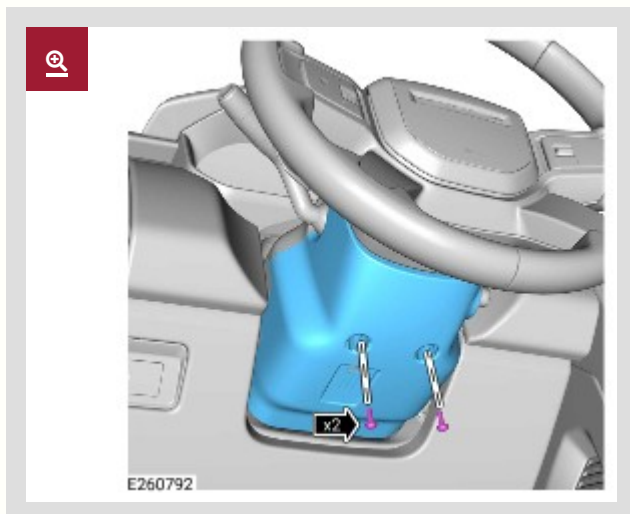
The illustration shows a Defender vehicle, Discovery and Range Rover are similar.

Remove the steering column lower cover.

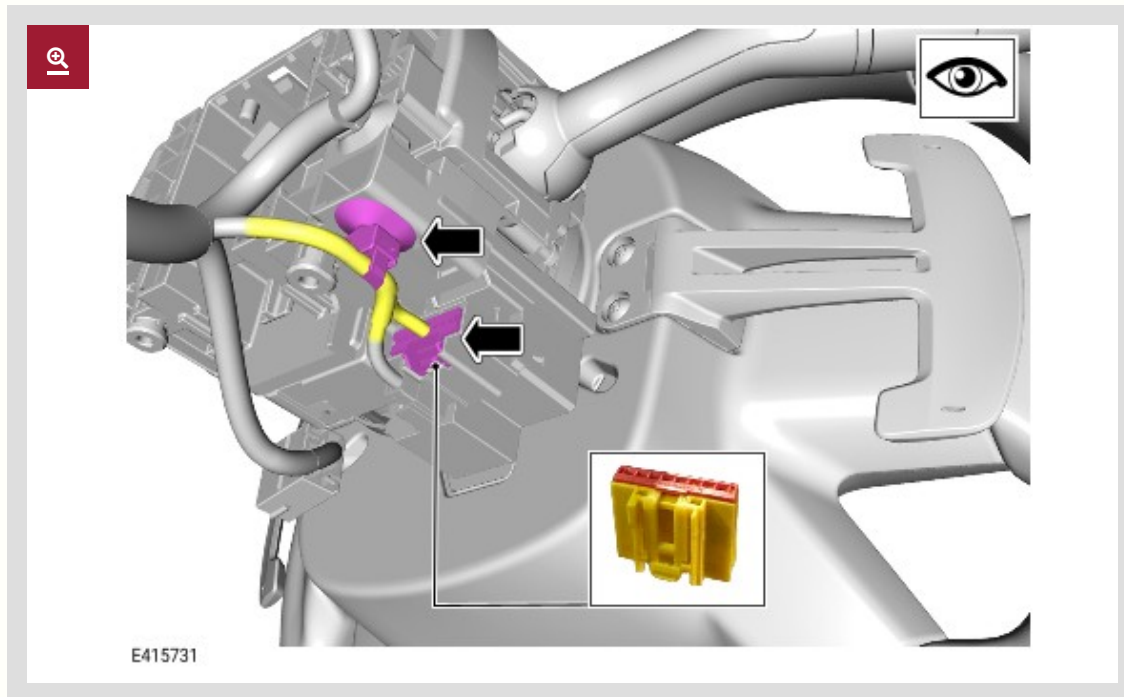
10. Locate and disconnect the electrical connector as shown in the illustration.

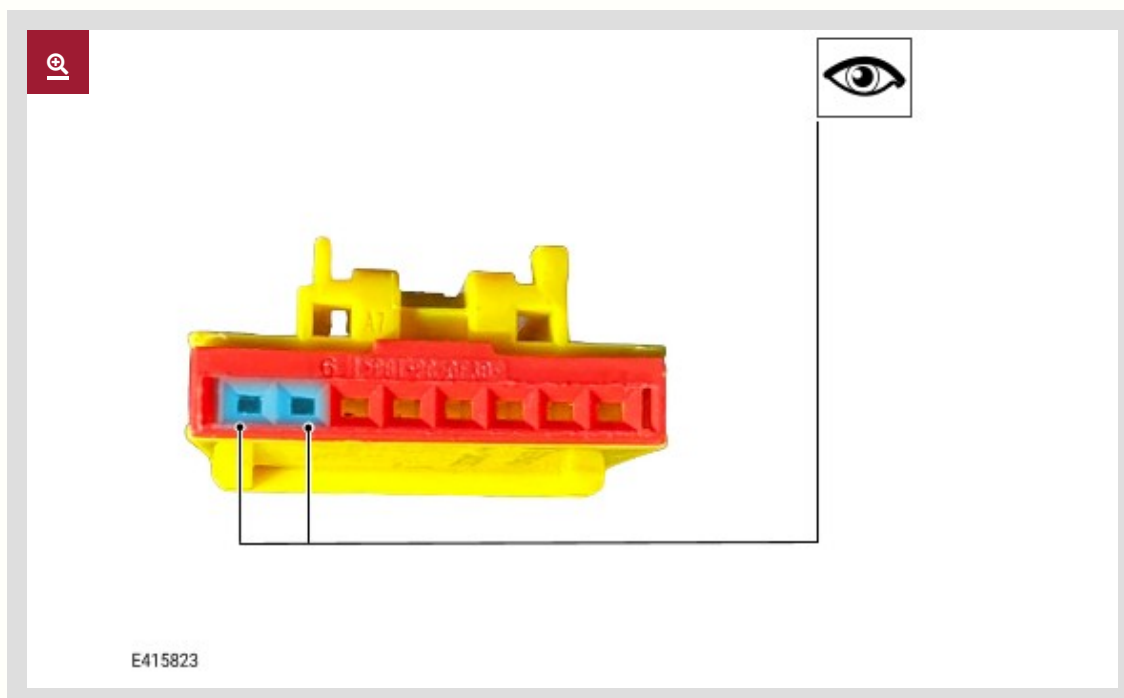
11. Inspect the electrical connector to identify which cavities contain terminals.

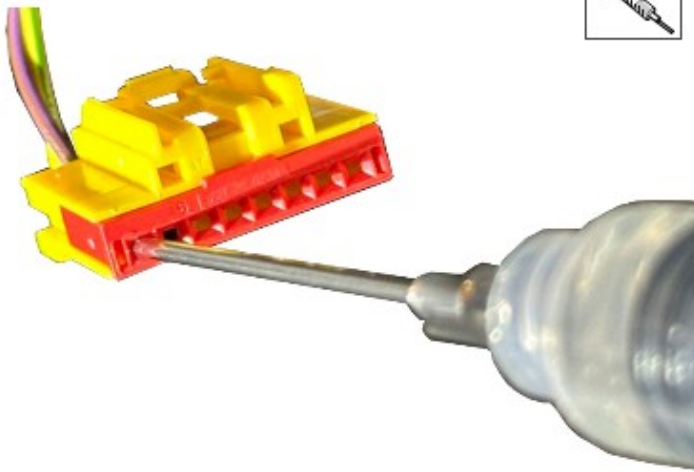
E415824

Apply a minimum of 0.2 grams of TECGEL 7436 EC OR Nyogel 760G gel into any cavity that contains a terminal.

- Extra care must be taken to **NOT** open or damage the terminals within the electrical connector.
- **DO NOT** apply TECGEL 7436 EC OR Nyogel 760G gel through the rear of the electrical connector.
- **DO NOT** disassemble the electrical connector in an attempt to gain improved access to the terminals.
- Only apply TECGEL 7436 EC OR Nyogel 760G gel as shown.

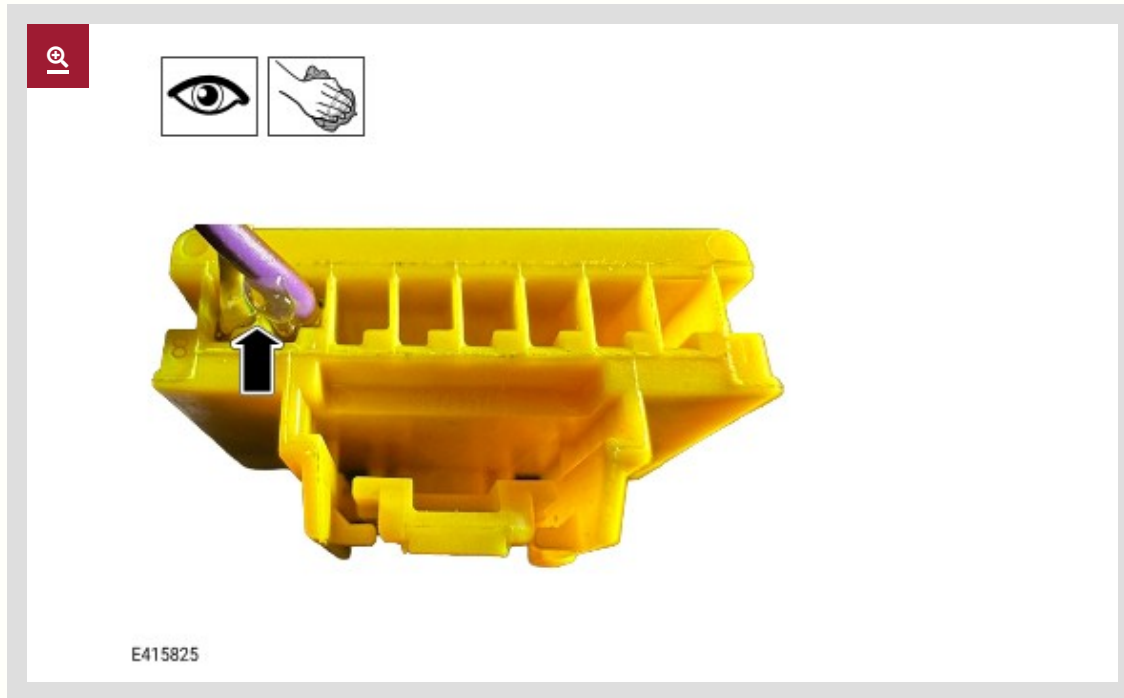
13. After applying a minimum of 0.2 grams of TECGEL 7436 EC OR Nyogel 760G into each cavity containing a terminal, inspect the rear of the electrical connector. Confirm that TECGEL 7436 EC OR Nyogel 760G is visibly present at the rear of the electrical connector, as shown in the illustration.

- If TECGEL 7436 EC OR Nyogel 760G **IS** visible at the rear of the electrical connector, wipe away any excess TECGEL 7436 EC OR Nyogel 760G from the front face and rear face of the electrical connector before continuing.
- If TECGEL 7436 EC OR Nyogel 760G **IS NOT** visible at the rear of the electrical connector, repeat steps 12 and 13.

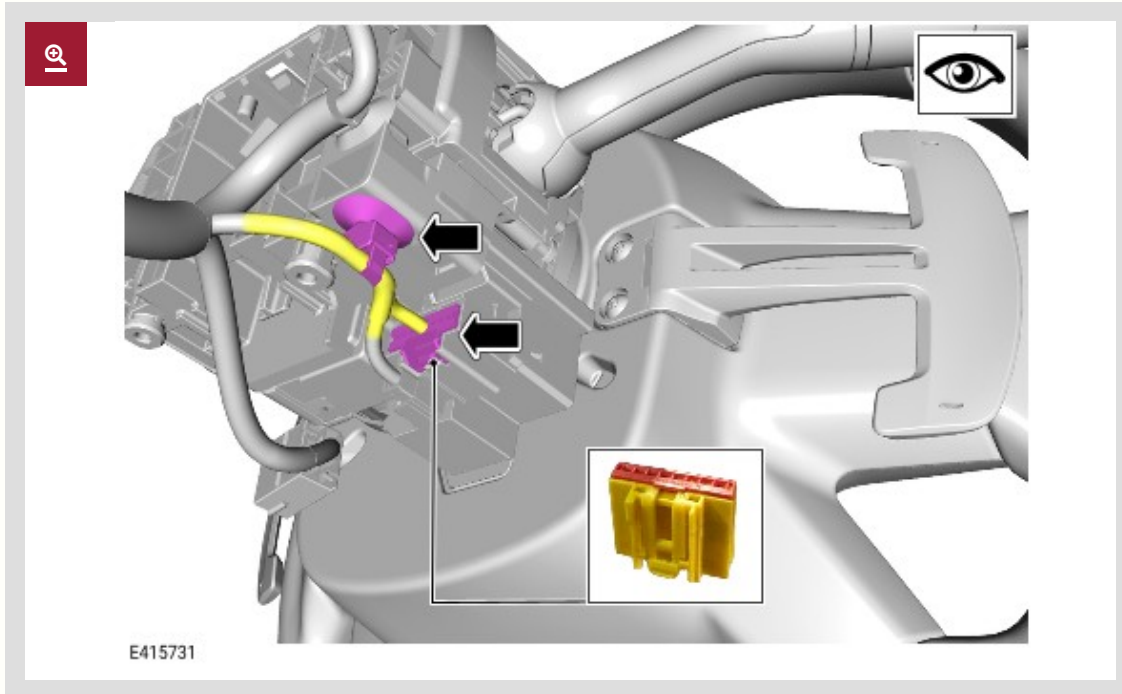
When the electrical connector is connected wipe away any excess TECGEL 7436 EC OR Nyogel 760G from the rear face of the electrical connector.

Connect the electrical connector as shown in the illustration.

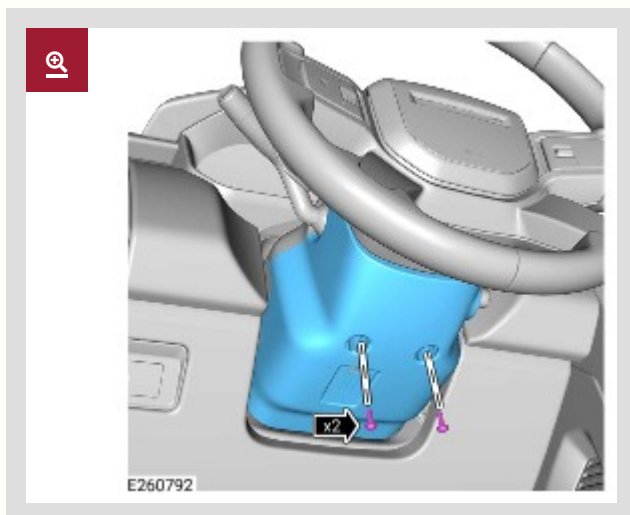
The illustration shows a Defender vehicle, Discovery and Range Rover are similar.

Install the steering column lower cover.
