# SAFETY RECALL

Volvo Trucks North America

| Date | Number | Release | Page |
|---|---|---|---|
| 07.2026 | RVXX2607 | 01 | 1 (6) |

## Steering Arm Inspection VN, VHD, VAH, VN (4)

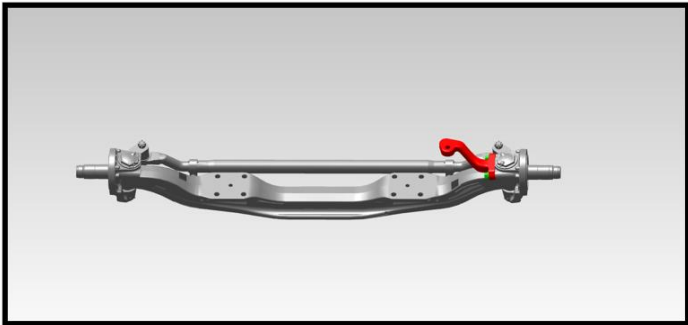
1. Single steering arm. A total of two bolts will be checked.

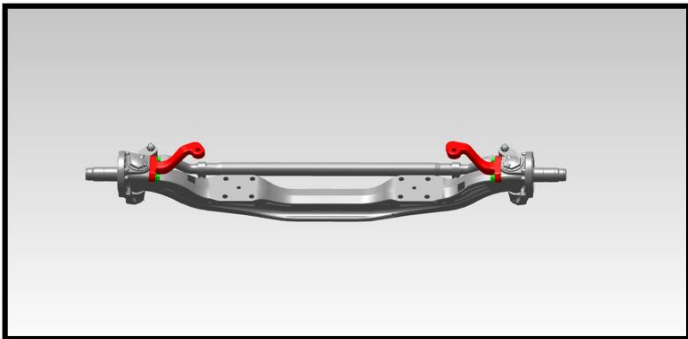
2. Dual steering arm. A total of four bolts will be checked.

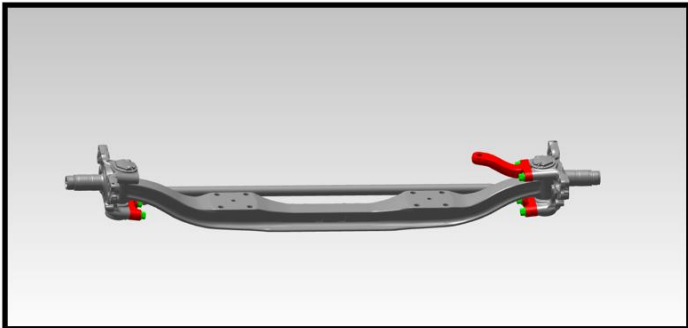
3. Single steering arm with bolt-on tie rod arms. A total of six bolts will be checked.

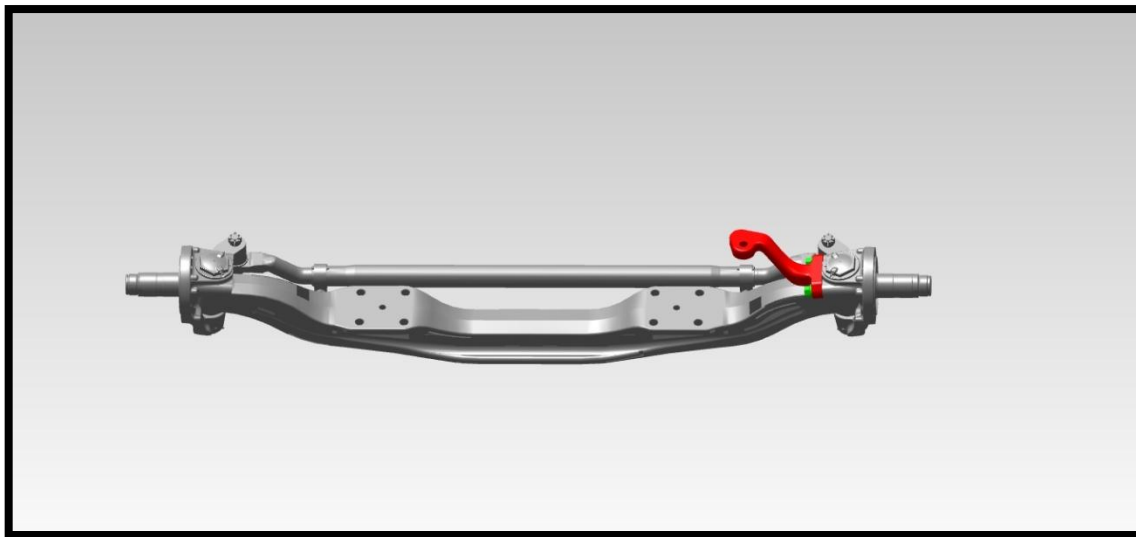
## Single Steering Arm

5. Locate the steering arm to knuckle bolts.

6. Set the torque wrench to **597 Nm (440 lbf·ft)** and tighten the bolt in direction of normal tightening.
- a. If the bolts move, continue to **step 7**.
  - b. If the bolts do not move, continue to **step 8**.
7. Remove both bolts and replace using new bolts **P/N 1079490**.
8. Set the torque wrench to **750 ±75 Nm (553 ±55 lbf·ft)** and tighten the bolts.
