# VOLUNTARY RECALL CAMPAIGN

## VOLUNTARY RECALL CAMPAIGN 2020-2026 ARMADA; CERTIFICATION LABEL

**CAMPAIGN ID #:** P6A13  
**APPLIED VEHICLES:** 2020-2024 Armada (Y62)  
2025-2026 Armada (Y63)

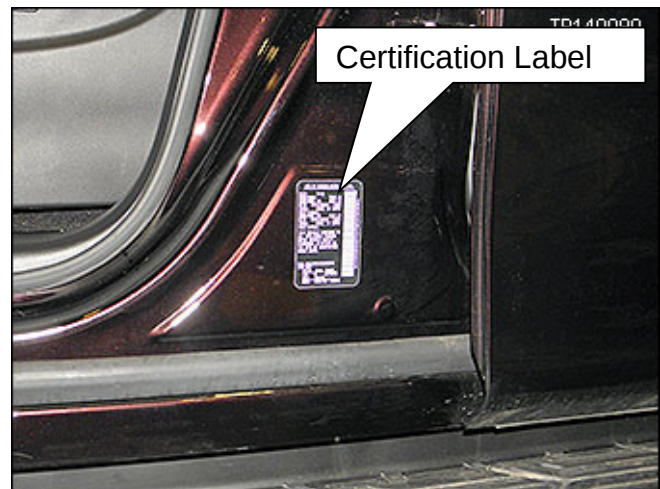
Figure 1

2. Open the driver's door.
  3. Locate the existing certification label (Figure 1).  
**HINT: The certification label has the VIN on it.**
  4. Make sure the VIN on the new certification label matches the VIN on the old certification label (Figure 2 and Figure 3).

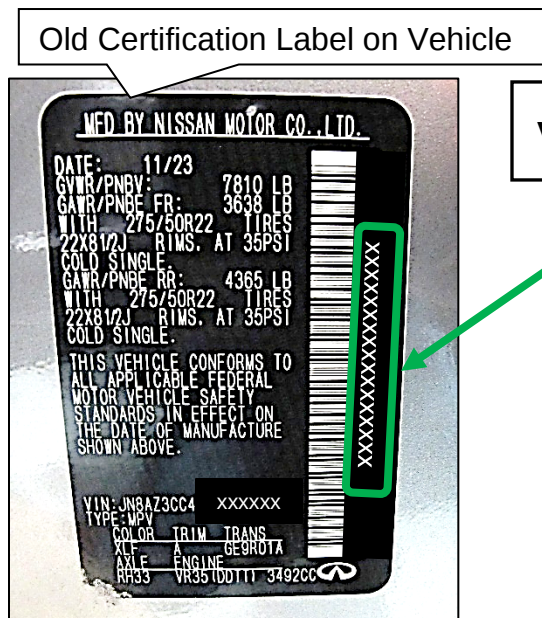
Figure 2

**VIN Must Match**

- The VINs MUST MATCH.

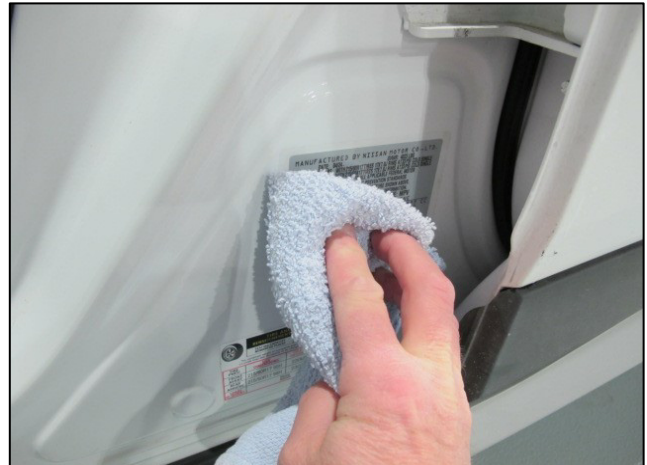
Figure 4

5. Clean the old Certification label and the area around it with a mild detergent and water.

- Care should be taken not to use harsh chemicals that may damage the existing label.
- It is important that the surface be free of dirt and oil to ensure proper adhesion of the new label.
