| <br><b>Technical Service Bulletin</b> | <b>GROUP</b><br><b>RECALL</b> | <b>NUMBER</b><br><b>26-01-066G-1</b> |
| | <b>DATE</b><br><b>AUGUST 2026</b> | <b>MODEL(S)</b><br><b>G80 (RG3)</b> |
| <b>SUBJECT:</b> IGNITION COIL GROUND BOLT RETIGHTENING<br>(RECALL 034G) | | |

**Description:** Certain G80 (RG3) vehicles may have an ignition coil ground bolt (GC101) that was not sufficiently tightened during vehicle assembly. A loose ground bolt may cause an engine misfire with illumination of multiple warning light(s), or in limited instances, an engine stall. This bulletin provides instructions to retighten the GC101 ground bolt.

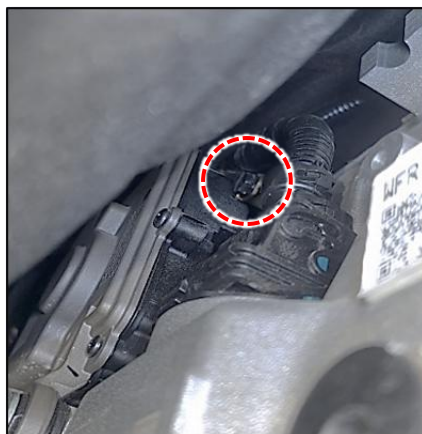
Ground Bolt Location on top LH side of the Transmission

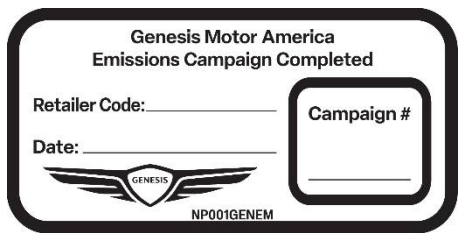
| Model | Part Name | Part Number | Figure | Remarks |
|---|---|---|---|---|
| G80 (RG3) | Emissions Label | NP001-GENEM | | Apply to all vehicles regardless of state. |

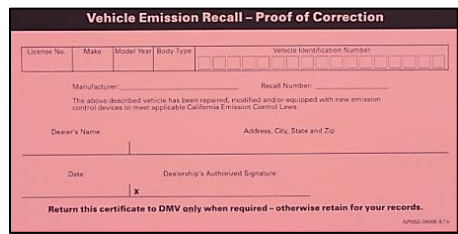
| Model | Part Name | Part Number | Figure | Remarks |
|---|---|---|---|---|
| | Vehicle Emission Recall - Proof of Correction Card | NP050-09006 | | Order only for states:<br>CA, CO, CT,<br>DE, ME, MD,<br>MA, MN, NV,<br>NJ, NY, OR,<br>PA, RI, VT,<br>VA, WA |

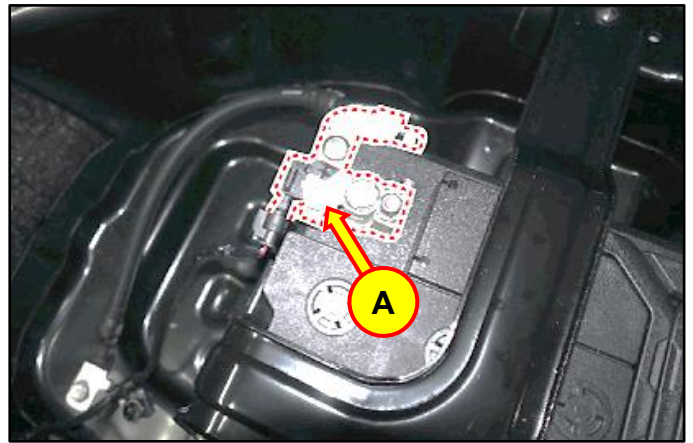
1. Disconnect the negative (–) battery terminal (A).

**Tightening Torque:**

| lb-ft | 6.5 |
| lb-in | 78 |
| N.m | 8.9 |

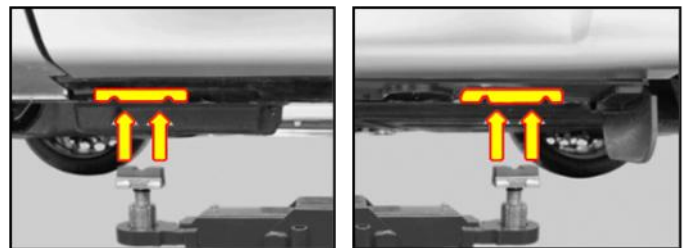
2. Visually check that the lift blocks are properly seated on the vehicle support points and raise the vehicle.

Raising the vehicle from anywhere other than the support points may damage vehicle components.

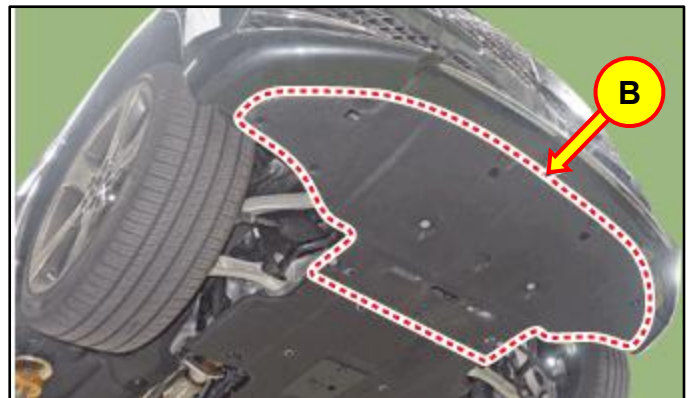
3. Remove the engine room front under cover (B).

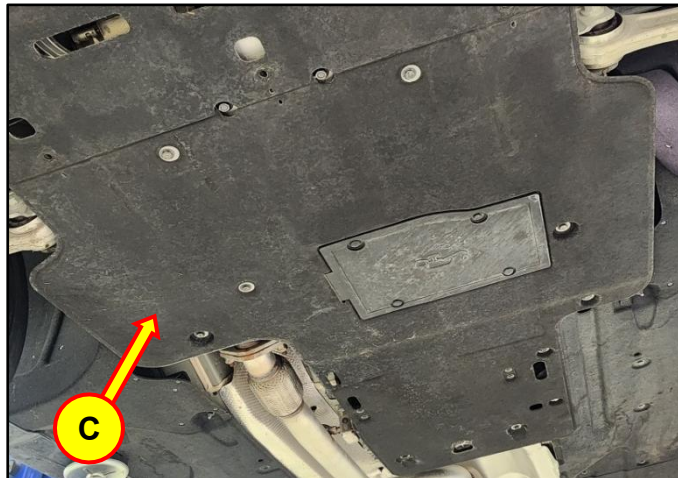
4. Remove the bolts and fixing clips, then remove the engine room rear under cover (C).

**Tightening Torque:**

| lb-ft | 7.3 |
| lb-in | 88 |
| N.m | 9.8 |

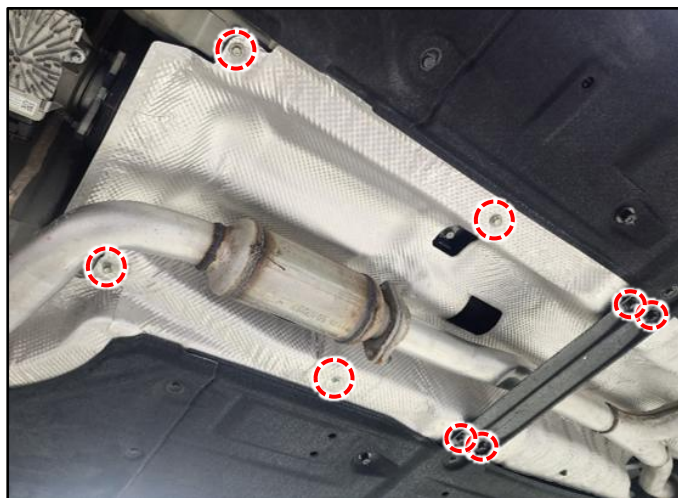
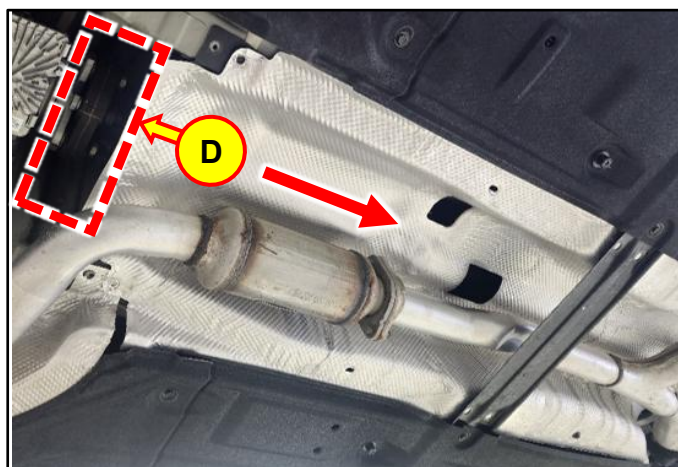
5. Remove the **8** fixing bolts, then slide the heat protector back toward the rear of the vehicle about **25 millimeters** or **1 inch** to uncover the rubber isolator (D) at the end of the transmission.

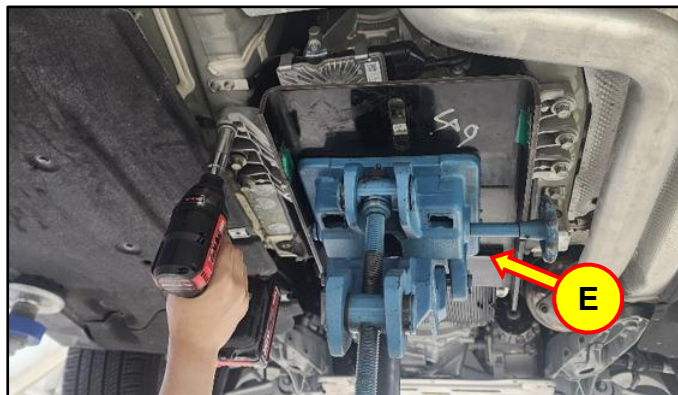
6. Place a transmission support jack (E) underneath the transmission support bracket to support it.

If a transmission support jack is **NOT** used, then the body fixing bolts may be damaged upon removal or reinstallation.

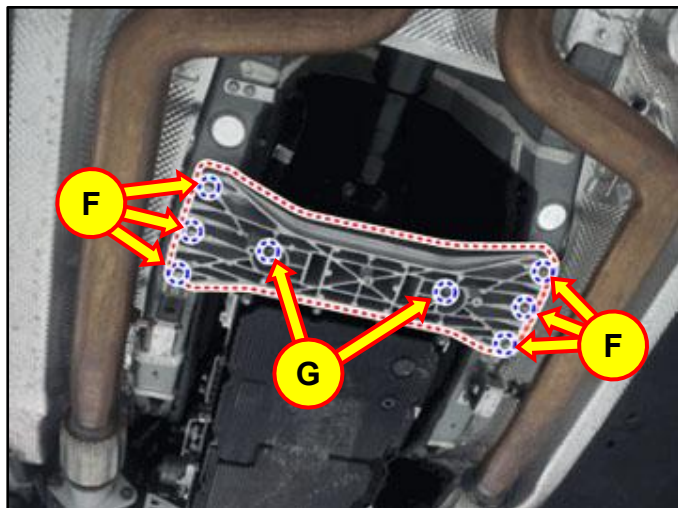
7. Remove the **6** transmission mounting bracket fixing bolts (F).

**Tightening Torque:**

lb-ft

36

N.m

48

Do **NOT** loosen or remove the **2** transmission center fixing bolts (G).

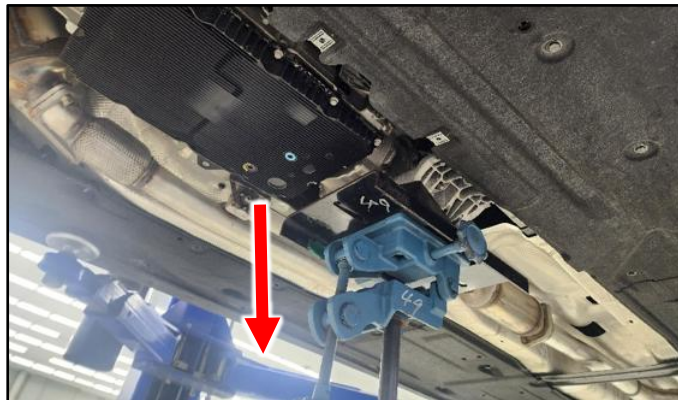
8. Use the transmission support jack to carefully lower the transmission from the vehicle.

The transmission should only lower **1-2 inches**. The rest of the required workspace will be created by an additional assistant prying the transmission down for the technician to apply the final torque.

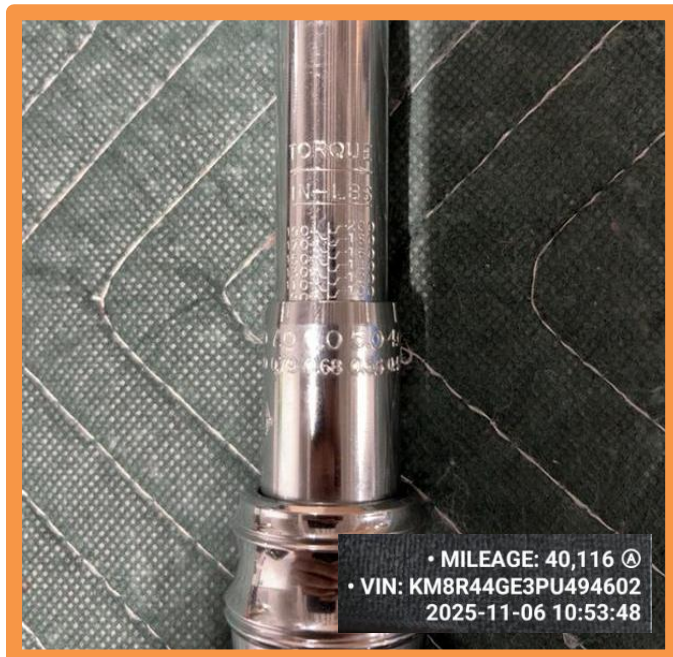
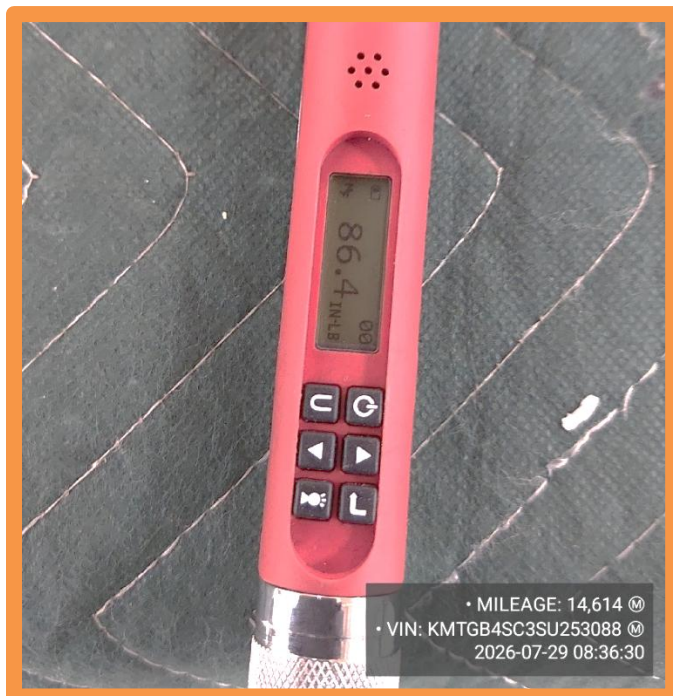
9. Set a **1/4-inch** torque wrench to the required specifications for the retightening of the GC101 ground bolt.

| lb-ft | 7.2 |
| lb-in | 86 |
| N.m | 9.8 |

Using the STUI camera function, take a photo of the **1/4-inch** torque wrench with the torque set to the proper specification.

Either an analog or a digital **1/4-inch** torque wrench can be used for this procedure.

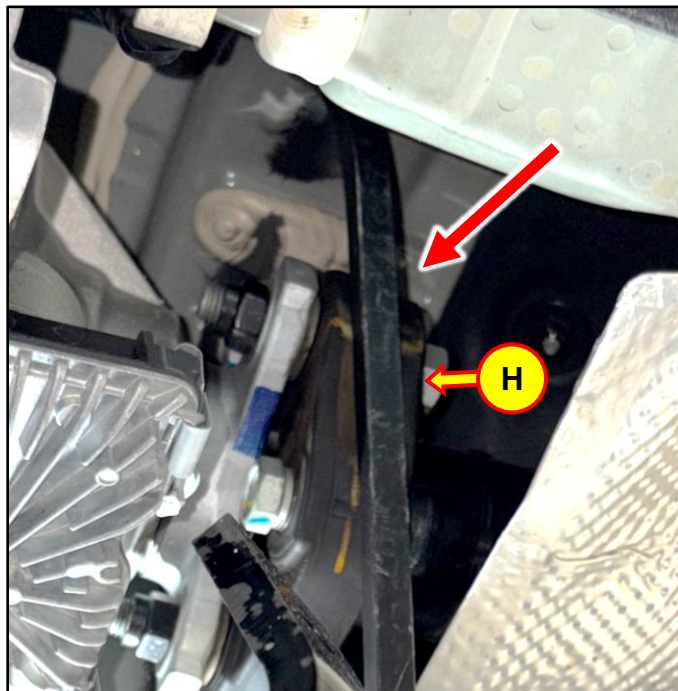
Use a pry bar (H) to push down on the rubber isolator at the back of the transmission, as shown, to create more workspace for the Technician to slide the torque wrench and socket into position.

Place a rag at the end of the prybar to prevent damage to the vehicle body.

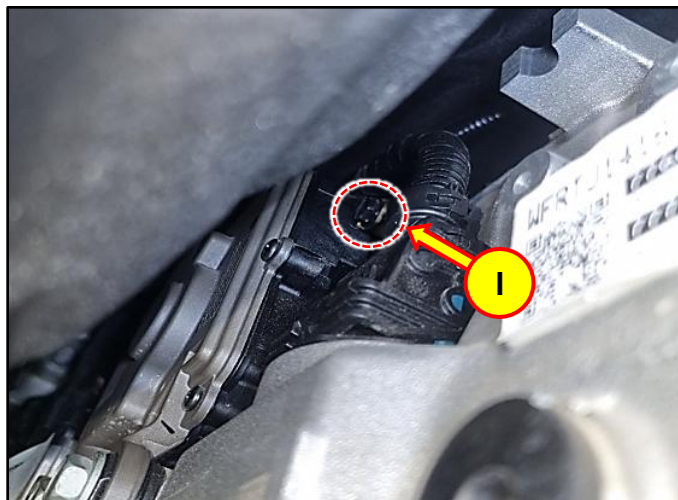
While continuing to pry the transmission down, shine a flashlight into the created workspace to help the first technician locate the GC101 ground bolt (I).

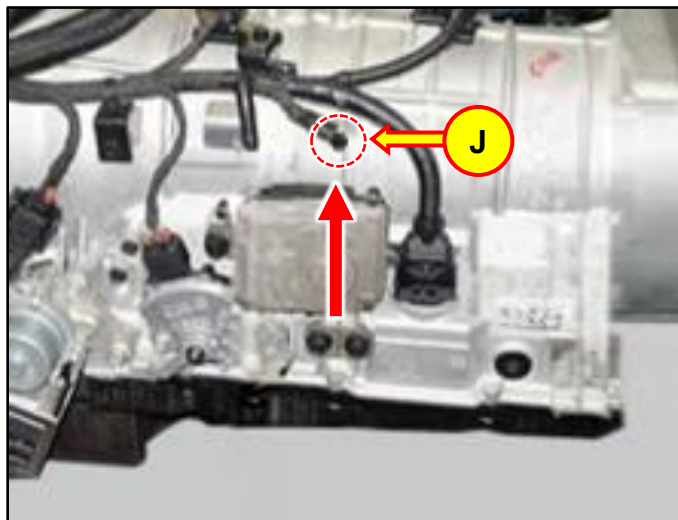
While the workspace is widened by the pry bar and lit up by the flashlight, locate the GC101 ground bolt (J) directly above the parking release actuator.

Follow the center of the **2** bolts that hold the parking release actuator **up** to locate the GC101 ground bolt more easily.

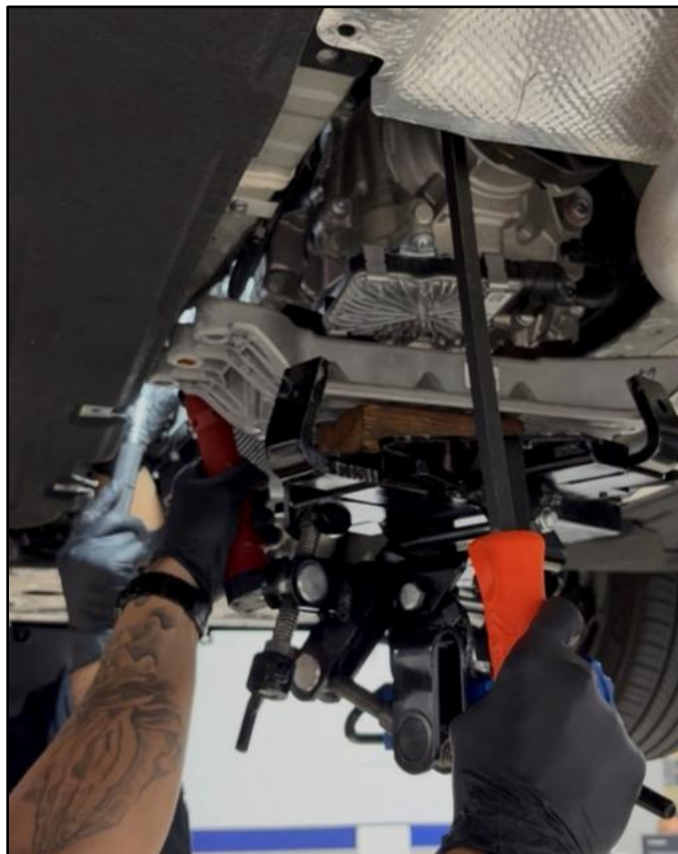
14. **Technician:**  
Slide the torque wrench and **10-millimeter-deep socket** onto the GC101 ground bolt and **prepare** for the STUI digital documentation of the final torquing procedure.

| lb-ft | 7.2 |
| lb-in | 86 |
| N.m | 9.8 |

Do **NOT** perform the final torquing until **step 15**.

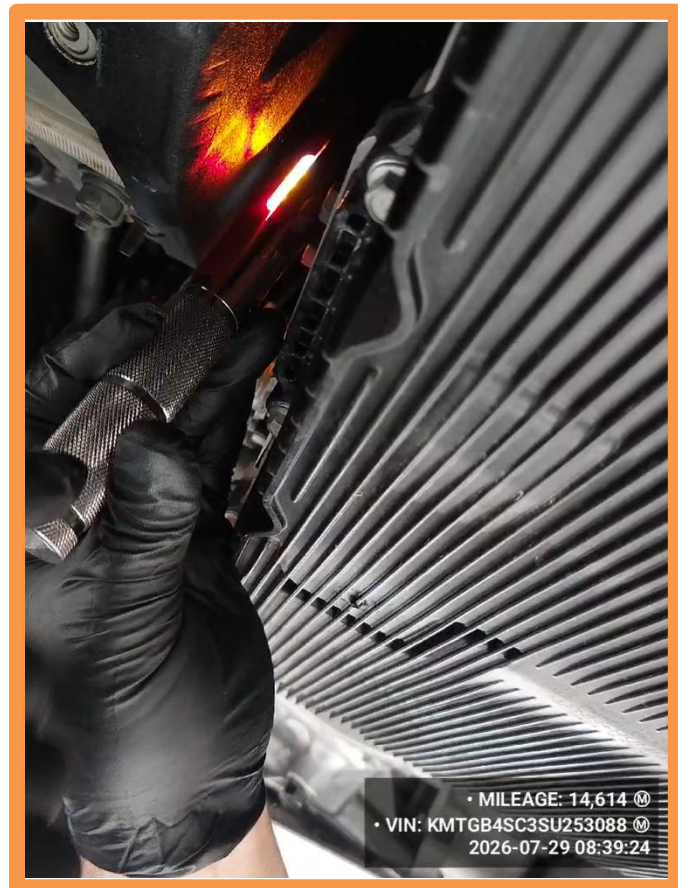
15. **Technician:**  
Use the placed torque wrench to torque the GC101 ground bolt to the proper specifications.

Using the STUI camera function, take a photo of the technician applying the final torque to the GC101 ground bolt.

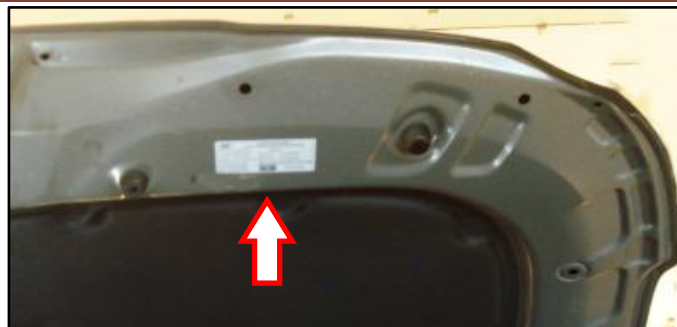
1. Fill in the Campaign ID, Dealer Code, and Date on the emissions label, and apply adjacent to the existing label, on the underside of the hood, as shown.

Be sure to clean the mounting surface to ensure proper label adhesion.

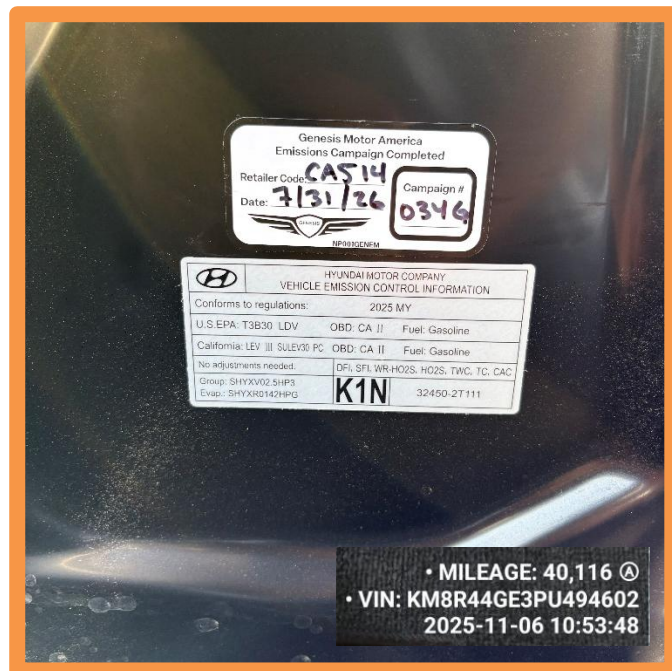
Using the STUI camera function, take a photo of the emissions label attached to the vehicle.
