# SAFETY RECALL

## Second-Row Seat Belt Buckle Anchor

Reference: 67D / NHTSA 26V-495

2019-2026 (DT) Ram 1500 Pickup

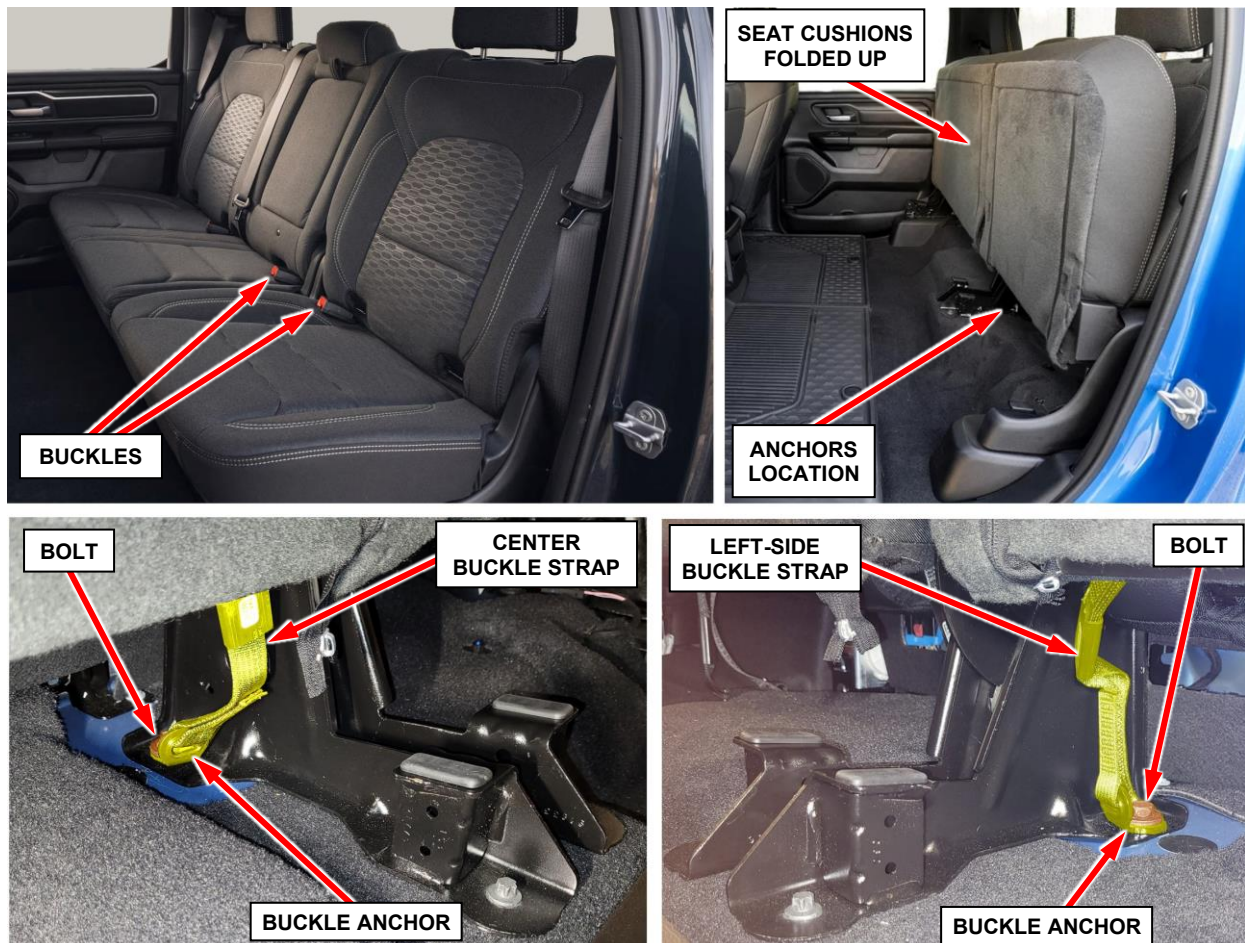
**Figure 1 – Second Row: Center and Left-Side Seat Belt Buckle Anchors**

1. Fold the second-row seat cushions up to access the center and left-side seat belt buckle anchor bolts (Figure 1).
2. Visually inspect to confirm both seatbelt buckle anchors are secured to the vehicle with the bolt. If not, replace the bolt and tighten to 55 N·m (41 Ft. Lbs.) (Figure 1).
3. Grasp the seatbelt buckle anchors and try to move or swivel them around the bolt. If movement is possible, replace the bolt and tighten to 55 N·m (41 Ft. Lbs.) (Figure 1).
4. If the seatbelt buckle anchor passed the first two inspection steps or was repaired during one of the prior steps, the vehicle may be returned to the customer or inventory.

Inspect and, if necessary, attach the second-row seat belt buckle anchor to the body structure.
