# Recall Campaign Bulletin

| NHTSA ID | 26V636 |
| SUBJECT | Check Driver's Seatbelt Anchorage |
| MODEL(S) | CLA (178 platform) |

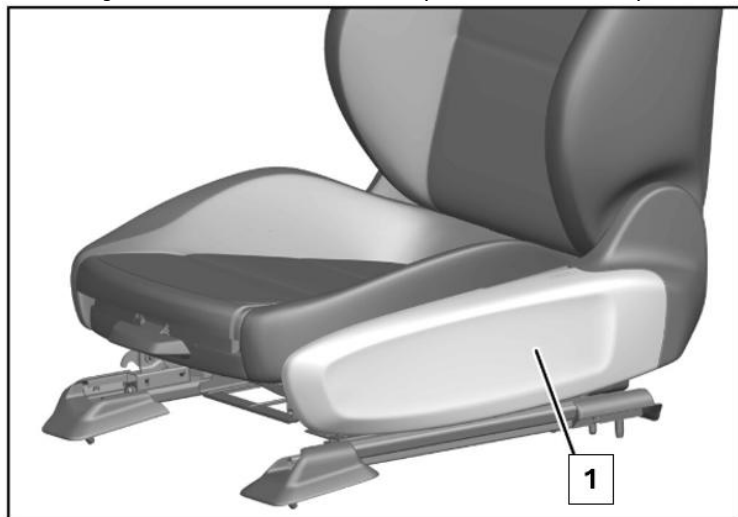
**Illustration 1: Shown with code 275**

1. Remove exterior trim on seat frame (1, Illustration 1).

**i** For basic information on **vehicles with code 275**, see **AR91.10-P-1201CLB**.  
**Only** the **trim** is removed (1, illustration 1).

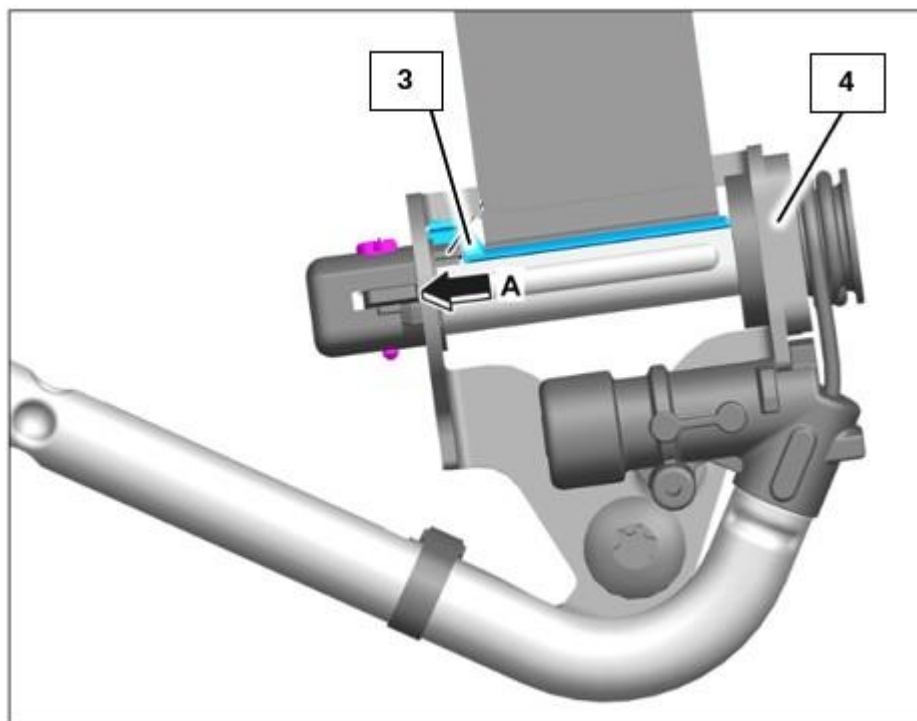
Illustration 3

2. Check seat belt end fitting (3, illustration 3) for correct installation.  
**i** Seat belt end fitting (3, illustration 3) must be installed **correctly**.  
**i** For basic information, see AR91.40-P-1030-02CLA.

- a. Seat belt end fitting (3, illustration 3) is **not** connected to seat belt end-fitting tensioner (4, illustration 3) and **not correctly** installed:

- b. Seat belt end fitting (3, illustration 3) is **correctly** connected to seat belt end-fitting tensioner (4, illustration 3) and **correctly** installed:

1. Install seat belt end fitting correctly (Illustration 3).

**i** For basic information, see **AR91.40-P-1030-02CLA**.
