January 30, 2026

Version 1

Safety Recall: 2024 Pilot Driver's Seat Lift Link Bolt Loose

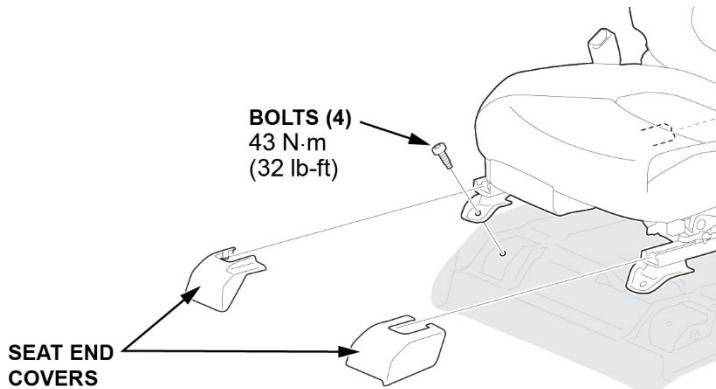
1. Remove the [seat end covers](#), then remove the four seat mounting bolts using a 50 IP TORX Plus socket driver.

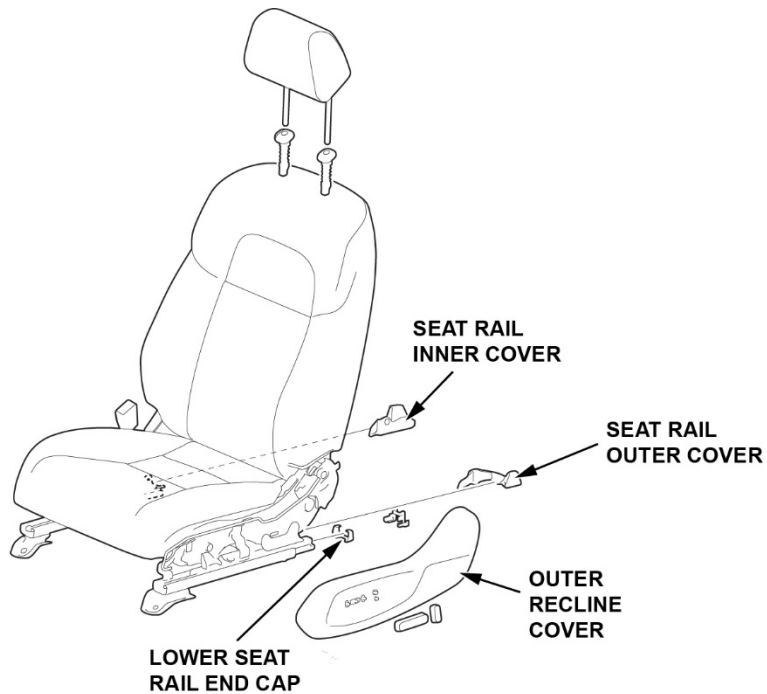
5. Remove the following:

1. [Outer recline cover](#)
2. [Seat rail inner and outer covers](#)
3. [Lower seat rail end cap](#)

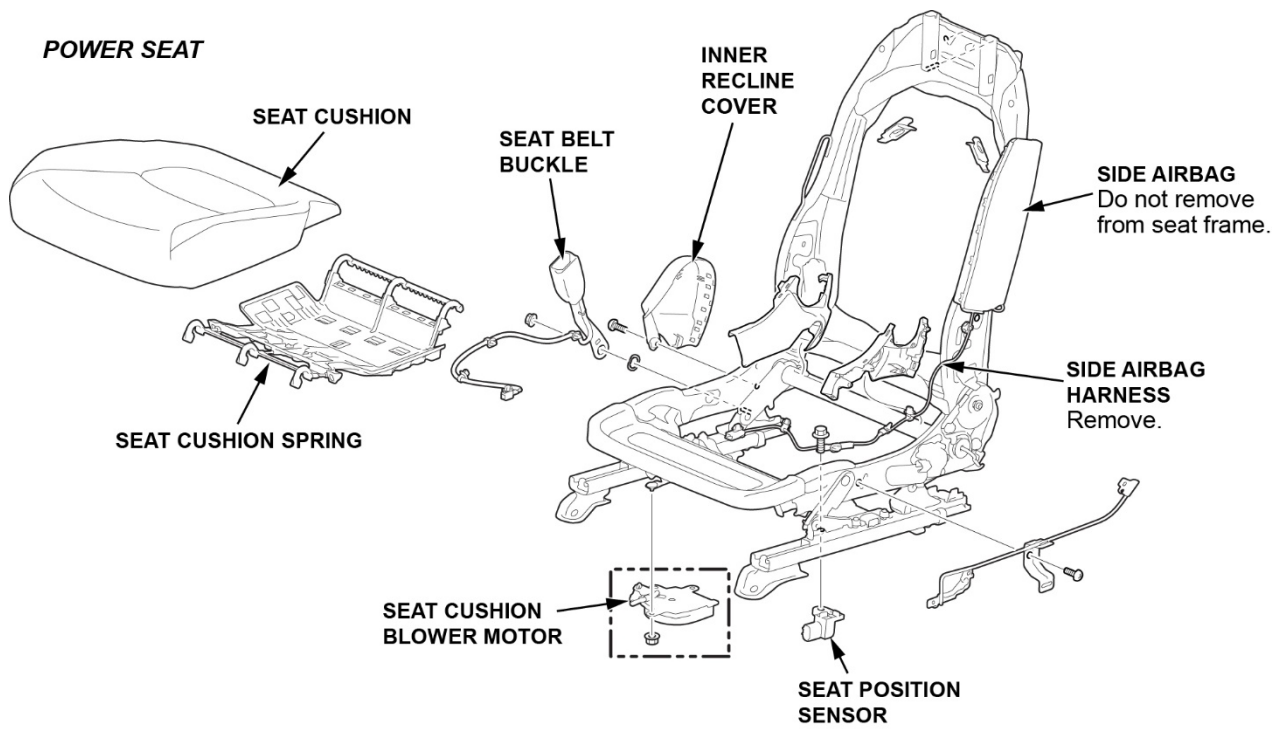
7. Remove the following:

1. [Inner recline cover](#)
2. Harness for [driver's side airbag](#) (do not remove the airbag)
3. [Seat cushion](#)
4. Seat harness
5. [Seat cushion blower motor](#) (if equipped)
6. [Seat cushion spring](#)

8. Disconnect the [seat position sensor](#) and [seat belt buckle](#).

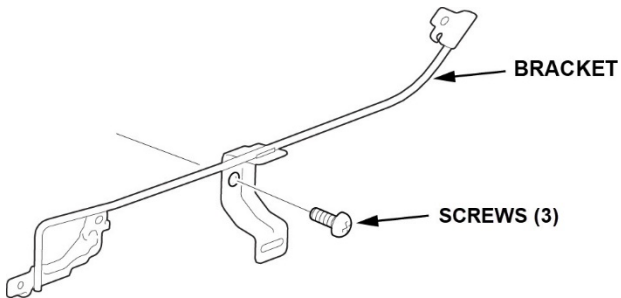
9. Remove the 3 screws, then remove the [bracket](#).

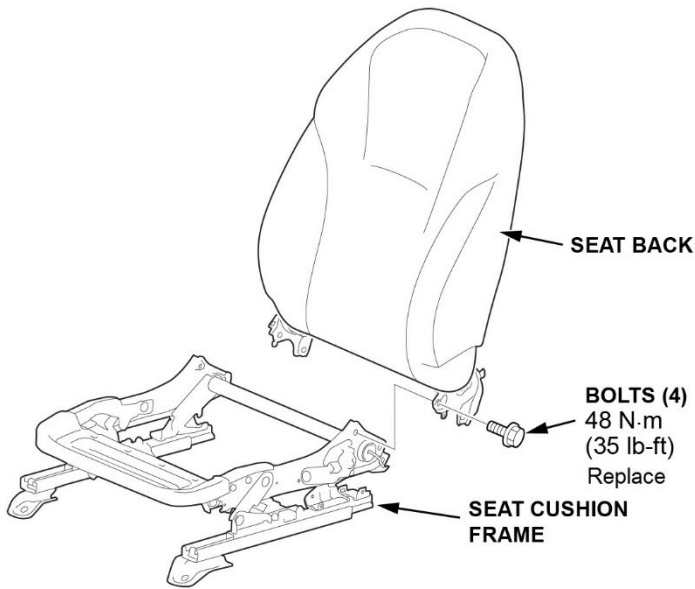
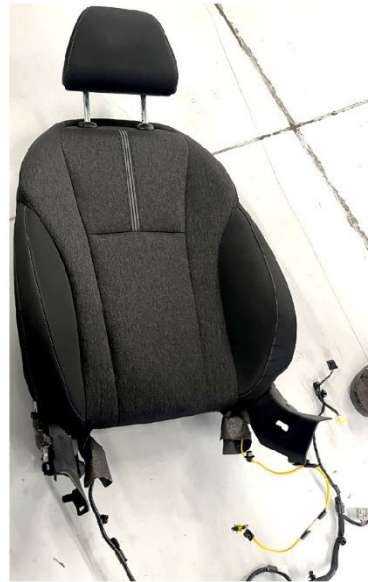
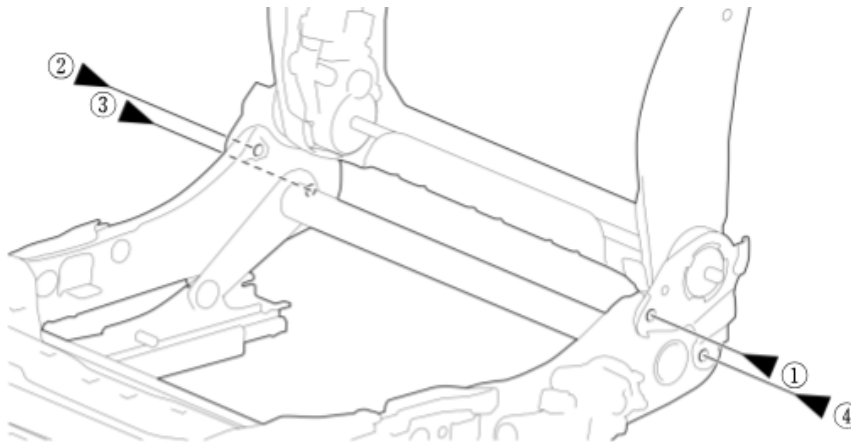
10. Remove the [four bolts holding the seat back](#) to the seat cushion frame and discard, then remove the seat back assembly.

- **Do not** disassemble the seat back assembly.
- Use new bolts to attach the seat back to the seat cushion.
- Torque in sequence on assembly.

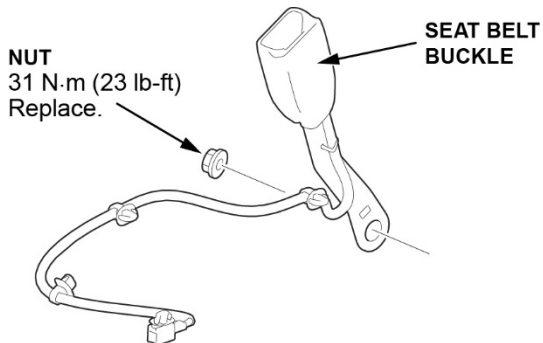
11. Transfer the [seat belt buckle](#) to the new seat cushion frame.

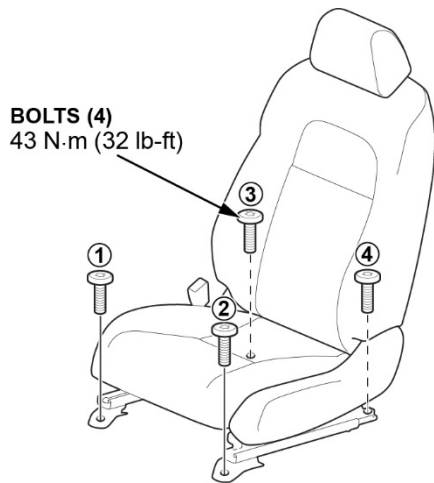
14. Install the driver's seat into the vehicle. Hand tighten the bolts, then torque, in sequence, using a 50 IP TORX Plus socket driver.
