# Safety Recall 610572 Rev. 1

NHTSA Recall No.: 26V280

Applicable for 2025 and 2026 Dodge Promaster

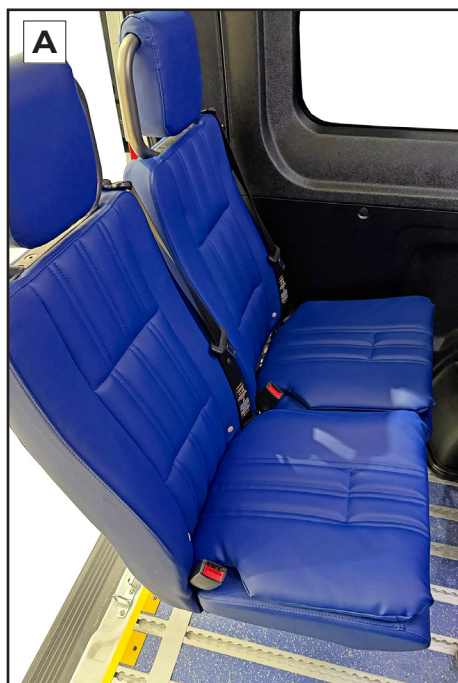
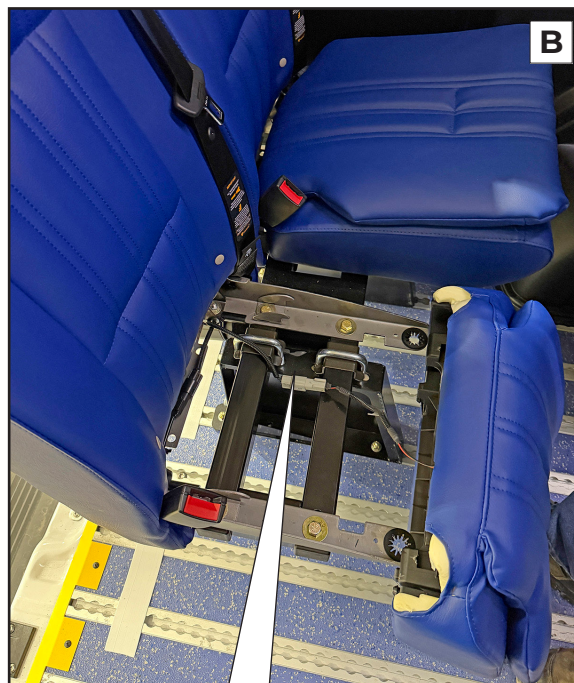
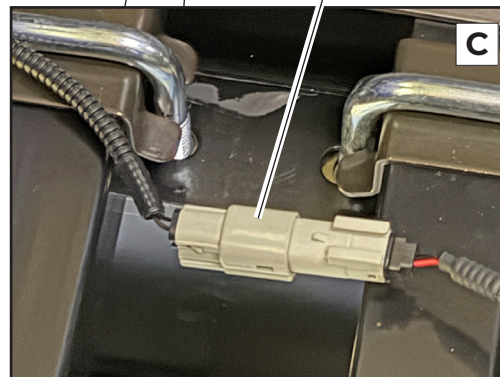
Seat Harness  
Connector

1. Remove seat cushion and disconnect harness (if present). See Photos A through C.

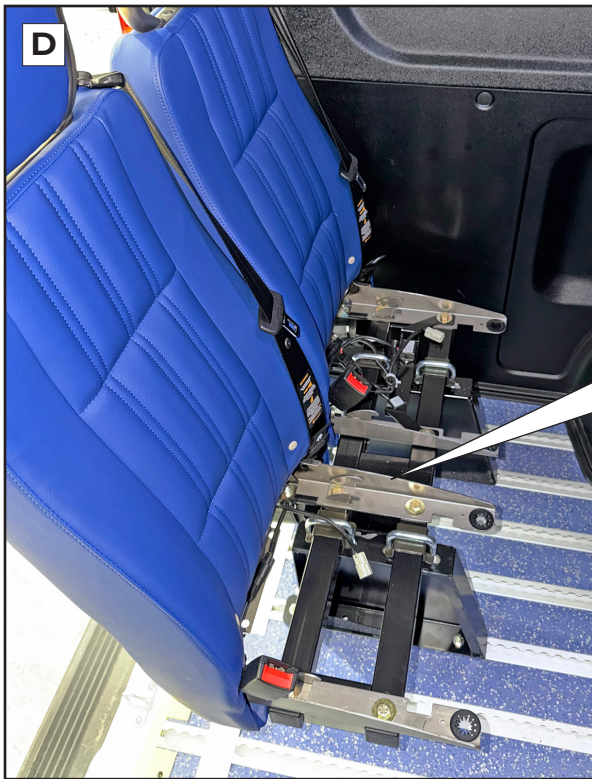
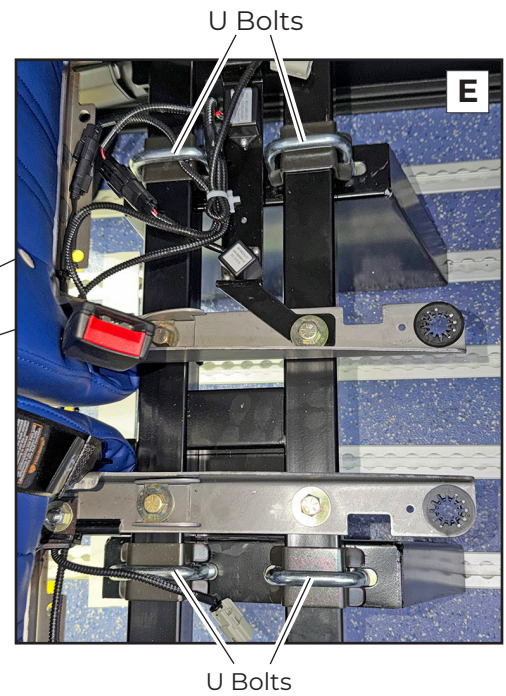
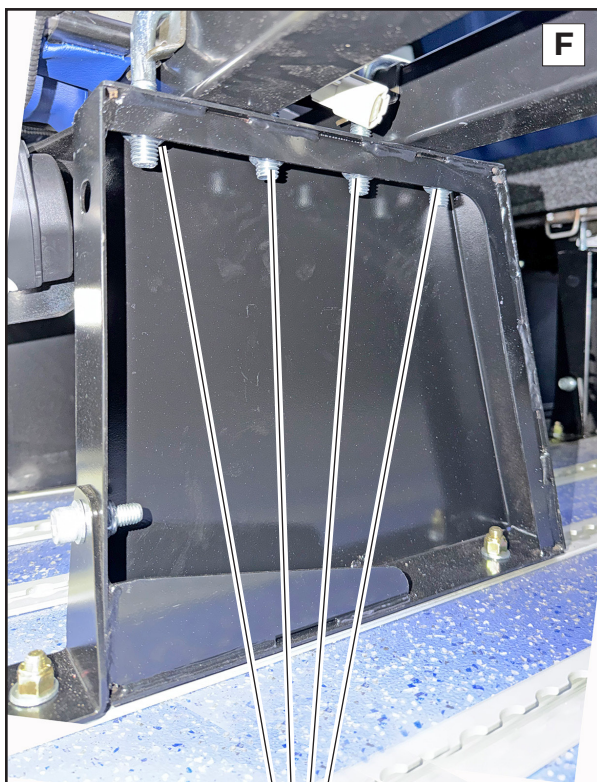
3. Using a 3/4" socket, remove U bolt Nuts. See Photos D through F.

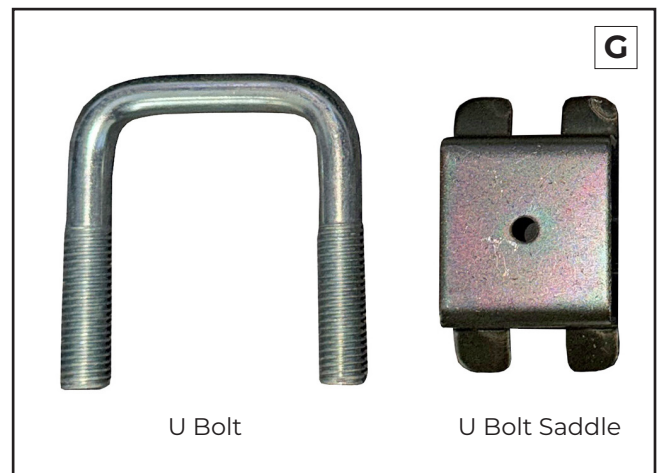
4. Remove U bolts and U bolt saddles. See photo G.

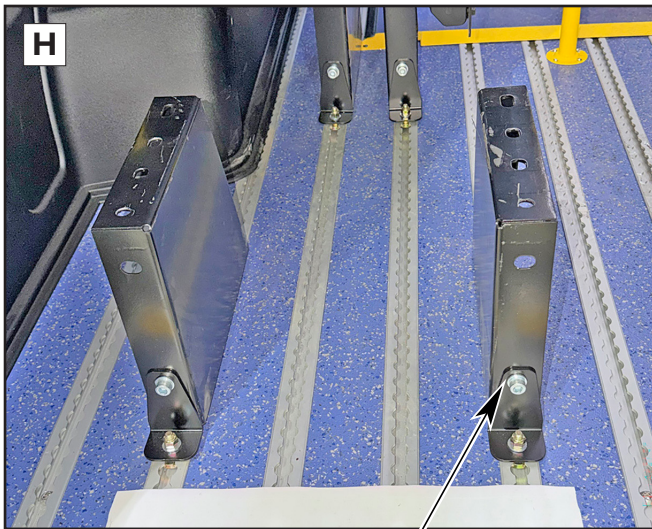
Right Seat Base

5. Remove seat. See photo H.

6. Remove right seat base. Refer to Photo H.

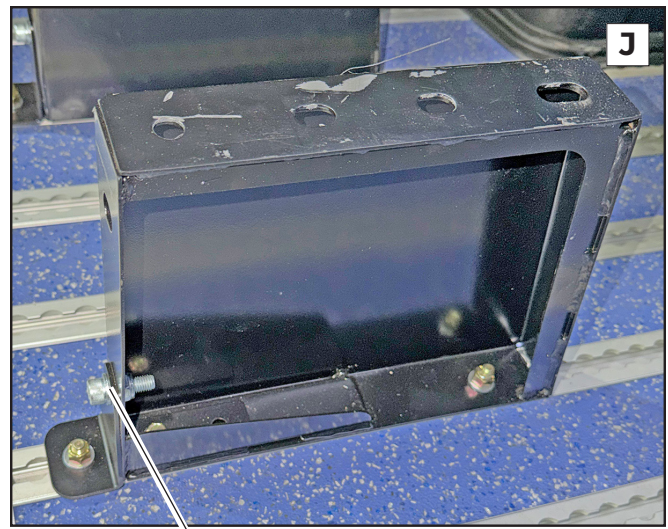
Hex Head Bolt

- a) Remove bolt shown using 5/16" hex socket and 17mm deep well socket. See Photo J.
- b) Remove track bolt nuts using a 9/16" deep well socket. See Photo K.
- c) Remove seat base and track bolts.

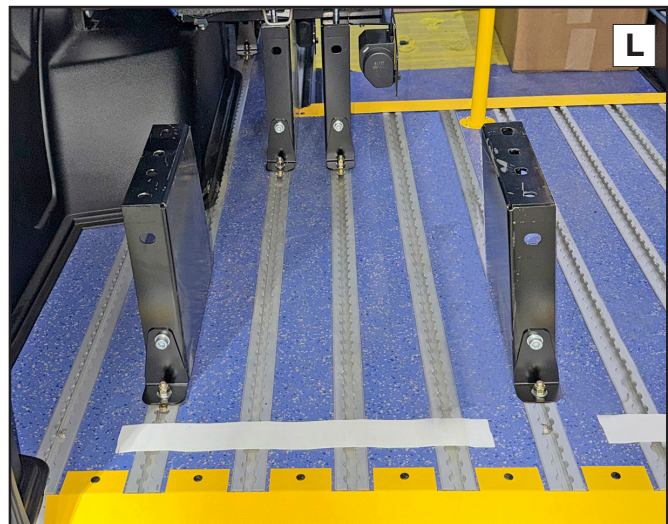
7. Reinstall seat base one track to the right by performing Step 6 in reverse. Ensure seat base is in the correct position on the track. See Photo L.

Torque all bolts to 35 ft·lbs.

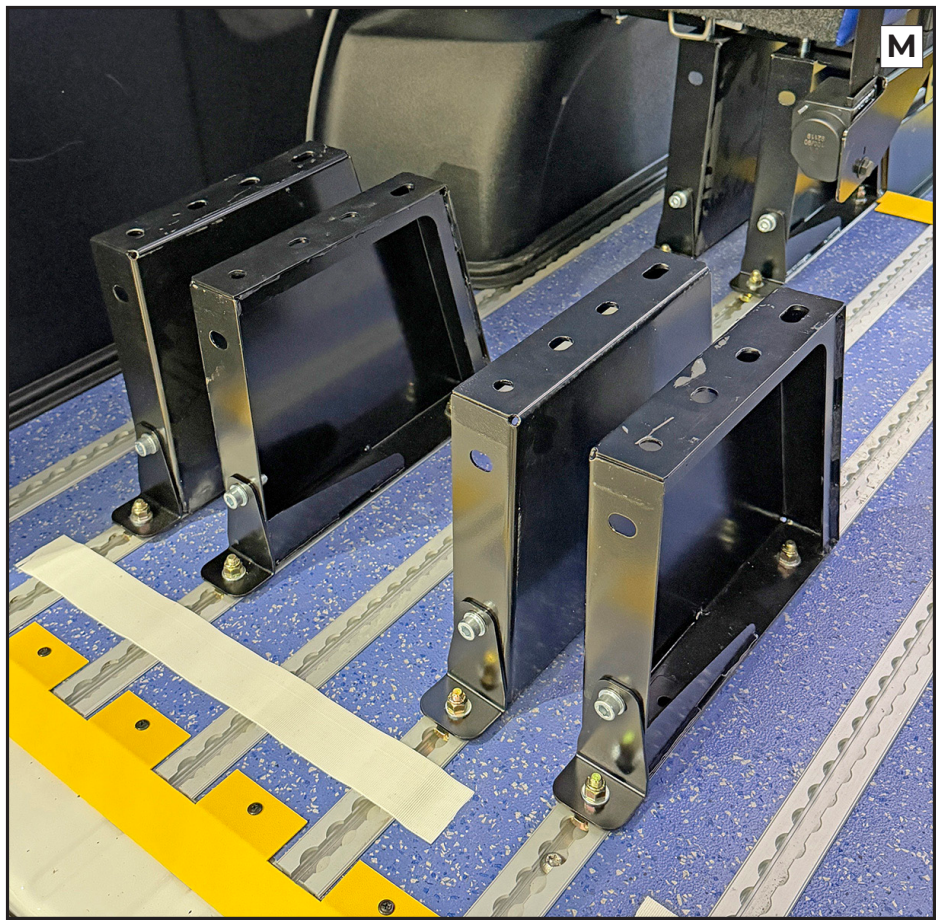
8. Install two seat bases, in kit, using mounting hardware contained in kit. Ensure the open faces of the two new seat bases are oriented to the center. See Photo M.

Torque all bolts to 35 ft·lbs.

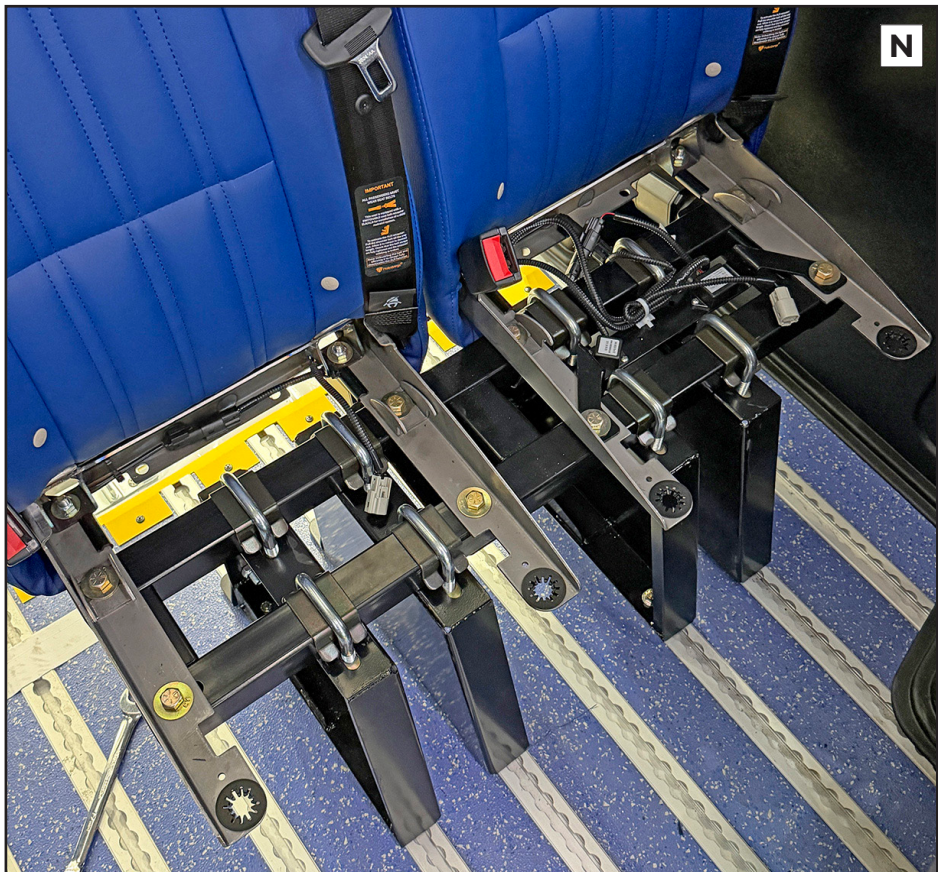
9. Install eight U bolts and U bolt saddles, using hardware contained in kit, by performing Steps 3 and 4 in reverse. See Photo N.

Torque all bolts to 35 ft·lbs.

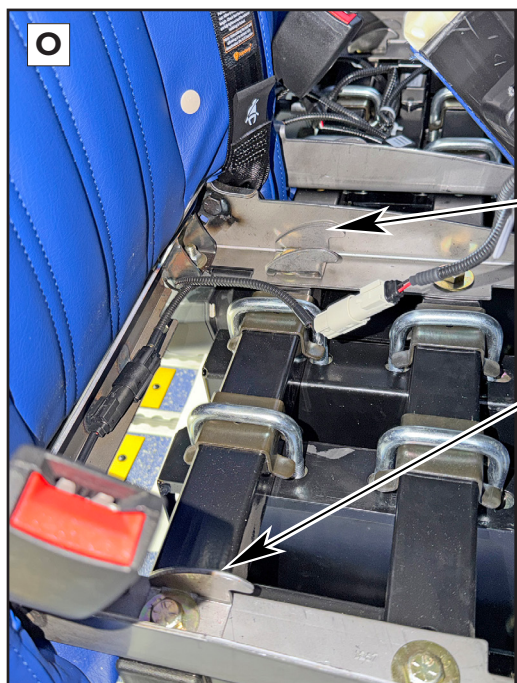
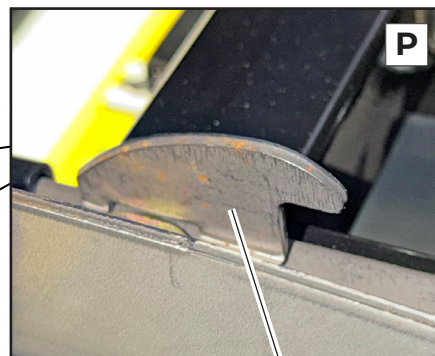
Seat Hook

10. Reinstall seat cushions.

Ensure seat cushion base engages hooks on seat frame when reinstalling.
