## Safety Recall: 2021, 2023 TLX Seat Weight Sensor

Affected vehicles may be equipped with seat weight sensors that are not built to proper specifications. Improperly built sensors could lead to cracking and/or a short circuit of the sensor, resulting in the illumination of the SRS warning light and the passenger airbag indicator remaining OFF. In certain collisions, these seat weight sensors may cause improper deployment of the front passenger airbags, increasing the risk of injury.

Replace the seat weight sensors.

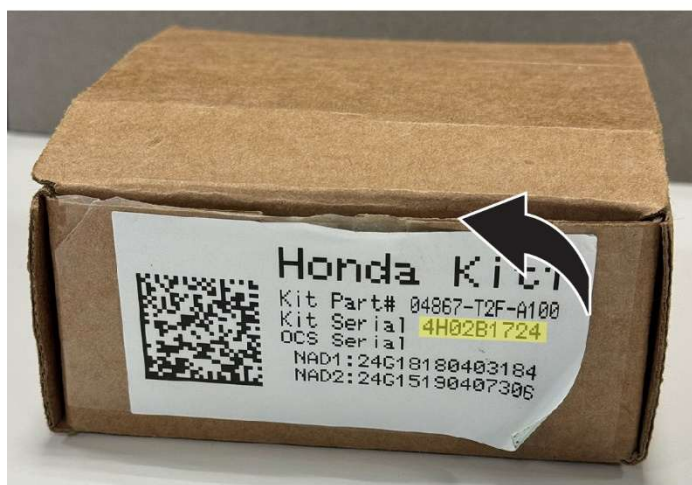
1. Remove the label from the new seat weight sensor box and affix it to the repair order.

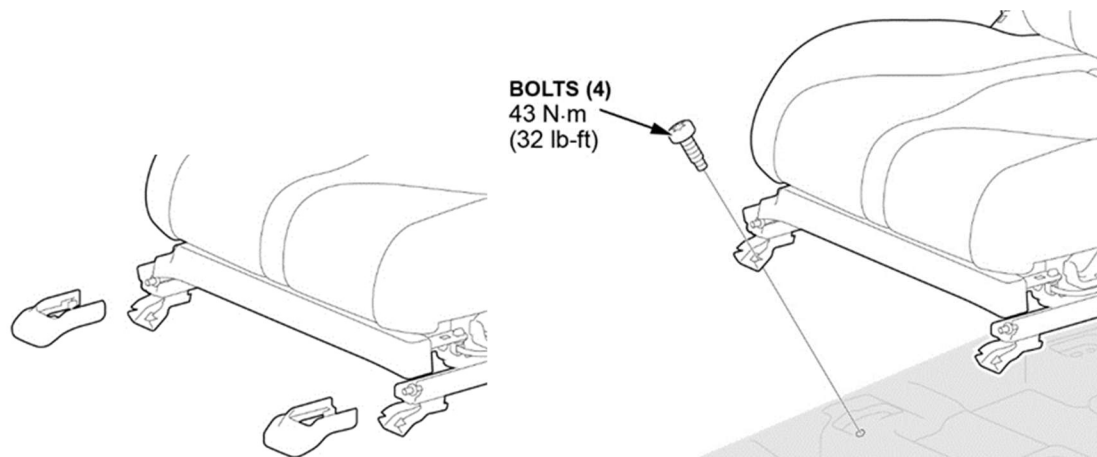
2. Remove passenger seat foot covers and seat mounting bolts.

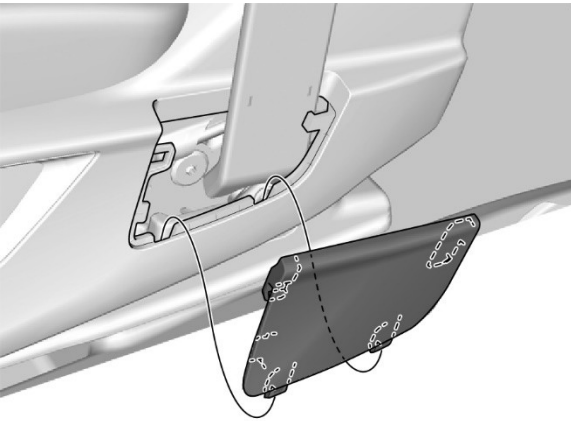
5. Remove the right front seat belt bolt cover and front seat belt anchor bolt. (driver's side is shown).

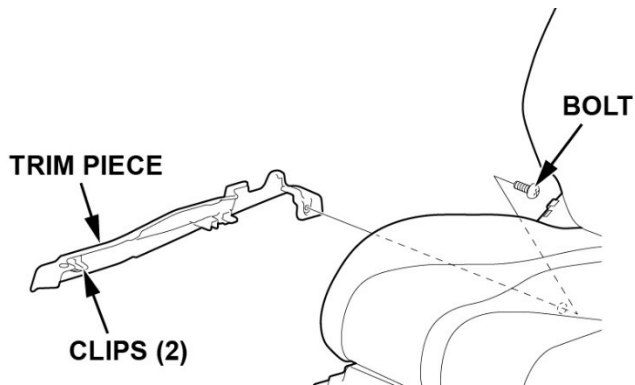
6. Disconnect the floor harness clip and disconnect the connectors underneath the seat.
7. Remove the seat from the vehicle.
8. Remove the right-side lower trim piece (one clip and one screw).

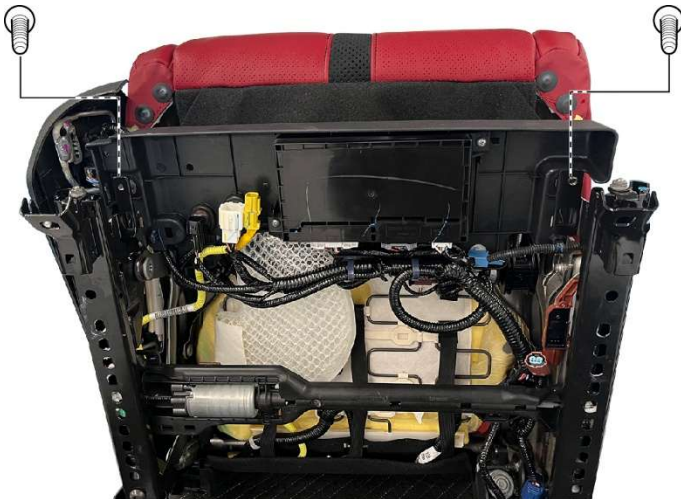
9. Remove the cover (2 screws).

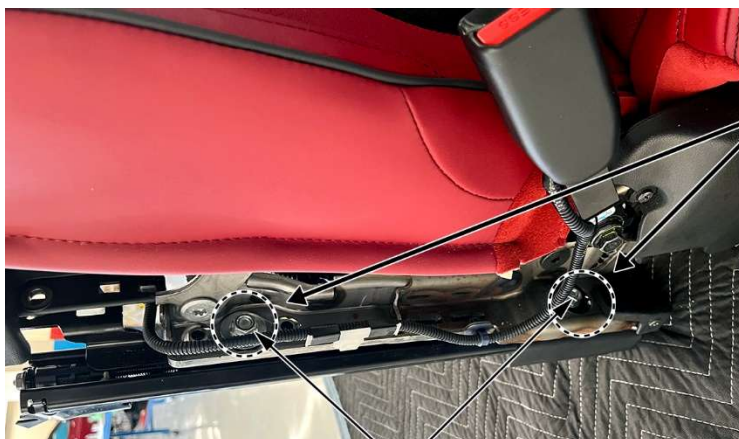
10. Remove the two flange nuts holding the left side seat frame.

**NUTS**  
55 N·m (40 lb-ft)

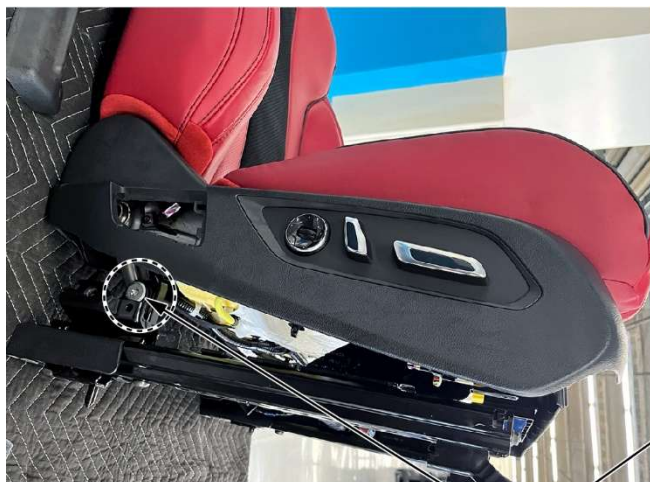
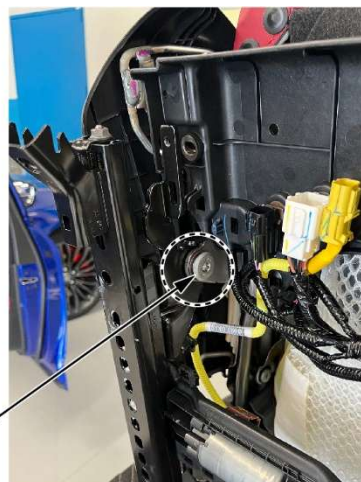
11. Remove the two bolts on the right side holding the frame.

**BOLTS**  
25 N·m (18 lb-ft)

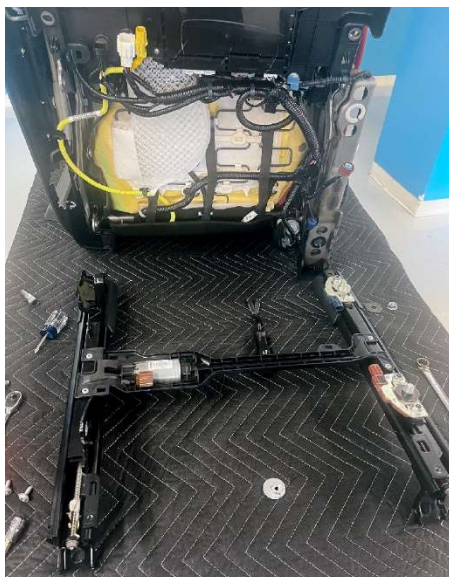
12. Remove the seat rail from the seat frame.

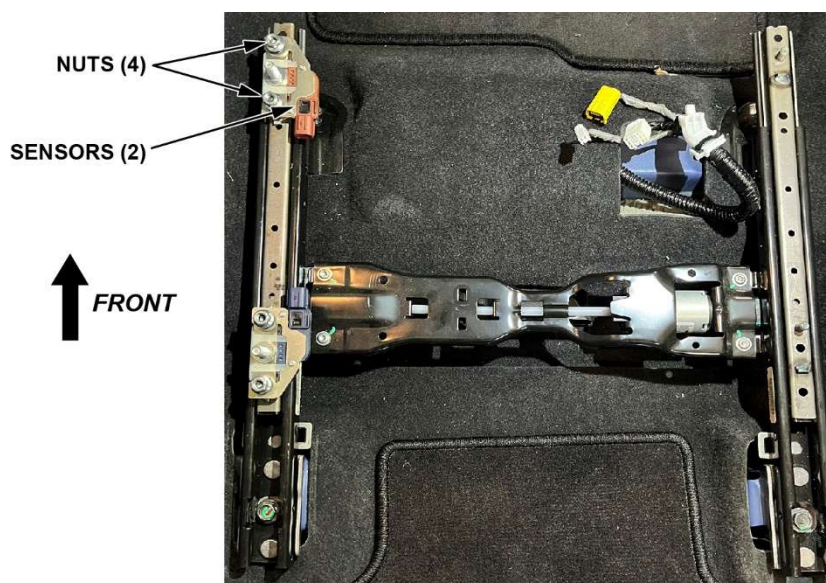
13. Mount the seat rail in the vehicle with the bolts and remove the 2 seat weight sensors, then discard the nuts and sensors.

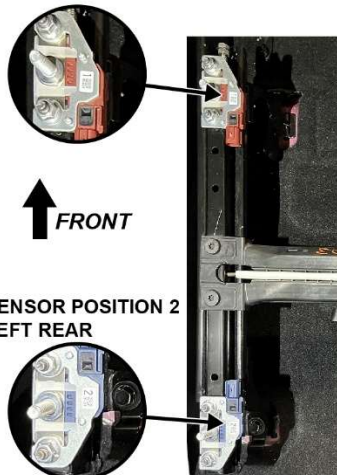
SENSOR POSITION 1  
LEFT FRONT

14. Loosely install the new seat weight sensors and nuts in the orientation shown.

NOTE: The new sensors have a number for installation in the correct location.

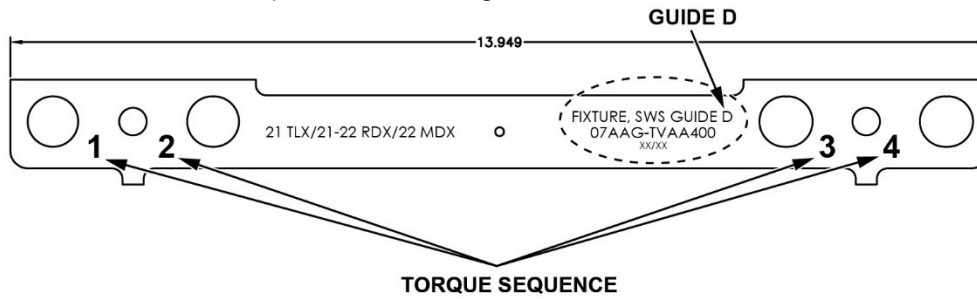
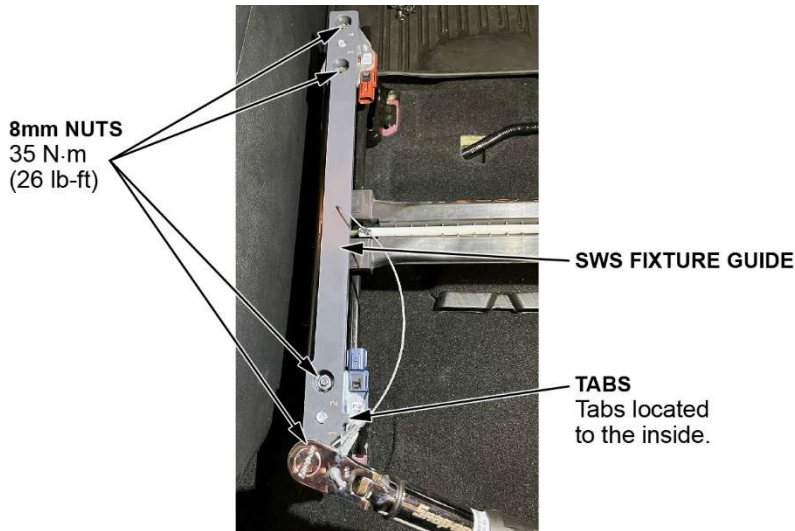
15. Place the **SWS Fixture Guide D** onto the new seat weight sensors with the tabs located to the inside of the seat track. With the guide properly seated on the new sensors, **torque nuts to 35 N·m (26 lb-ft) in the order shown on the SWS fixture guide, using the socket provided with the guide.**

NOTE: Use the socket provided with the guide.

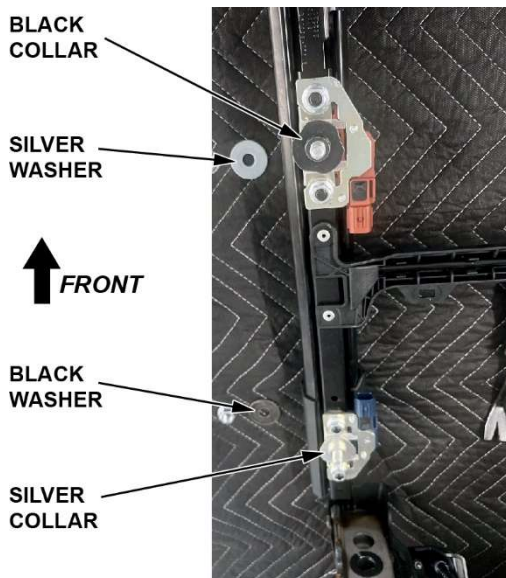
16. Install the seat rail to the seat frame with the metal collars.

NOTE: The silver washer, black collar for left front and black washer, silver collar for left rear.

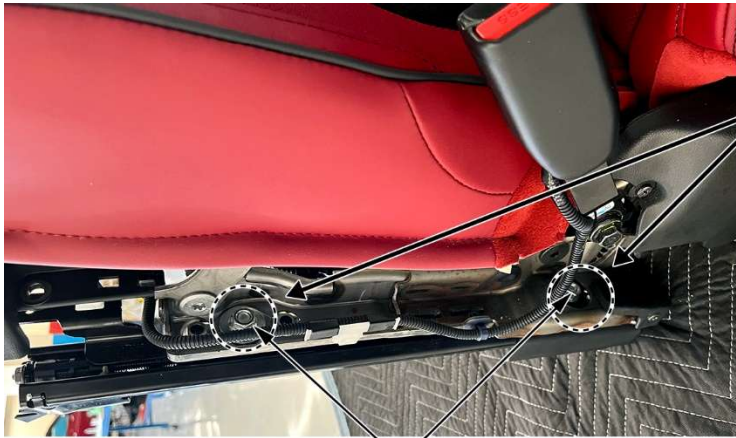
17. Using new washers and nuts, torque the left side seat frame flange nuts to **55 N·m (40 lb-ft)**. Torque the right-side bolts to **25 N·m (18 lb-ft)**.

NOTE: Use the Snap-On Torque Wrench (P/N: 07AAA-TVAA400) and the box-end head to tighten the seat rail nuts.

**NUTS**  
55 N·m (40 lb-ft)

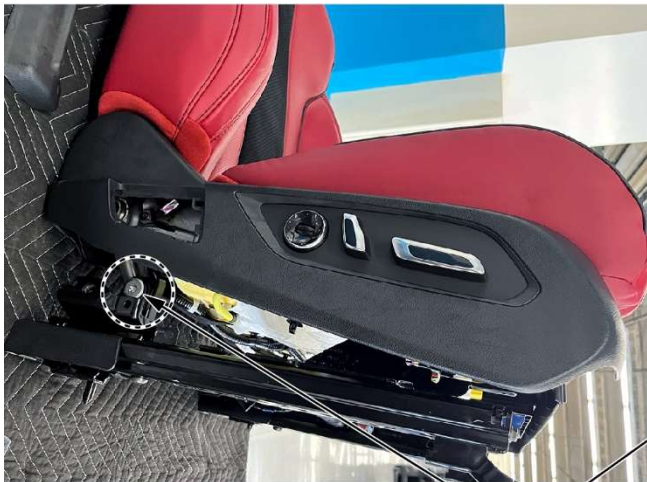
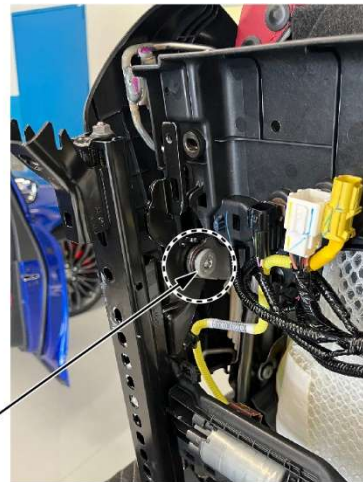
**BOLTS**  
25 N·m (18 lb-ft)

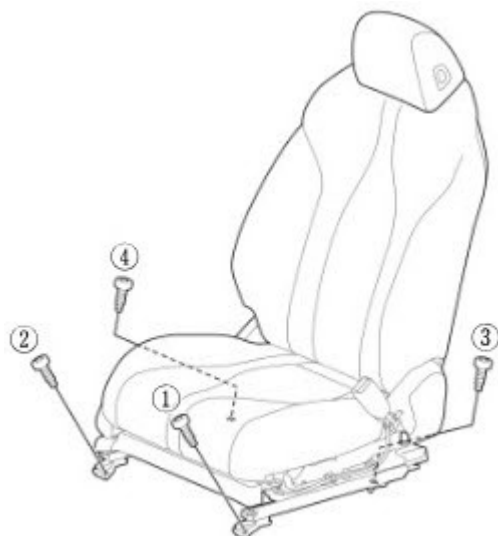
18. Install the seat and hand tighten the bolts first, then torque them in the sequence shown **43 N·m (32 lb-ft)**.

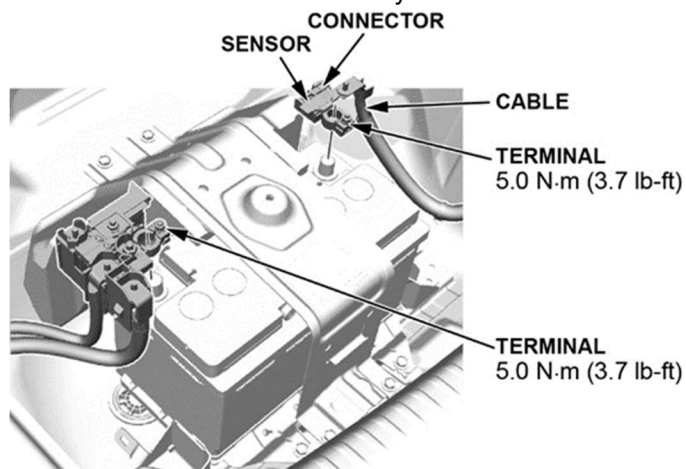
20. Connect the terminal to the 12-volt battery.

NOTE: Do not hold the 12-volt battery sensor connector when installing the terminal to protect it from damage.
